FINAL REPORT

AAIU Synoptic Report No: 2009-024
State File No: IRL00909014
Published: 07/12/09

Aircraft Type and Registration:	BAe RJ85, EI-RJF
No. And Type of Engines:	4 x Lycoming LF 507-1F
Aircraft Serial Number:	E2337
Year of Manufacture:	1998
Date and Time (UTC):	2 March 2009 @ 17.44 hrs
Location:	Dublin Airport Ramp Area
Type of Flight:	Public Transport
Persons on Board:	Crew - 5 Passengers - 48
Injuries:	Crew - Nil Passengers - Nil
Nature of Damage:	Serious, aircraft skin punctured by impact with tug vehicle
Commander's Licence:	ATPL(A)
Commander's Details:	Male, aged 31 years
Commander's Flying Experience:	4,700 hours, of which 2,800 were on type
Notification Source:	Airside Duty Manager, Dublin Airport
Information Source:	AAIU Pilot Report Form submitted by Pilot - AAIU Field Investigation

SYNOPSIS

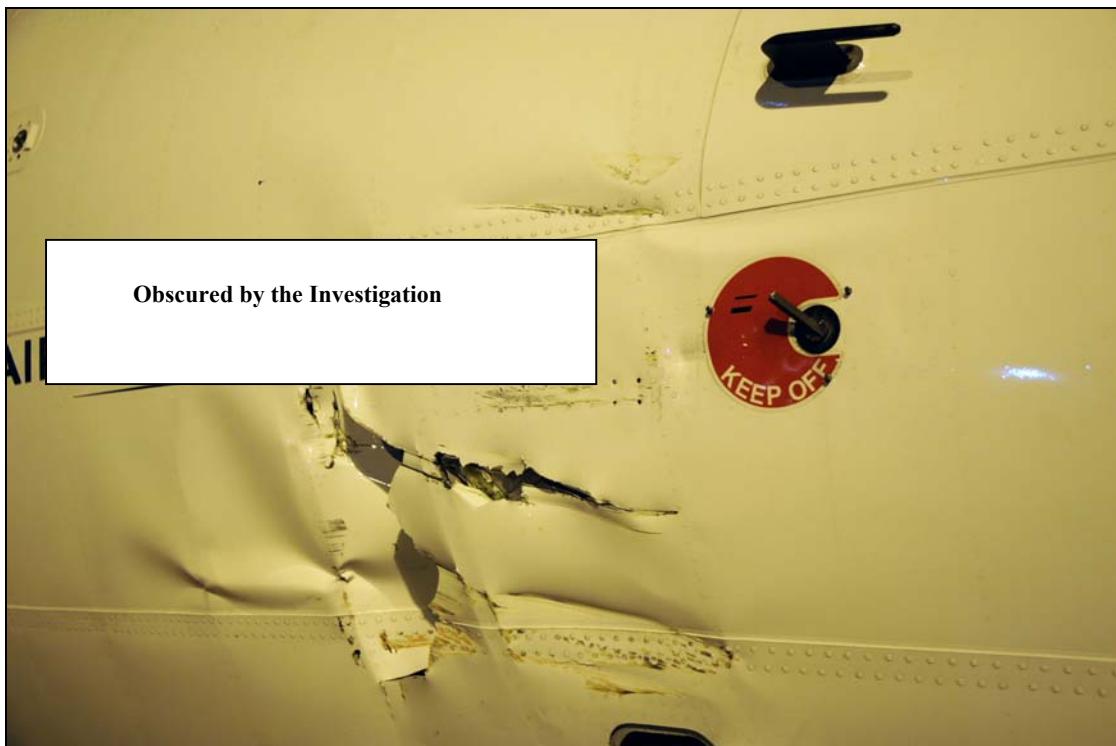
During the pushback to abeam Stand 37, the other three engines were started with the permission of the engineer and were at ground idle as the pushback stopped abeam Stand 37. Here, the tug driver initiated a pull forward with a turning component, in other words this pull forward was not in a straight line but in an arc. This was carried out on his own initiative with the probable intention of a minor realignment of the aircraft nose wheel back onto the taxi-line. During this pull the tug driver felt that the aircraft was pushing the tug (the aircraft weighed approximately 34,300 kgs), he braked but the aircraft continued forward, the tug jack-knifed and the tow bar broke (the shear-pins did not shear). The aircraft continued forward under its own inertia and struck the tug. The impact caused the tug to be lifted up against the starboard side of the front of the aircraft, having been turned through 180 degrees. As a result, the aircraft suffered serious damage to its forward skin under the cockpit and to a number of its structural frames (**Photo No. 1**).

At the request of the Operator of EI-RJF, the manufacturer, BAe Systems, was requested to carry out a structural survey of the aircraft following this accident. Their comprehensive Report showed that the aircraft had sustained damage at various locations between Frames 4 and 12. The recommended corrective action included repairs to fuselage skin panels, frames and sub-structure. This repair work was carried out at the Operators hangar facility at Dublin Airport. The aircraft then returned to service on 18 of May 2009.

Photo No. 1: Damage to aircraft
