FINAL REPORT

AAIU Formal Report No: 2009-027

Model: PA 28-180 Archer

Registration: G-BGTJ

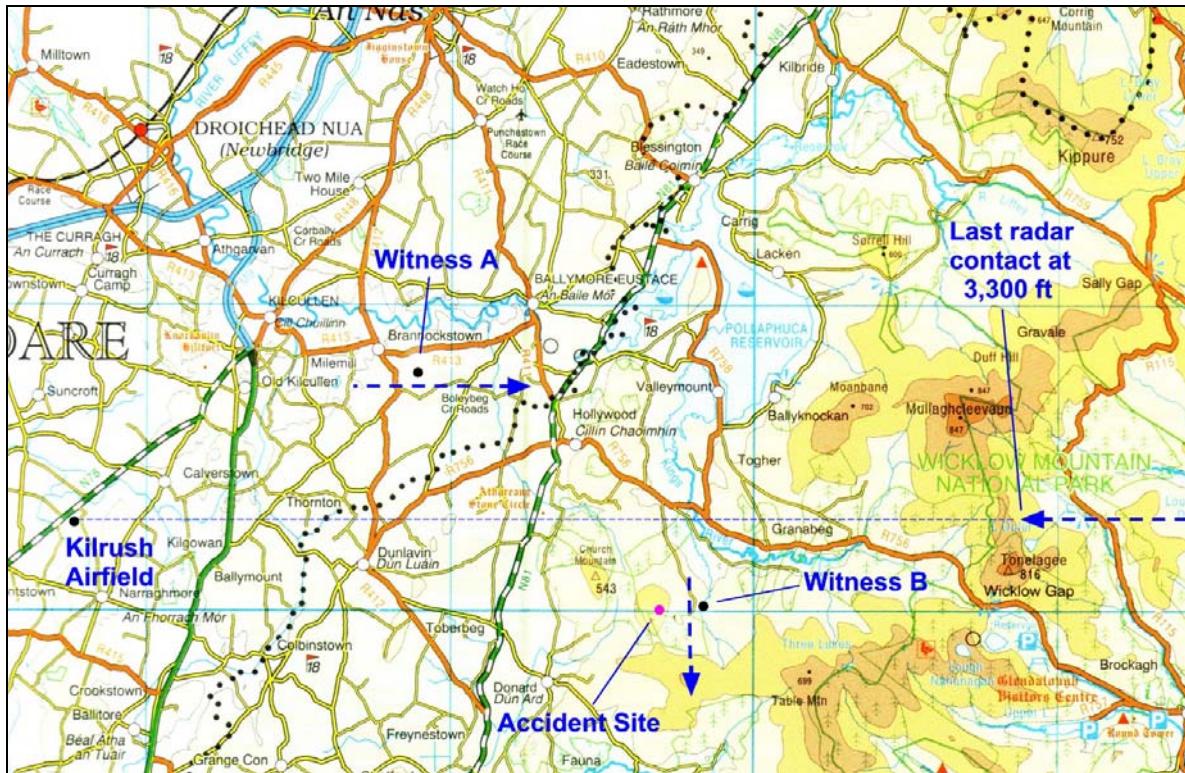
There is evidence based on witness statements that suggests the aircraft was manoeuvring at low level for some time prior to the accident. The position of witnesses relative to the intended flight path is illustrated in **Figure No. 1**. Witness A (a pilot himself) recalls hearing a single-engine aircraft '*going over his house on an easterly direction under considerable power*'. The witness's house was situated at Boleybeg, near Brannockstown, Co. Kildare, 8 miles northeast of Kilrush, and 3 miles North of the direct track the aircraft would have taken to Kilrush. He could not see the aircraft due to the low cloud, and he estimated the cloudbase to be approximately 500 ft above the ground. He heard no other aircraft in the area that day.

A second witness, Witness B, located at her house 1 mile to the east of Corriebracks Mt. stated she saw the aircraft '*at low level, in and out of cloud*' heading in a southerly direction to the east of the summit. Neither Witness could recall the time the aircraft passed their location. The exact time of impact could not be established. However considering the last recorded radar contact, position of witnesses, and the location of the accident site, it is probable that the aircraft was airborne for at least 20 minutes after the last recorded radar contact at 11.26 hrs.

Figure No. 1: Positions of witnesses, known flight paths indicated
(based on Ordnance Survey 1:250,000)

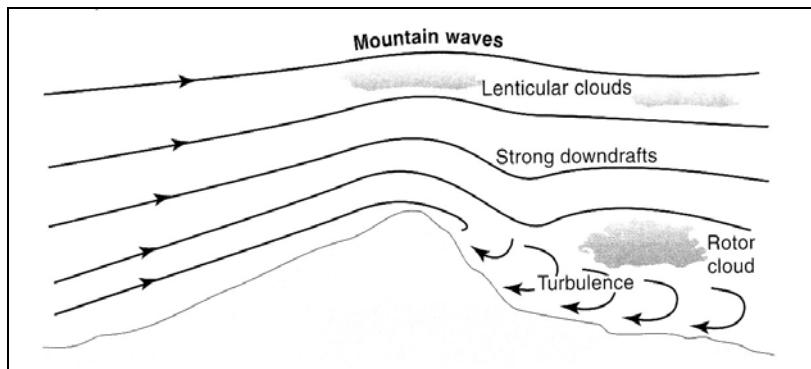
Included in the above report is a reference to '*Mountain Wave*' formation. This phenomenon is found when strong winds pass over mountainous terrain, producing strong up and down currents (windshear), the effect of which may extend well above ground level and many miles downwind of the range. Also, on the lee side of the mountain, rotor cloud may form producing severe turbulence (**Figure No. 2**). The area of downdraught can be quite extensive and vertical air movements exceeding 1,000 ft/min have been encountered by glider pilots in this mountain range.

Figure No. 2: Mountain waves and rotor cloud (*Airlife Publishing*)

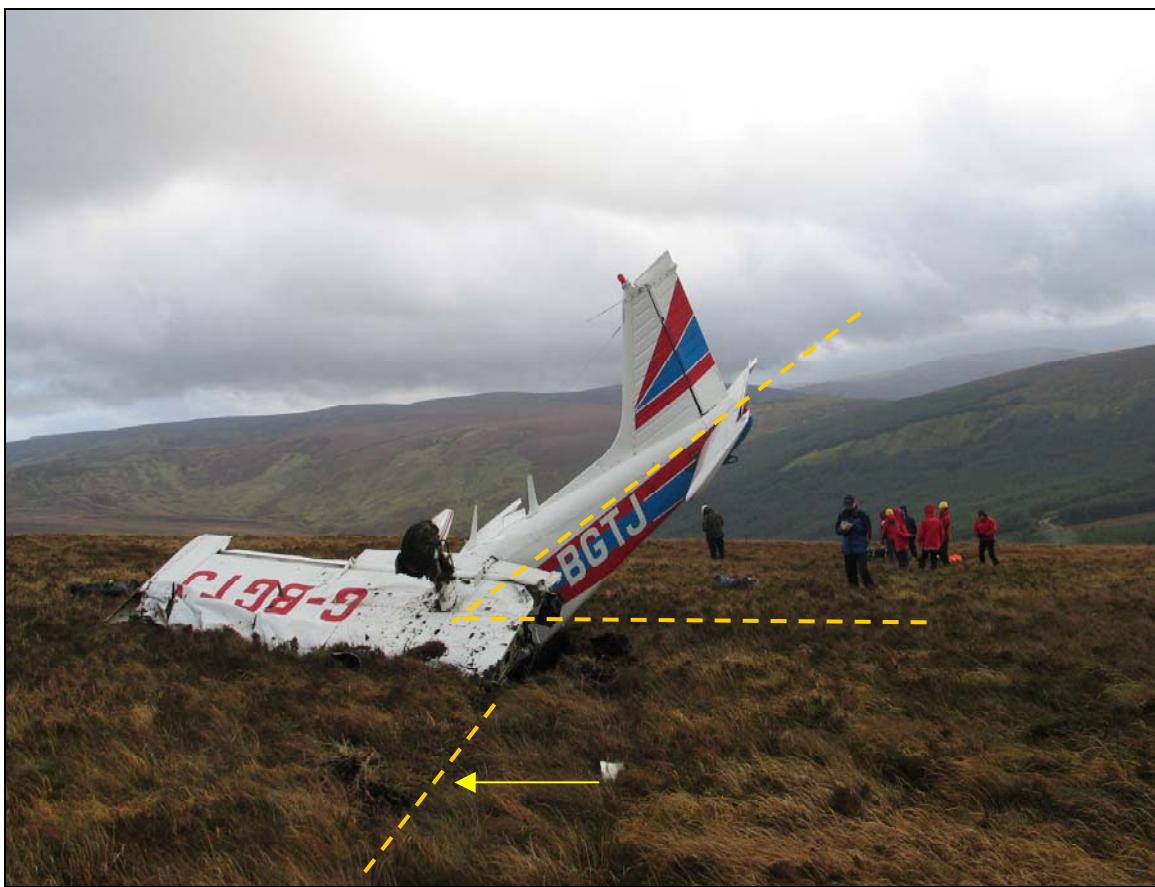
All components of the aircraft were accounted for at the accident site. The aircraft impacted into wet, boggy terrain and came to rest with the propeller, engine and forward cabin embedded below ground level. The fuselage was found at an angle of approximately 40° to the horizontal and on a magnetic heading of 076° (**Photo No. 1**). Initial ground contact was made by the nose undercarriage, shearing off the leg. The forward fuselage penetrated the bog until the leading edges of the wings made ground contact.

The left wing suffered the more severe contact and separated from the fuselage at the root, coming to rest lying against the fuselage. The inboard leading edge of the right wing also made heavy impact, causing the inboard section to crumple significantly while the outboard leading edge remained virtually intact. As the aircraft penetrated the bog the undercarriage and left wing made ground witness marks on the surface. The undercarriage marks were 1 metre from the rear of the final resting position of the fuselage, consistent with a steep entry angle at low speed. There was no evidence of aircraft rotation at impact.

The propeller was completely embedded in the peat bog and only the lower blade tip sustained minor deformation. The engine bearer showed significant distortion. The aircraft fuselage was substantially intact showing only signs of minor crumpling. The engine turned freely by hand once the sparkplugs had been removed to permit draining of ground water from the cylinders. Except for the extreme tip of the lower blade, the propeller showed no deformation on impact. The aircraft clock and personal wristwatches of the occupants were still functioning when examined by the Investigation.

Photo No. 1: Wreckage impact angle and initial port wing impact (indicated by arrow)

Evidence at the accident site revealed the aircraft impacted in a nose-down attitude of approximately 40 degrees at a relatively low forward speed. The nose impacted first followed by the wing leading edges. After the initial impact the aircraft penetrated the water-soaked peat at a steep angle. Distortion of the engine bearer occurred at this point. The engine stopped under increased load during the final forward movement, bending the lower propeller blade tip rearwards. The absence of gross distortion of the fuselage indicates a relatively low impact speed. The lack of engine damage and the condition of the propeller indicates that the engine was under power at the time of impact. Detailed inspection of the airframe and engine at the AAIU facility at Gormanston did not reveal any defects that could have contributed to, or caused a loss of control leading to the accident. The direction of impact corresponded with the aircraft heading downwind. A rapid turn onto a downwind heading could have precipitated a stall, given the weather conditions pertaining at the time.

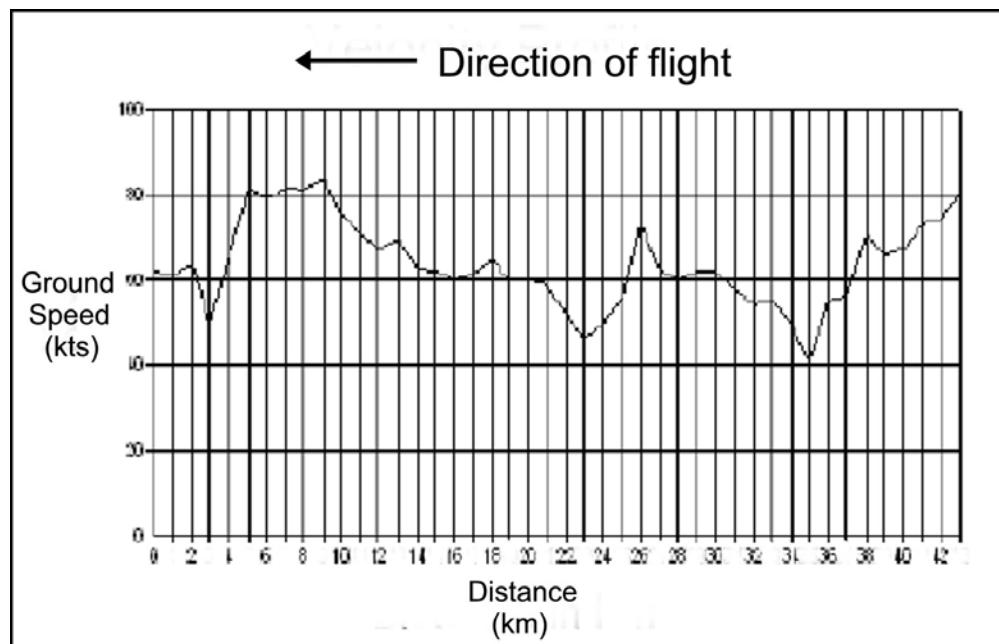
The groundspeed profile of G-BGTJ was extracted from radar information recorded by Dublin ATC. This profile is reproduced in **Figure No. 3**. This graph shows the aircraft's groundspeed (kts) vs. distance flown (km) measured at 1 km intervals. The distance scale reflects the final 43 km the aircraft was in radar contact (direction of flight indicated). The data shows the aircraft groundspeed averaging 64 kts and varying between 84 and 42 kts over a distance of 29 km. The erratic groundspeed indicates gusty wind conditions. The Pilot's ATC flight plan showed an intended cruising speed of 110 kts (True airspeed).

Figure No. 3: Profile of groundspeed (kts) vs distance (km)

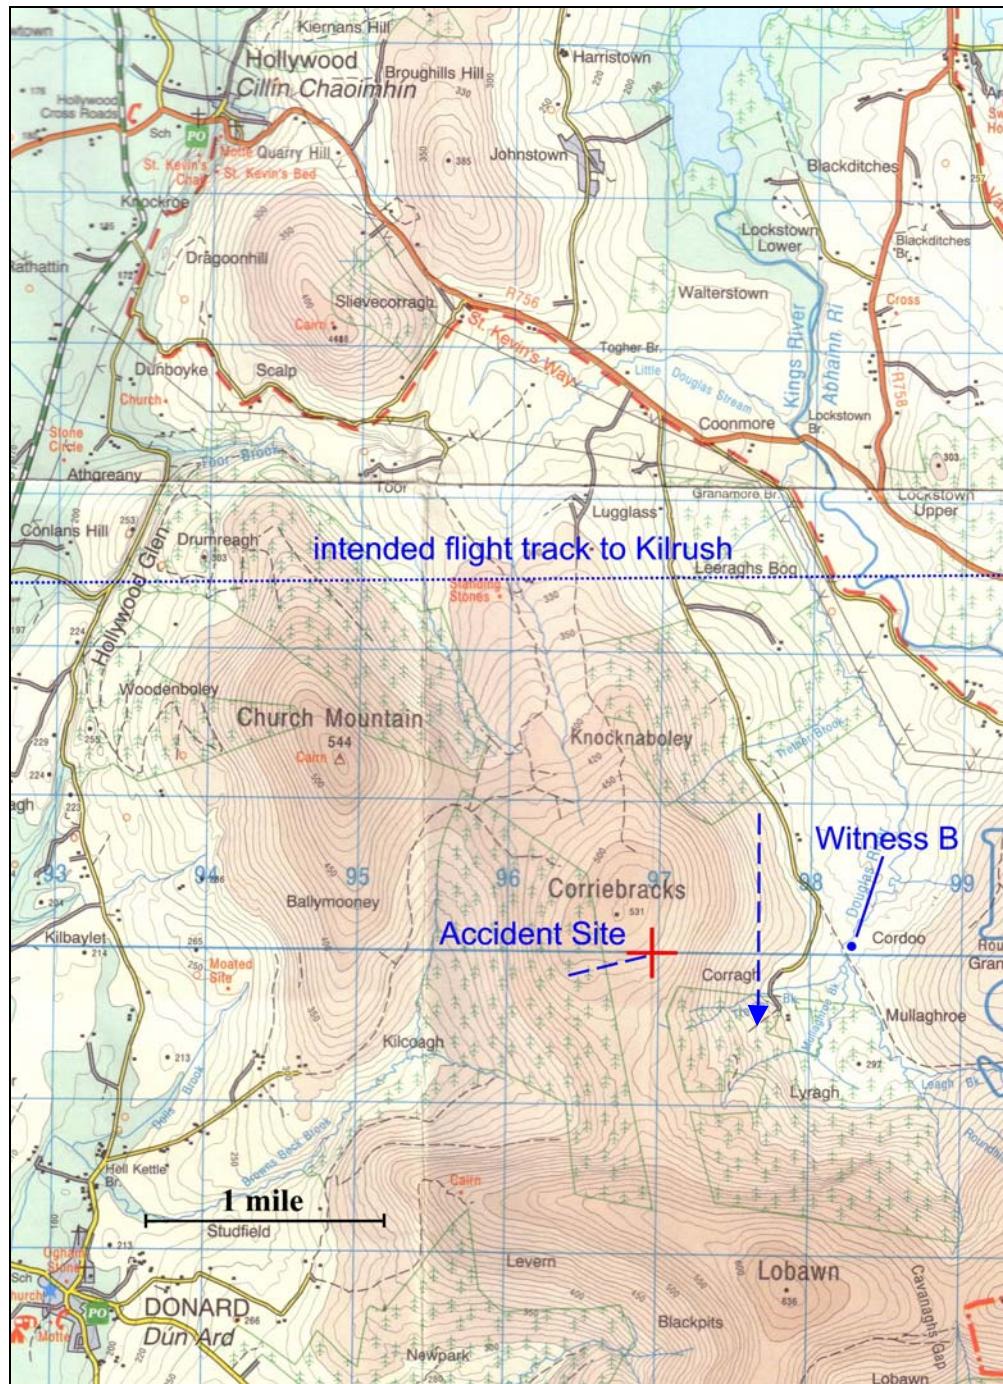
Appendix B

The aircraft crossed the Irish Sea at Flight Level⁴ (FL) 065 and made initial contact with Dublin ATC at 10.12 hrs. At 10.49 hrs the Pilot had descended to FL060 at the request of ATC and reported approaching the FIR boundary, approximately 20 nm east of the Irish coast. At this point the Pilot requested further descent and descended to an altitude of 4,000 ft. At 11.10 hrs the Pilot informed Dublin ATC that he was crossing the coast at Newcastle, and ATC requested that he report closing his flight plan at Kilrush. At 11.17:02 hrs, the Pilot advised Dublin ATC that he was 24 miles from Kilrush, requested to continue on his own navigation and to close his flight plan. Dublin ATC closed the flight plan as requested at 11.17:13 hrs. No further transmissions were received from the aircraft. The last radar contact was observed at 11.26 hrs with the aircraft on a westerly heading at an altitude of 3,300 ft in the vicinity of Glenmacnass Waterfall, Northeast of Tonelagee Mt, Co Wicklow. Weather conditions at the time of the accident were poor, with strong winds gusting in excess of 50 kts, poor visibility and rain. The aircraft impacted into boggy terrain southeast of the summit of Corriebracks Mt at an altitude of 1,500 ft AMSL⁵ (**Appendix B**).

Shortly after the sighting by Witness B, it is probable that the aircraft carried out a downwind turn to the right. This turn is significant, as it placed the aircraft downwind in severe gusting conditions. It is also highly probable that windshear and severe turbulence were present in this area of mountainous terrain. If the turn was made quickly in these conditions, the effect of drag together with the changes in relative airflow, may have resulted in a substantial loss of lift across the wing precipitating an aerodynamic stall. Ultimately, the aircraft probably entered an aerodynamic stall downwind at a low airspeed. Recovery from such a stall was not possible in the height available.

Final witnessed flight path and accident site
