FINAL REPORT

AAIU Synoptic Report No: 2006-008

Aircraft Type and Registration: Eurocopter SA 365N, EI-MIP

Location: Platform Bravo, Kinsale Gas Field

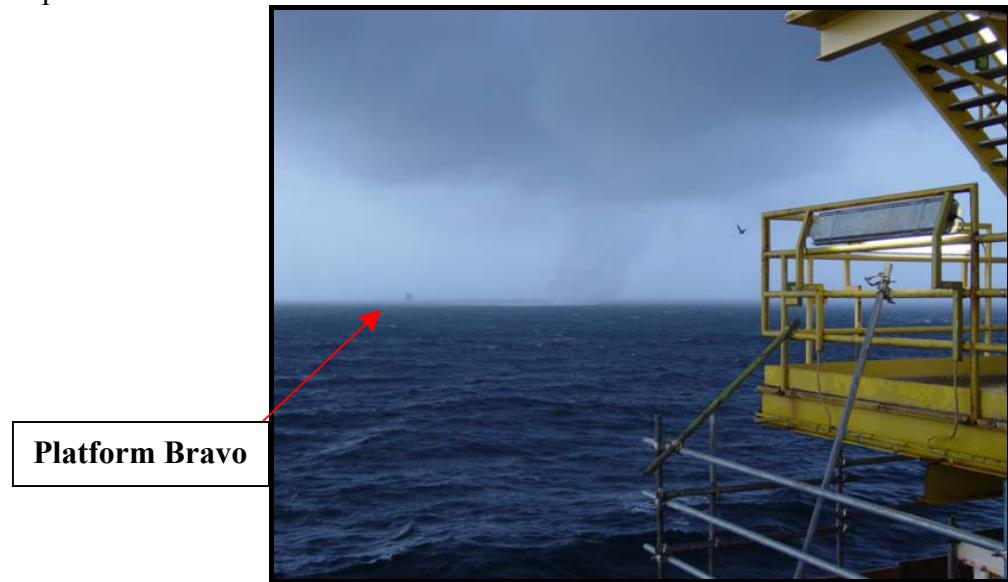
Photograph No. 1 was taken from Platform Alpha as the weather event had just passed Platform Bravo. The general wind direction at the time was 225°/35 kts. The track of the weather system originated southwest of Platform Bravo, passed directly overhead and tracked north-northeast at approximately 35 kts. **Photograph No. 2** shows the weather event passing northeast of Platform Alpha.

Photographs No. 1 and 2 could support a view that the event was a waterspout or tornado, however, this is not definitive. The winds encountered could also have been caused by a substantial Cb downdraught and the picture is reflective of a gust front rather than a waterspout or tornado. The radar picture (**Appendix A**) shows widespread Cb activity in the general area at the time of the incident.

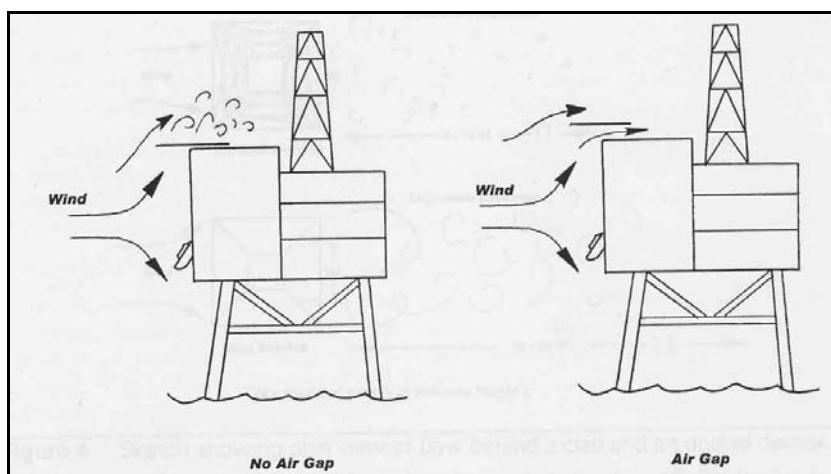
Difficulties arise when the wind has to deviate around the bulk of the offshore installation plus structures attached to the infrastructure such as cranes, drilling derricks and exhaust stacks. This causes large areas of flow distortion, accelerated winds and turbulent wakes/eddies. An air gap, separating the helideck from the superstructure beneath it, encourages the disturbed airflow to pass under the deck leaving a relatively linear and clean flow over the top. See Figure 1 below courtesy of CAA Paper 2004/02 - Helideck Design Considerations- Environmental Effects.

It is essential that the air gap is preserved throughout the installations' operational life, and does not become a storage area for bulky items that might obstruct the free flow of the air through the gap.

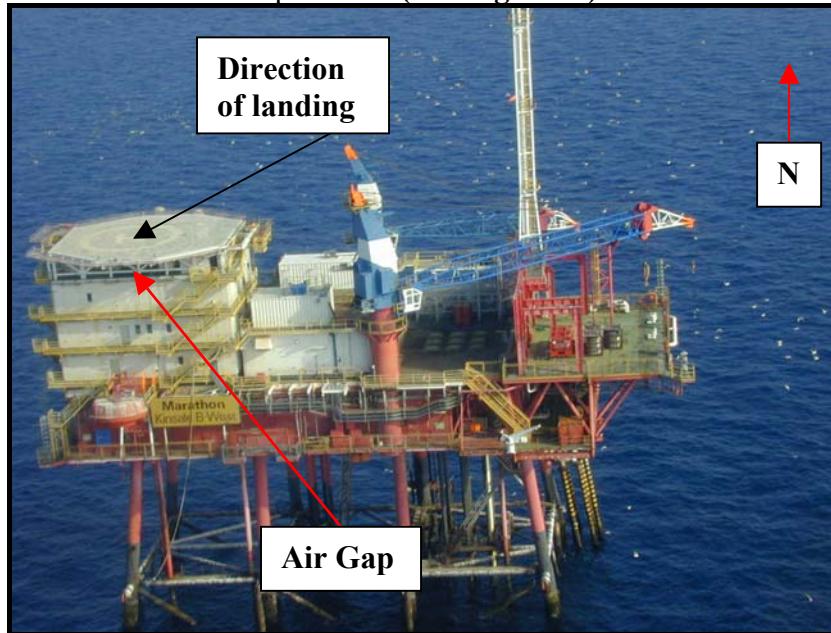
Photograph No. 3 Bravo Platform

The original design of Platform Bravo dates back to 1976. The helicopter deck is approximately 144 ft above mean sea level (amsl) and has a non-skid landing surface dimension of 18.5 metres by 19.7 metres. There is a clear narrow air gap running north/south underneath the helideck (**Photograph No. 3**). The air gap is approx 8 feet in height, but it also accommodates on either side, the east and west shelters that serve to facilitate helideck operations by storing necessary equipment and providing an area where passengers can don survival suits and life jackets. In addition, there are a number of water tanks located in the area together with fire fighting equipment associated with helideck operations (**See Figure 2.**).

Providing a clear air gap between the helideck and the superstructure does encourage disturbed air to pass under the deck, leaving a relatively linear and clear airflow over the top. Both Platform Alpha and Bravo were designed and fabricated in accordance with the required specifications of the day, and both helidecks have retained their operating certificate annually since they came into service. A clear 8 ft high airgap does exist underneath the centre of these helidecks, however, shelters, water tanks and fire fighting equipment are also accommodated on either side of the airgap. Essentially, the layout of these shelters and the other equipment located within the airgap, is in accordance with the original design of the facility. However, in the light of two recent 'turbulent deck' events, it is considered possible that under extreme wind conditions, the inclusion of ancillary structures in the area beneath the helideck, is affecting the full efficiency of the air gap.

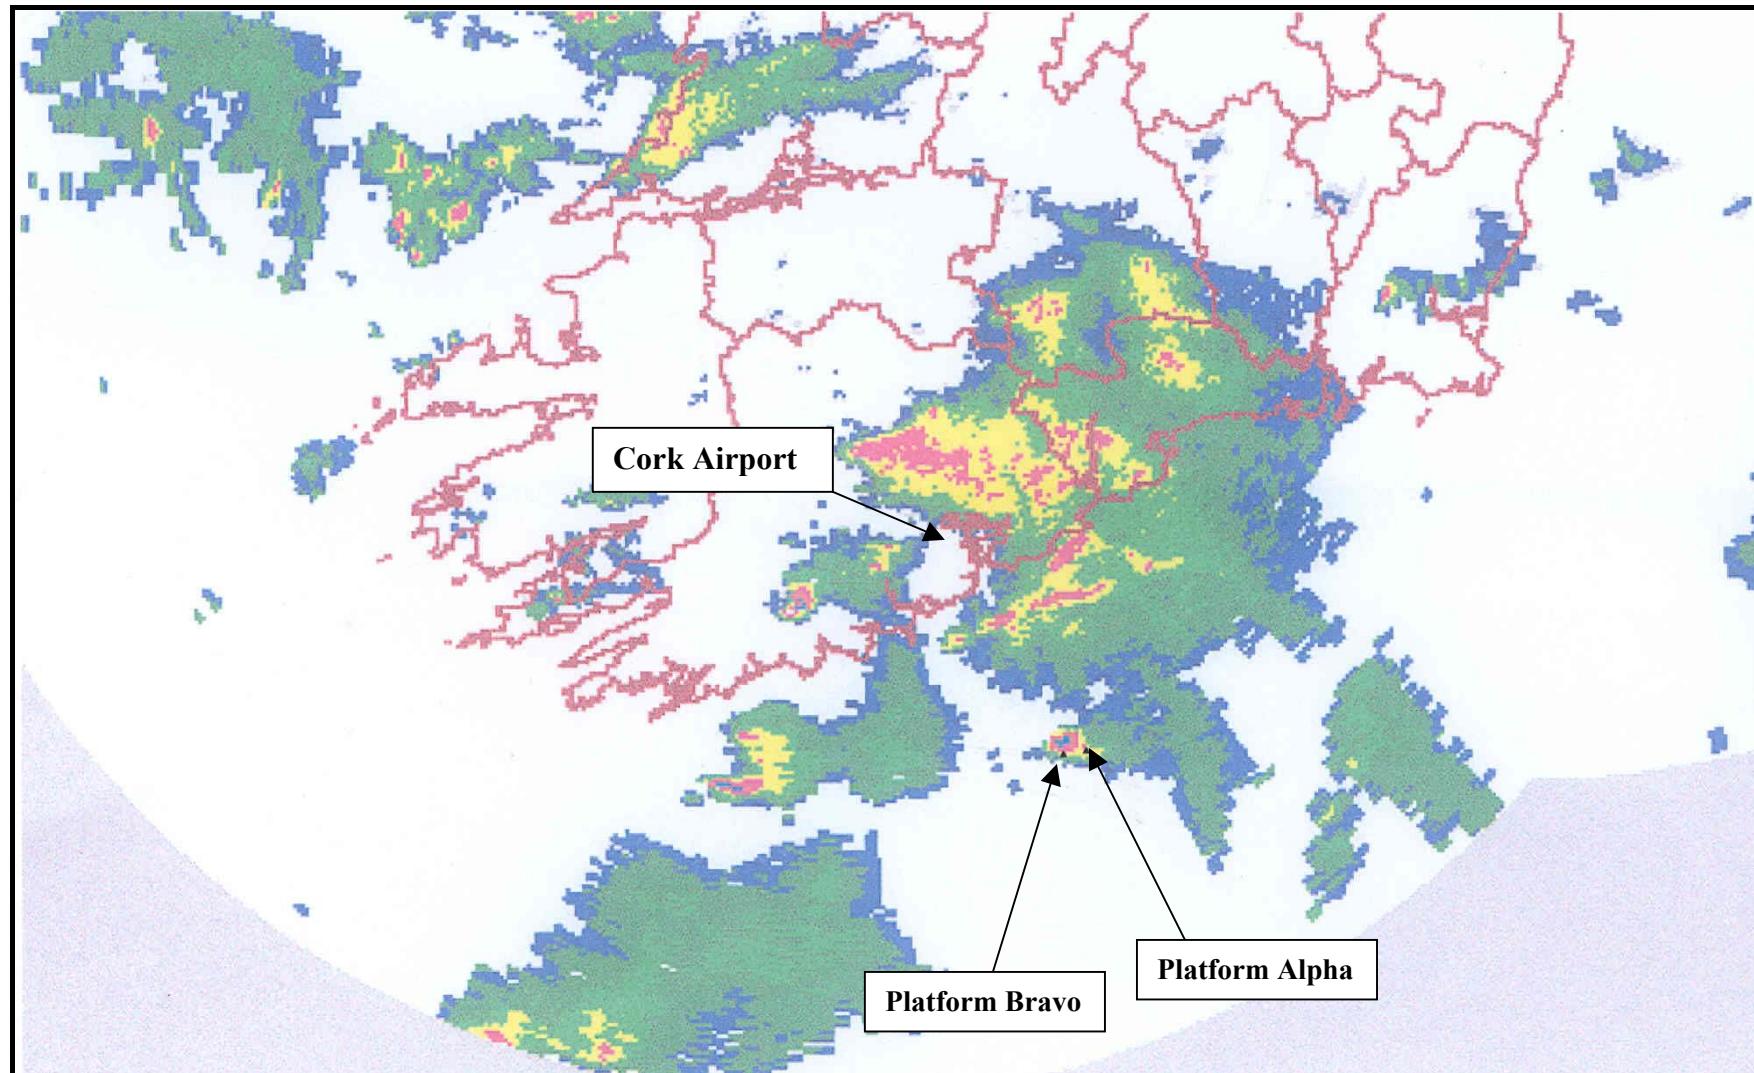
Appendix A Radar Picture Taken 08.45 hrs Local

Radar Images: Radar images at 08.45 hrs (L), as presented at **Appendix A**, show very active shower activity in the vicinity of the Kinsale gas platforms around the time of the event.

Note: Intense Cb activity (Red Colour) can be seen in the vicinity of both Platforms around the time of the event.
