FINAL REPORT

AAIU Synoptic Report No: 2008-026
State File No: IRL00900932
AAIU File No: 2007/0067
Published: 13/11/08

Aircraft Type and Registration:	Steen Skybolt, EI-CIZ
No. And Type of Engines:	1 x Lycoming IO-360-A1B 6D (Modified)
Aircraft Serial Number:	001
Year of Manufacture:	1980
Date and Time (UTC):	29 July 2007 @ 15.26 hrs approximately
Location:	Ardfert Private Airfield, Co. Kerry
Type of Flight:	Private
Persons on Board:	Crew - One
Injuries:	Crew - One (Fatal)
Nature of Damage:	Aircraft Destroyed
Commander's Licence:	PPL (A)
Commander's Details:	Male, aged 57 years
Commander's Flying Experience:	1,600 hours (of which approximately 500 were on type)
Notification Source:	A member of Coonagh Flying Club notified the AAIU
Information Source:	AAIU Field Investigation

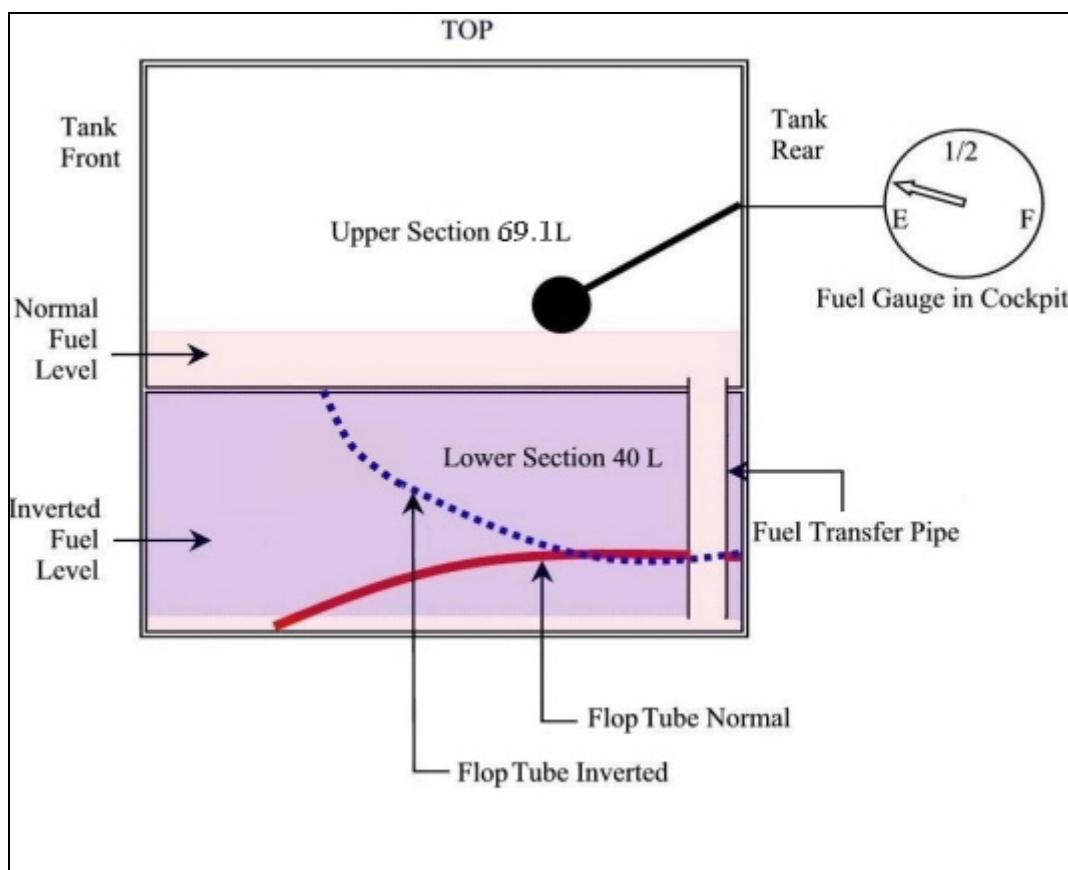
Diagram No. 1: Main Fuel tank

This pipe ensures that, in straight and level flight, while any amount of fuel remains in the upper section, the lower section will always be full. This pipe extends to within 35 mm of the bottom floor of the lower section to ensure that, in inverted flight, only a portion (approximately 9 litres) of the lower section contents would drain into the upper section. Only the upper section was fitted with a fuel measurement transmitter, which was of a float resistance type. The lower section had no fuel transmitter. Thus, the Pilot could only read the contents of the upper section from the cockpit fuel gauge. In addition, prior to flight, the Pilot was known to use a wooden dipstick to measure the upper section's fuel contents. However, it should be noted that there was no access to the lower section and thus it was impossible to measure its contents, even with the dipstick (**Appendix A**). Accordingly, when the fuel gauge in the cockpit reaches zero, the aircraft would still have 40 litres of fuel remaining in the lower section.

The flop tube fitted to EI-CIZ was a 3/4-inch diameter hose, with its fixed end mounted on the rear of the wall of the lower section of the tank. The flop tube was a length of semi rigid rubber hose, with an outer covering of braided steel, and a long brass weight (a 'clunk') on its free end. The clunk ensured that the free end of the flop tube moved about the tank so as to constantly stay close to the lowest point in the tank and was thus always submerged in fuel. The Investigation noted that it was not very flexible. When the tank was positioned, as it would be if the aircraft were in a vertical climb, it was noted that the flop tube did not fall to the side of the tank. It remained aligned along the forward/aft axis, due to the rigidity imposed by the braided steel hose, rather than fall to the side of the tank.

However, if the tank was positioned vertically and simultaneously rotated vigorously so as to simulate a climbing roll, it was noted that the flop tube fell against the side of the tank about half way up the wall. An arc-shaped mark was clearly visible on the inside of the tank where the clunk had, over a period of time, rubbed against the top, bottom and side walls of the lower section. The Investigation also noted that the combined length of the hose and the clunk was 38.5 cm. Thus the fuel intake, located at the end of the clunk, came to within 6.5 cm of the front wall of the tank.

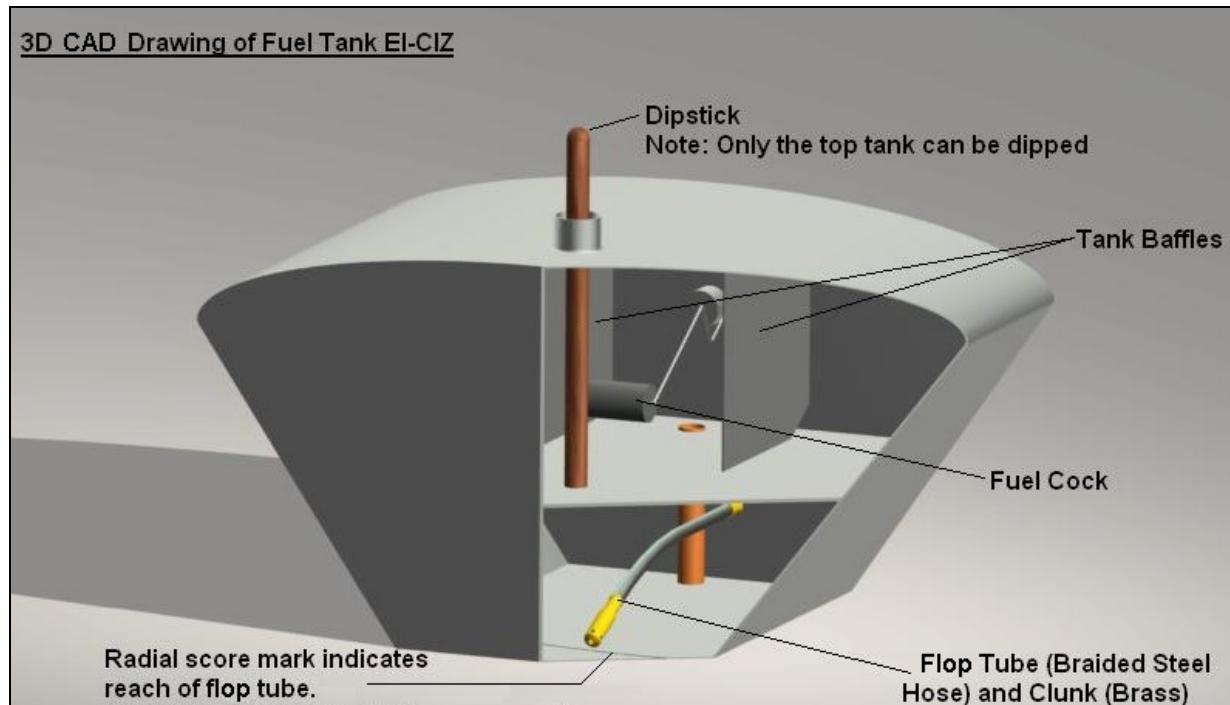
Appendix A

A pictorial representation of the main fuel tank.

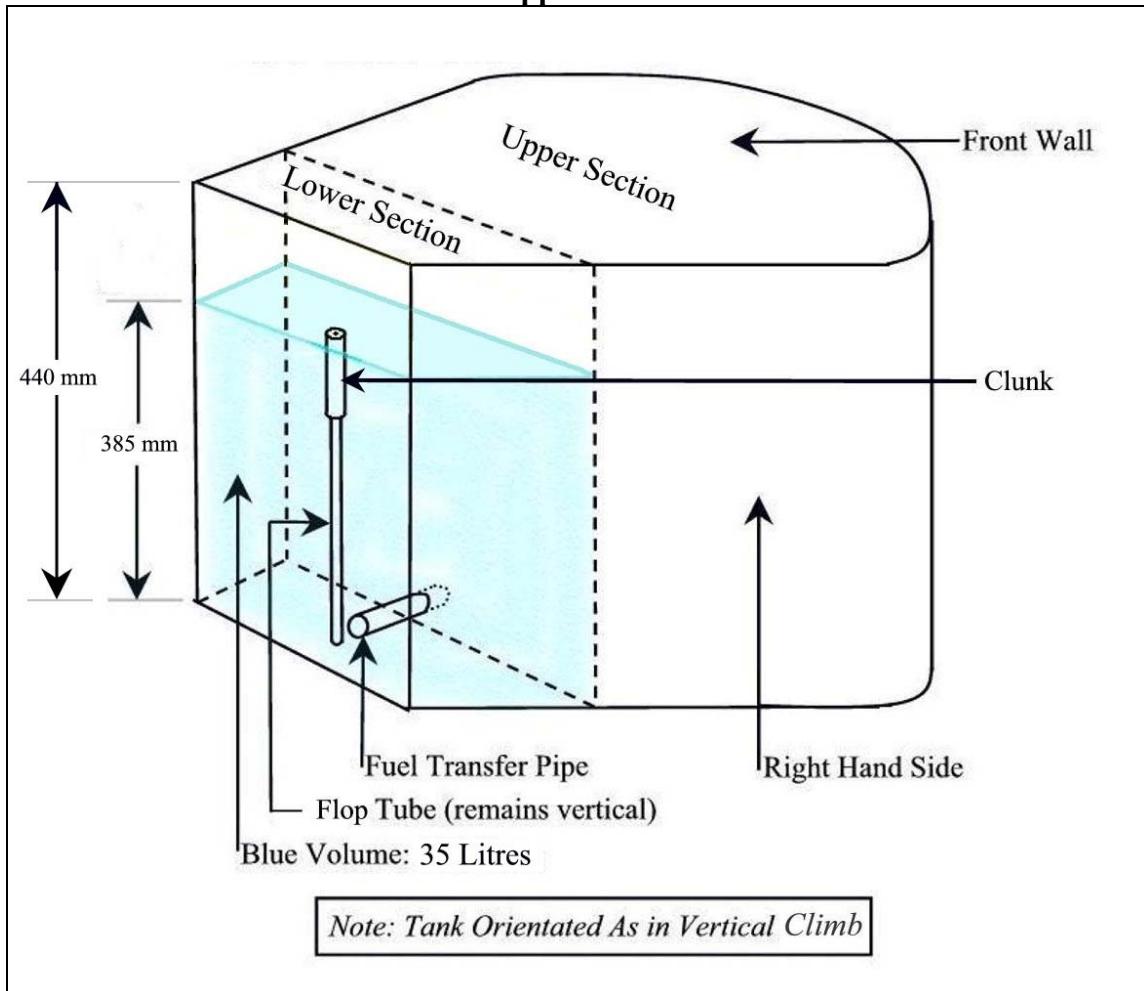
Appendix B

Calculations show that if the lower section contained approximately 34 litres of fuel (and zero in the upper section) the flop tube inlet can uncover if the tank is pitched into a vertical position, as would occur when the aircraft enters a vertical climb. This condition is shown in **Appendix B**.

The Investigation is of the opinion that if the aircraft had entered a near-vertical climb, with approximately 34 litres or less fuel in the lower section, and the clunk remained central, the fuel inlet in the clunk would have uncovered and air would have been sucked into the fuel system. During such a steep climb, the fuel level in the lower section would further reduce due to fuel draining into the upper section through the transfer tube.

This is shown in **Appendix B**. In a 3 second climb, as much as 4.5 litres would have transferred in this manner, lowering the fuel level in the lower section, thereby further increasing the uncovering of the clunk (flop tube inlet).

A pictorial diagram of the main fuel tank when the aircraft was in a vertical or very steep zoom climb
