FINAL REPORT

AAIU Report No: 2010-001
State File No: IRL00909040
Published: 18/01/10

Aircraft Type and Registration:	Beech Duchess 76, EI-BUN
No. and Type of Engines:	1 x Avco Lycoming O-360-A1G6D 1 x Avco Lycoming LO-360-A1G6D
Aircraft Serial Number:	ME 371
Year of Manufacture:	1980
Date and Time (UTC):	04 June 2009 @ 15.48 hrs
Location:	Weston Airport (EIWT), Co Kildare
Type of Flight:	Training
Persons on Board:	Crew - 2 Passengers - 1
Injuries:	Crew - Nil Passengers - Nil
Nature of Damage:	Significant
Commander's Licence:	Air Transport Pilot Licence (Aeroplanes) issued by the Irish Aviation Authority
Commander's Details:	Male, aged 37 years
Commander's Flying Experience:	11,500 hours, of which 250 were on type
Notification Source:	Weston Airport Manager
Information Source:	AAIU Pilot Report Form submitted by Pilot. AAIU Field Inspection.

SYNOPSIS

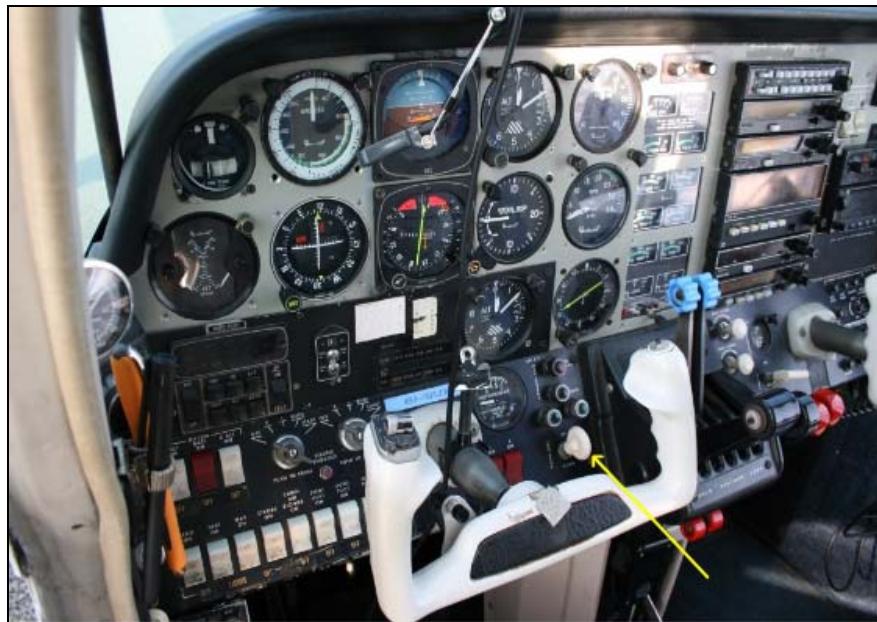
Photo No. 1: Location of Landing Gear Selector

The landing gear is controlled by a two-position selector handle located on the left sub-panel, (**Photo No. 1**). The handle must be pulled out of a safety detent before it can be moved to the opposite position.

The landing gear position indicator lights are located above the selector handle. Three green lights, one for each wheel, are illuminated whenever the landing gear is down and locked. The red light illuminates whenever the gear is in transit or in any intermediate position. All of the lights are extinguished when the gear is up.

The landing gear retracted due to the inadvertent movement of the landing gear selector switch from the DOWN to the UP position in the moments after touchdown.

Hawker Beechcraft Corporation should review the design and location of the Beech Duchess 76 landing gear selector switch so as to eliminate the possibility of inadvertent selection to the UP position. **IRLD2010001**

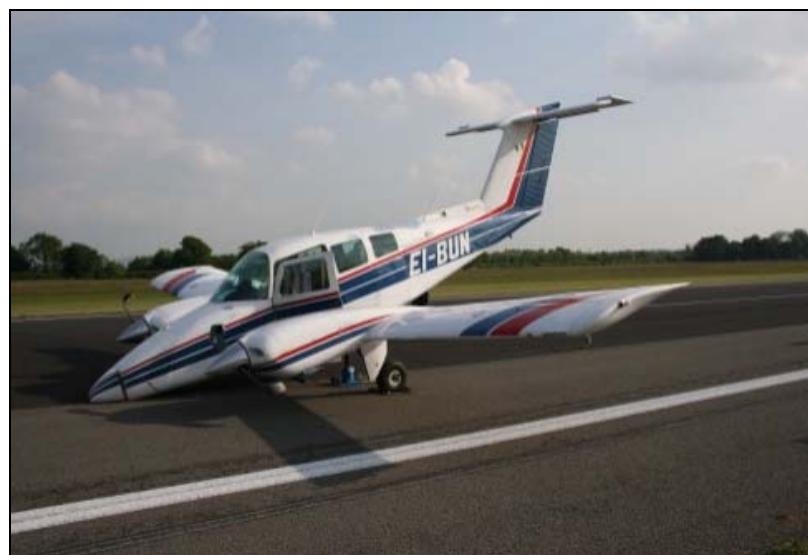
Photo No. 2: EI-BUN Final Resting Position

The aircraft suffered significant damage in the accident. The underside of the nose and the nose landing gear doors were badly damaged by the sliding contact with the runway asphalt surface. Propeller blade tips on either side of the aircraft had significant “curl” damage and undoubtedly both engines received consequent shock loading.

Two Inspectors from the AAIU arrived at Weston within an hour of the accident occurring. Other than jacks being placed under each wing for safety, the scene had been preserved for examination, (**Photo No. 2**).

The aircraft was sitting on its main landing gear and on its nose. It remained on the runway although it veered to the left during its slide and finished up with the port wing tip very close to the left hand runway edge. The nose gear was fully retracted and the nose gear doors were closed. The port landing gear leg had moved inboard by approximately 10° from the vertical while the starboard leg appeared to be in or close to the vertical position. The Investigation noted that the landing gear selector handle was in the UP position. The Investigation then placed the selector in the DOWN position and electrical power was switched on. The red landing gear in-transit light illuminated and by manually closing the main gear microswitches it was possible to illuminate the left and right “gear down” green lights. It was decided to attempt to extend the nose gear by taking the weight off the nose, using the landing gear circuit breakers to control the process. This operation was successful.

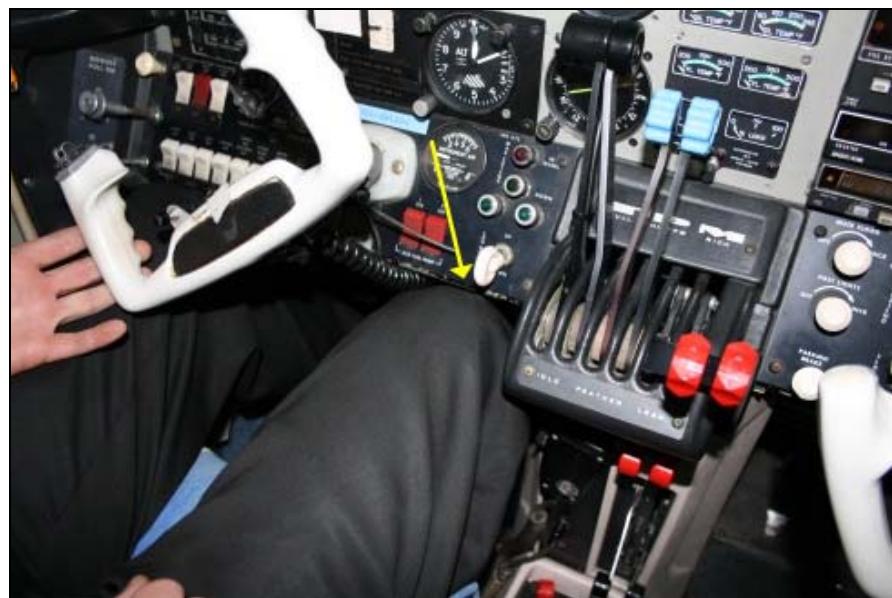
Photo No. 3: Student Seating Position

After the aircraft had been recovered to a hangar, the student sat into the left hand seat, which was in the same fore/aft position as when he had been flying. It was noted that the seat position was relatively far forward and that consequently his knee was within 5 cm of the landing gear selector, (**Photo No. 3**).

When he moved his feet upwards onto the brakes, which are located at the top of the rudder pedals, it was possible for his right knee to come into contact with the selector. It was also noted that, while it was necessary to pull the selector out of a detent to move it from DOWN to UP, the pulling action required was minor. A deliberate upward motion of the student's knee, while seated in his flying position, did in fact move the selector handle from the DOWN position to UP.

The inexperience of the student on type is likely to have led to a lack of awareness of the relative proximity of his right knee to the landing gear selector switch when seated in his normal flying position.
