## FINAL REPORT

**AAIU Report No: 2010-005**  
**State File No: IRL00910015**  
**Published: 28/06/2010**

<b>Aircraft Type and Registration:</b>	Schleicher ASK 13 (Glider) EI-GLD	
<b>No. and Type of Engines:</b>	N/A	
<b>Aircraft Serial Number:</b>	13131	
<b>Year of Manufacture:</b>	1969	
<b>Date and Time (UTC):</b>	6 March 2010 @ 15.35 hrs	
<b>Location:</b>	Field adjacent to Gowran Grange Airfield, Punchestown, Co. Kildare	
<b>Type of Flight:</b>	Private	
<b>Persons on Board:</b>	Crew - 1	Passengers - Nil
<b>Injuries:</b>	Crew - 1 (Minor)	
<b>Nature of Damage:</b>	Significant	
<b>Commander's Licence:</b>	Bronze C Cert issued by the Irish Gliding & Soaring Association (IGSA)	
<b>Commander's Details:</b>	Male, aged 63 years	
<b>Commander's Flying Experience:</b>	123 hours, of which 45 hours were on type	
<b>Notification Source:</b>	Dublin Gliding Club	
<b>Information Source:</b>	AAIU Pilot Report Form submitted by Pilot

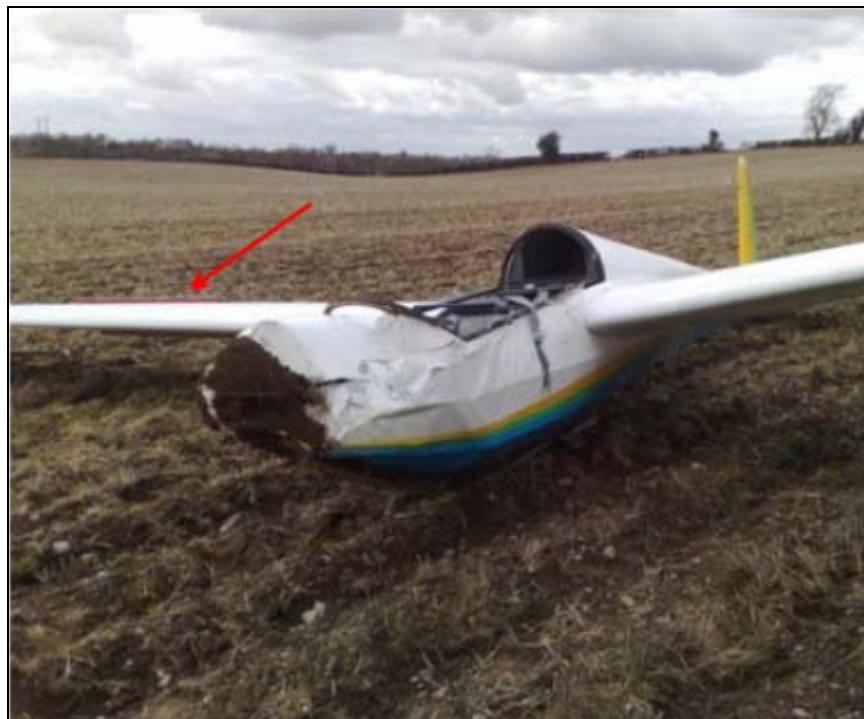
The canopy split apart on ground impact. The nose and forward cockpit section was compressed upwards and the starboard wing was damaged approximately halfway along the aileron cut out (**Photo No. 1**).

Observations from the ground on the day of the accident indicate that the airbrakes were partially deployed up to ground impact. Examination of the glider on the ground indicated that the airbrakes were deployed to approximately 25% of full deployment. **(Photo No. 1)**

**Photo No. 1: Damage to EI-GLD and part deployment of airbrake above and below wing (red arrow)**
