## FINAL REPORT

**AAIU Report No: 2010-019**

**Manufacturer:** Sikorsky

**Model:** S-76B

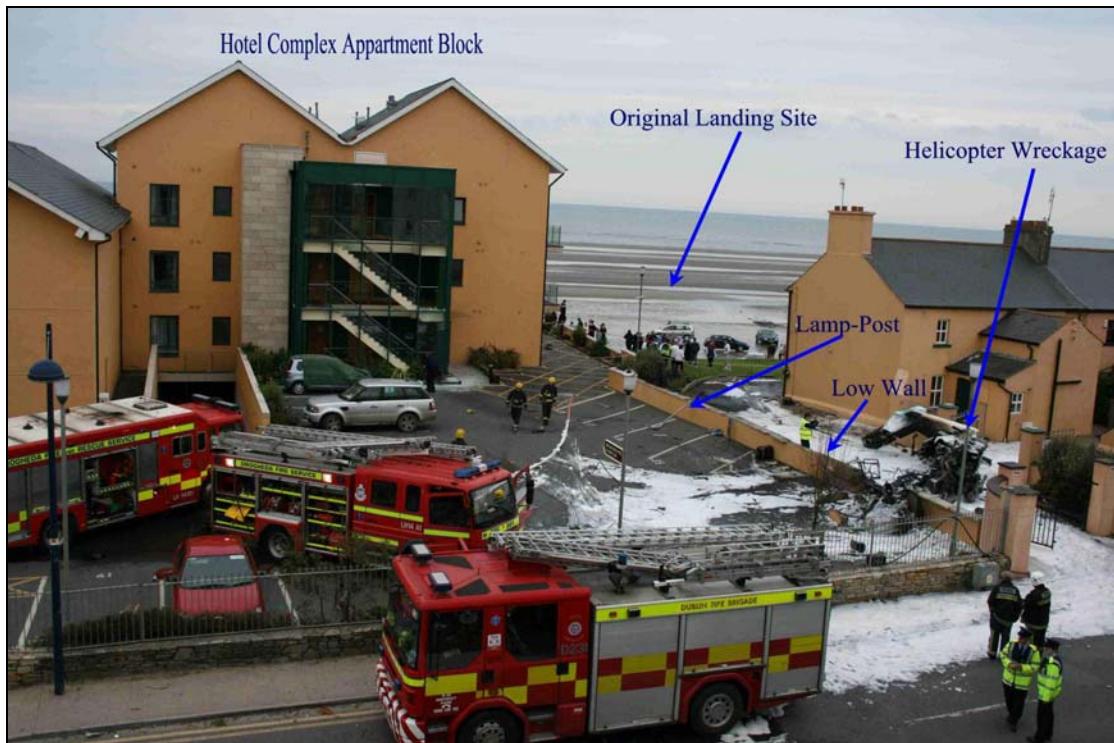
**Photo No. 1: Accident site looking east**  
(View from the apartment of a witness in Section 1.1.6.3)

The apartment block (to the east) contained within the Hotel complex was 14.3 metres (47 ft) high, while the apartment building on the main street (to the west and from where this photograph was taken) was 10.2 metres (33 ft) high. The gap between the apartment block and the house on the far side of the laneway (**Photo No. 1**) was measured at 12.5 metres (41 ft).

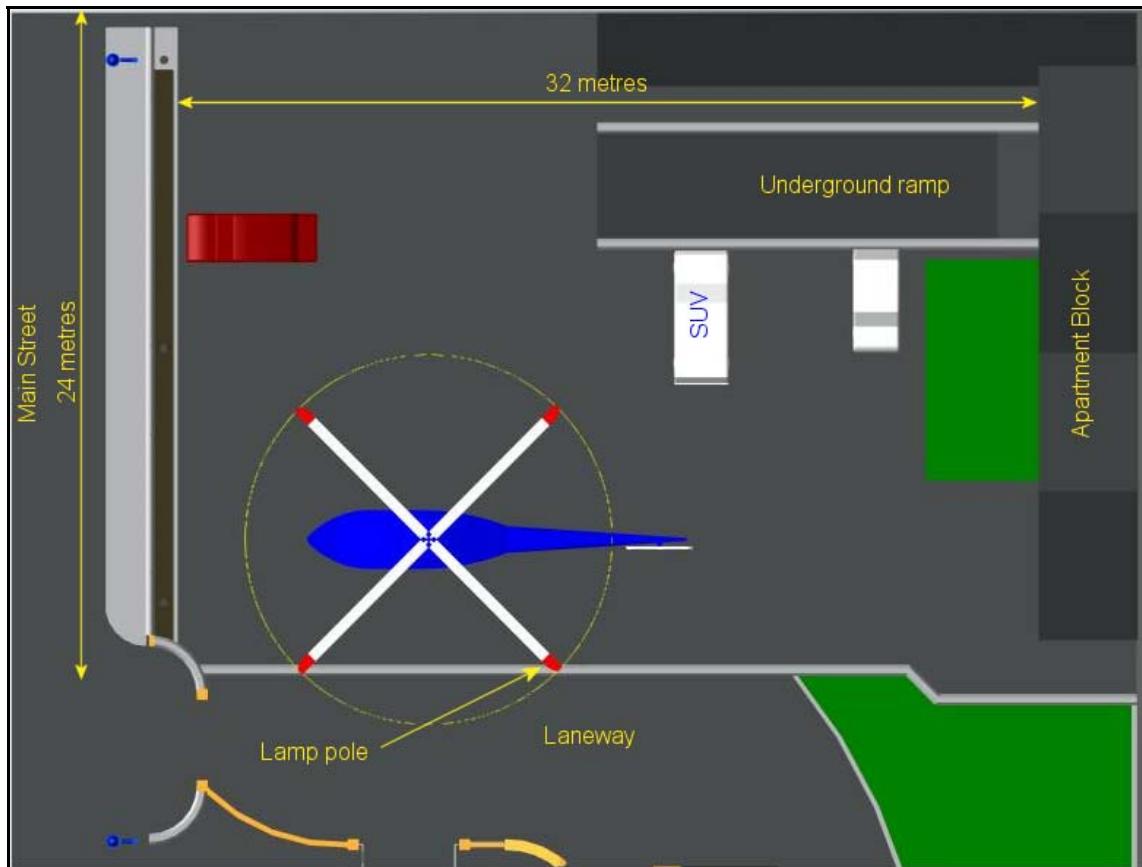
**Graphic 1** details the relevant measurements. The clear useful area in which the Pilot was attempting to land was approximately 15 by 15 metres.

**Graphic 1: Helicopter in estimated landing position**  
(Sketch-map orientation north up)

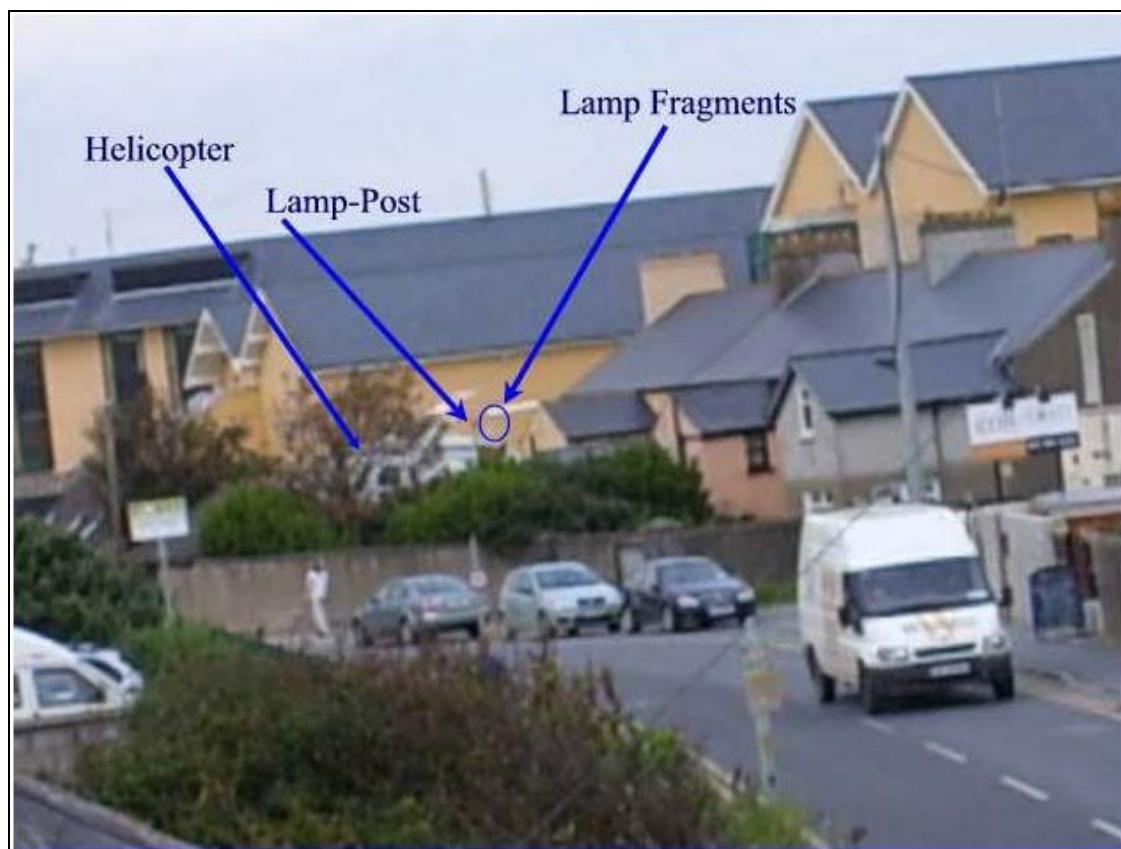
**Photo No. 2:** Initial contact with lamppost

**Note:** The falling lamp fragments appear as a lighter coloured (encircled) spot under the rotor blade. The darker coloured spot beside it is the lamppost.

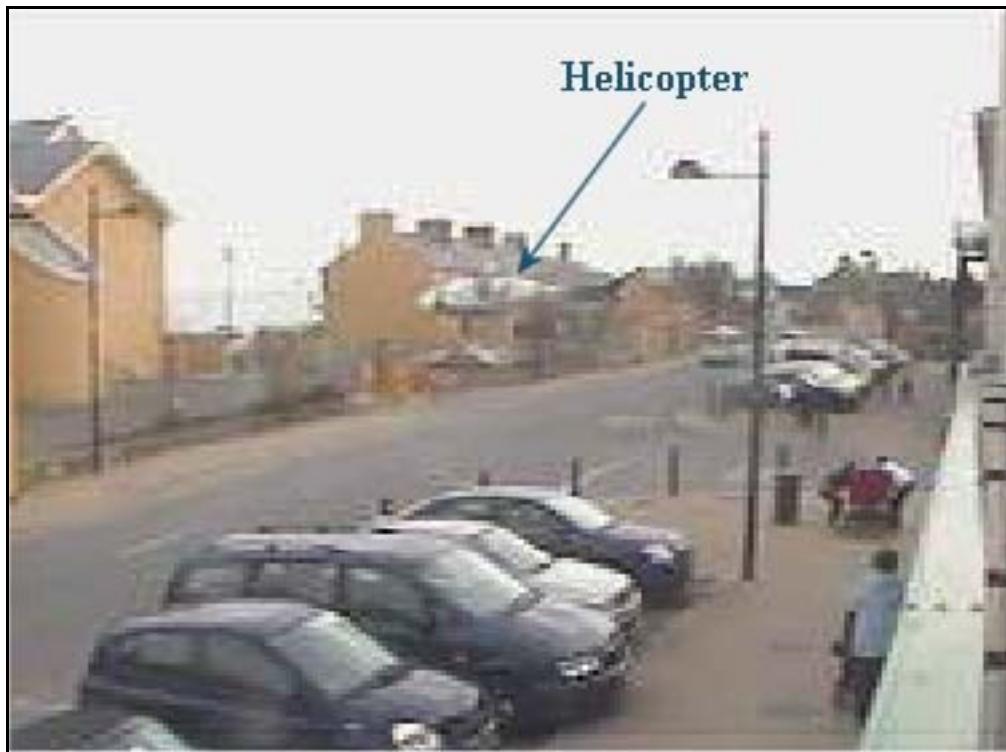
**Photo No. 3:** CCTV image recorded at time 15.41:08.25

**Photo No. 3** was taken from an image recorded by the CCTV camera at 15.41:08.25 hrs and shows the main rotor contacting the ground. The aircraft is on its side facing east, at right angles to the camera having yawed 180°, with an approximate 60° left bank angle.

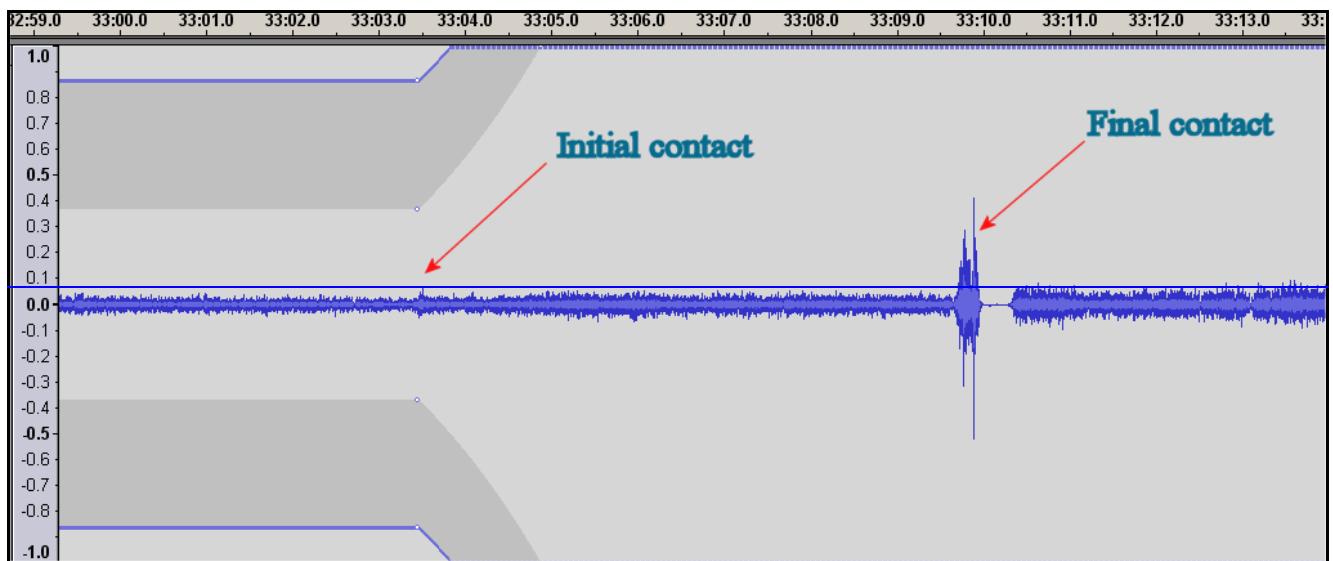
**Graphic 3 - CVR Channel No. 4, final segment of CVR recording**

**Note:** The blank trace recorded after the Final Contact is due to the CVR erase head having erased the earlier 30-minute recording, the beginning of which follows the erased section.

Channel No. 4 frequency graph shows 3 initial strikes of increasing amplitude. The initial contact above is amplified in **Graphic 4**:

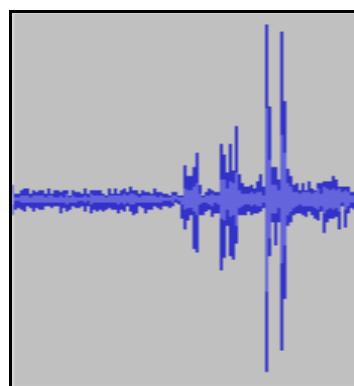
**Graphic 4 – Initial contact**

The elapsed time from Initial Contact to then end of Final Contact is 6.08 seconds.
