FINAL REPORT

AAIU Synoptic Report No: 2008-028
AAIU File No. 2007-0077
State File No: IRL00900942
Published: 03/12/2008

Aircraft Type and Registration: Solar Wings Aviation Pegasus XL-Q, G-MZCP
No. and Type of Engines: 1 x Rotax 462
Aircraft Serial Number: SW-TE-0434
Year of Manufacture: 1993
Date and Time (UTC): 03 September 2007 @ 12.10 hrs
Location: Carnew, Co Wexford
Type of Flight: Private
Persons on Board: Crew - 1
Injuries: Crew - 1
Nature of Damage: Microlight destroyed
Commander's Licence: None
Commander's Details: Male, aged 55 years
Commander's Flying Experience: 25 hours, of which 0 were on type
Notification Source: Garda Síochána in Gorey
Information Source: AAIU Field Inspection

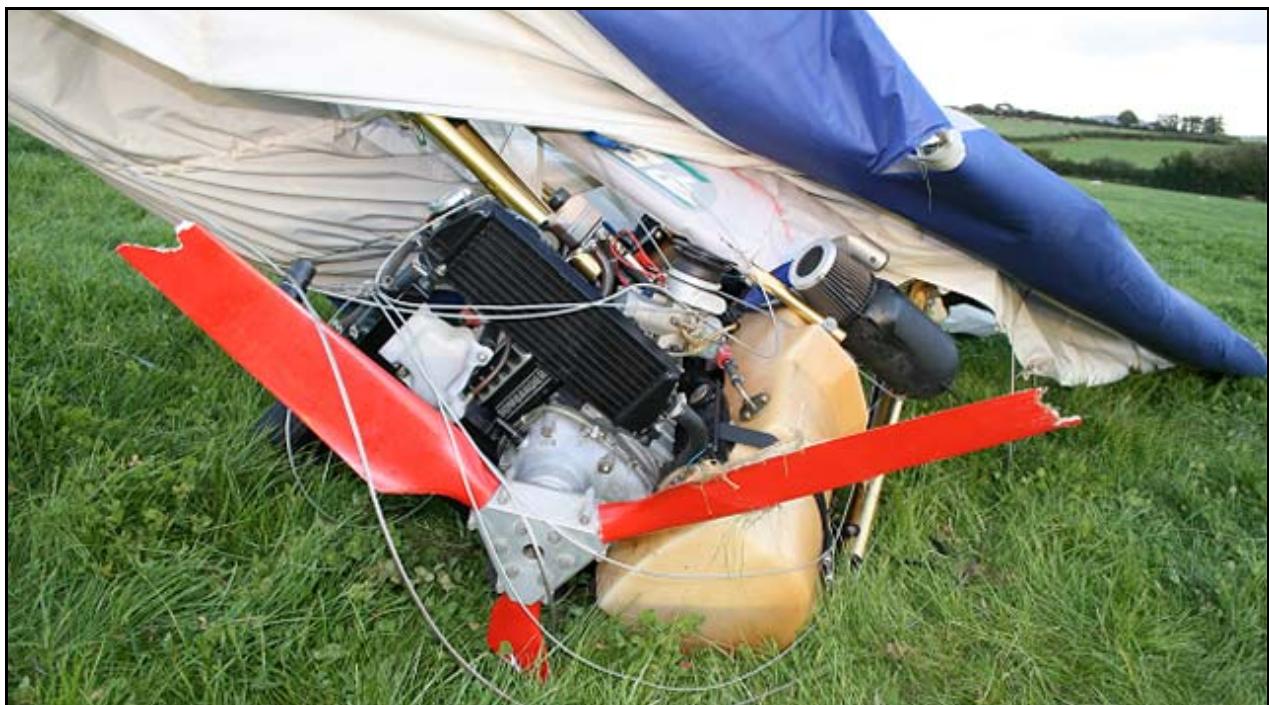
The Pilot had bought the aircraft in the UK and it had been delivered the previous day. Having rigged the aircraft he decided to take it for a flight. After take-off the Pilot found the handling of the microlight to be difficult possibly, he judged, due to a rigging error. He turned to the right and decided to land in a farm field, approximately 300 meters from his take-off point. After touchdown the nose initially lifted but, when it came back down, the microlight flipped over. The nose dug in, the nose wheel separated and the wings folded forward (**Photo No. 1**). The Pilot was injured and taken to hospital where his injuries were found to be minor.

Photo No. 1: G-MZCP post accident

The IAA, in conjunction with the NMAI, should review the regulatory and operational framework of microlight operations in Ireland. **(SR 24 of 2008)**
