Air Accident Investigation Unit Ireland

**ACCIDENT REPORT
Hoffman H-36 Dimona, EI-CRV,
Waterford Airport, Ireland
15 October 2010**

AAIU Report No: 2011-009

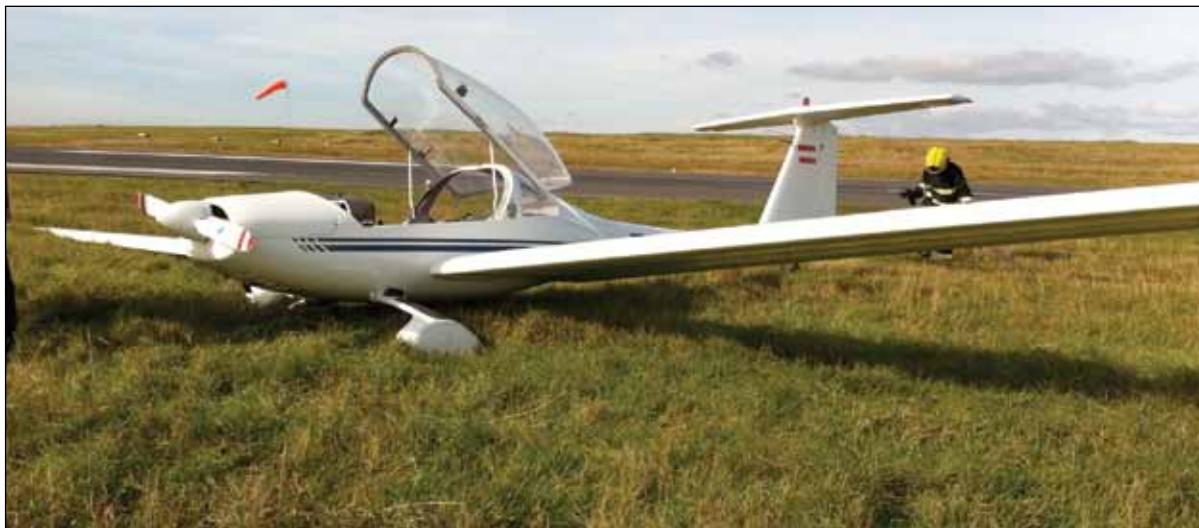
The Commander described how a swing developed to the right and he immediately called "*I have control*". He stated that "*the handling Pilot did not respond and appeared to freeze on the controls*". The aircraft departed the runway to the right passing over a runway edge light. As the aircraft left the runway, the right undercarriage leg collapsed. The aircraft came to rest in the grass approximately 17 m from the runway edge at an angle of approximately 100° to the runway centreline heading, **Photo No. 1**.

Photo No. 1: Final Resting Position of EI-CRV

The right hand undercarriage leg collapsed as the aircraft left the runway.

The Commander also commented that a contributory factor to the undercarriage collapse may have been "*the uneven transition from the runway surface to the runway strip*". He stated that there was a 5 cm lip at the runway edge, followed by a sunken gravel drain about 0.5 m wide, followed by a rough grass surface.
