Air Accident Investigation Unit Ireland

**ACCIDENT REPORT
Robinson R22 Beta II, EI-EAS
Hazelwood, Co. Sligo
27 June 2011**

AAIU Report No: 2011-015**State File No: IRL00911058****Published: 28/09/2011**

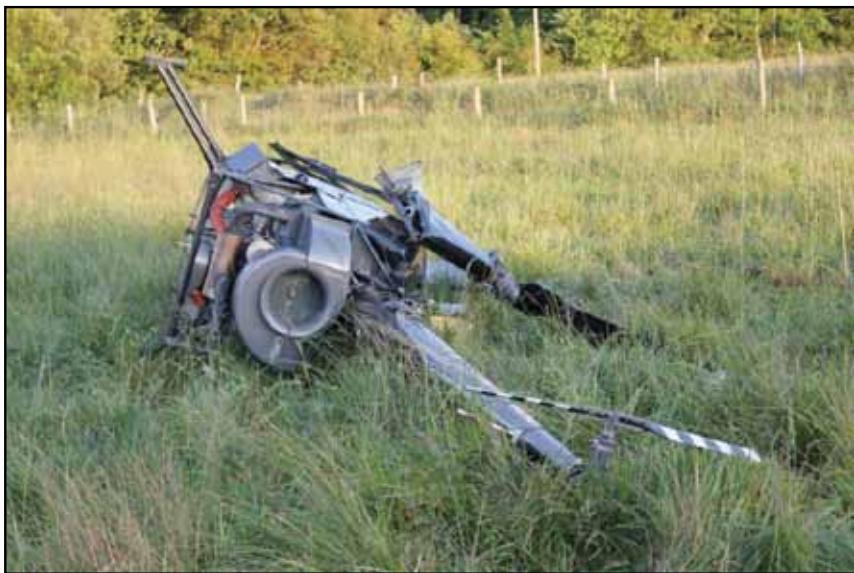
The landing site was a large rectangular open grassland field orientated in a north/south direction. The northern and eastern sides of the field were bounded by forest/trees. The southern and western sides were open fields free of significant obstacles. The area in which the Pilot positioned the helicopter for departure was open and flat. However, the surface was made up of deep grass with large 'clumps of grass' embedded. (**Photo No. 1**).

Photo No. 1: Final resting position of EI-EAS in deep and 'clumpy' grassland

The helicopter was substantially damaged. In particular, following main rotor blade ground contact, the main rotor driveshaft and pylon separated from the fuselage. In addition, the tail rotor drive shaft fractured within the tail boom.

1. The helicopter was manoeuvring nose out of wind with a downwind component.
2. The increased demand for power was not appropriately responded to by the Pilot, the helicopter descended and the right skid impacted the ground.
3. The helicopter subsequently suffered dynamic rollover to the right, following which the main rotor blades made ground contact and it came to rest on its right side.
4. The surface condition of deep clumpy grassland would have increased exposure to the risk of dynamic rollover during any lateral movement.
