FINAL REPORT

AAIU Formal Report No.2005-003
AAIU File No: 2003/0026
Published:03/02/05

| Registration: | G-OPDM |
| Location: | Glenbeigh, Co. Kerry |

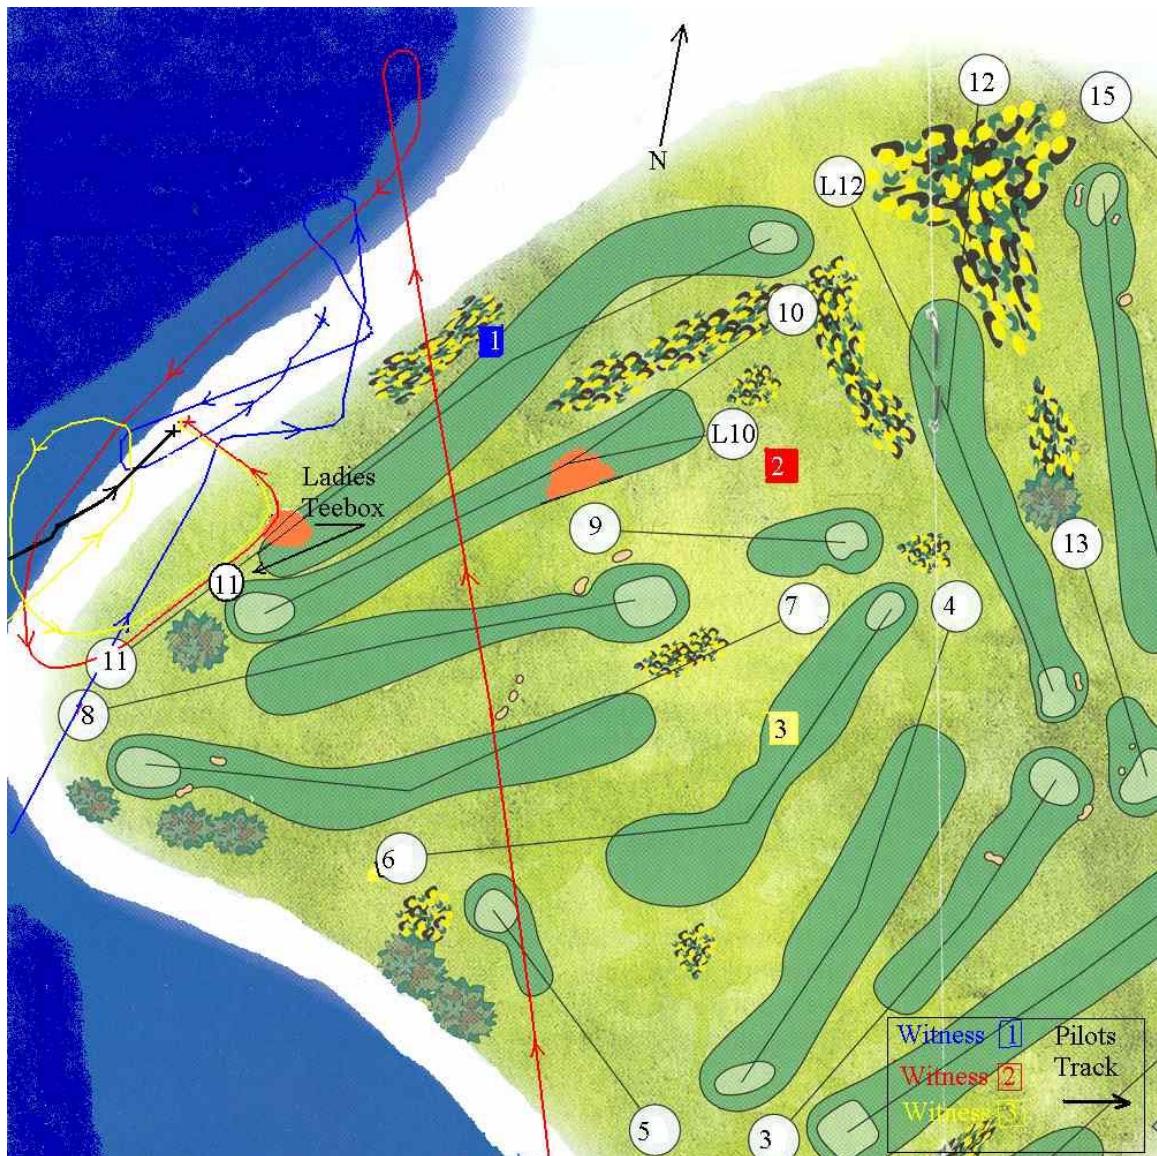
APPENDIX A

Plan of section of the golf course showing the pilot's reported track of G-OPDM (colour black) and the track as observed by three witnesses positioned at their relative locations throughout the course (1,2 &3 in blue,red & yellow).

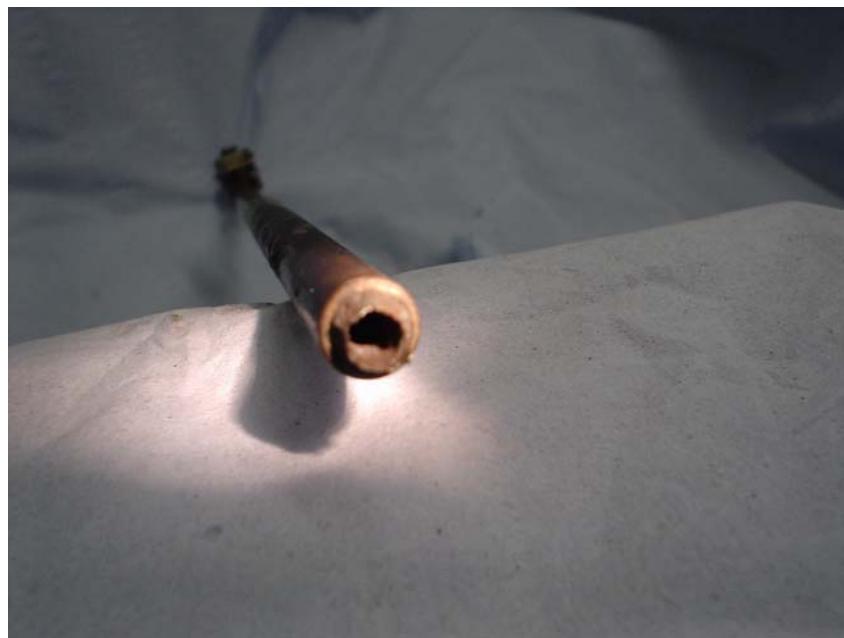
APPENDIX C

During the removal of the engine from the helicopter, the tube end of the wastegate collapsible link broke away from the gate valve due to heavy corrosion of the rod end (**Appendix C**). The turbocharger was inspected at the UK facility and considered serviceable. However, the collapsible link between the fuel servo and the wastegate on the turbocharger was found to have had recent scoring of the rod at a point where the rod is secured to the tube by the plunger. This scoring was indicative that the rod had, at some time, been moving in the tube. These marks indicate that the collapsible or “breakaway” function of the linkage was operative in the recent past. The rod was also slightly bent at the fuel control end.

Photo showing corrosion on butterfly end of wastegate linkage.

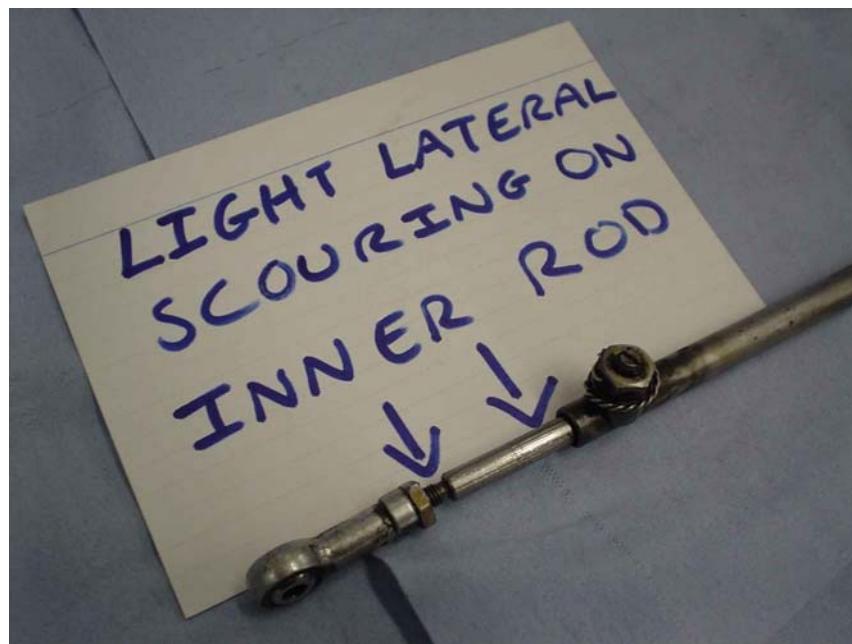
When the turbocharger was examined it was found that the wastegate linkage spring plunger had been screwed tight into its detent. There were recent score marks on the rod which would indicate that the “breakaway” action was functioning at some stage prior to the spring plunger being screwed down tight. This detent is required in flight in a case where the exhaust gate valve sticks. The exhaust temperature is in the region of 890° C and the valve may seize in the exhaust line. The pilot should in such a case be able to control the flow of fuel to the engine but only if the detent is operating correctly and free to “breakaway”. There is no evidence to show that the valve in the exhaust pipe did seize at the time of the accident. The throttle would have been stiff to rotate if this happened. This was not evident on the no-load test run immediately following the accident and was not mentioned in the pilot’s report. The valve was functioning normally, when examined by the Investigation at the UK facility. It is concluded that the incorrect setting of the wastegate linkage could not have contributed to a loss of available engine power prior to the accident.

Photo from engine contractor showing other end of linkage with score marks on inner rod.
