FINAL REPORT

AAIU Synoptic Report No: 2005-007

Aircraft Type and Registration:	Robinson R22 B2, EI-EHC
No. and Type of Engines:	1 x Lycoming O-360-J2A
Aircraft Serial Number:	3442
Year of Manufacture:	2003
Date and Time (UTC):	12 April 2004 @ 14.45hrs
Location:	Shannon Airport
Type of Flight:	Training
Persons on Board:	Crew - One Passengers - Nil
Injuries:	Crew - Nil Passengers - Nil
Nature of Damage:	Tail boom skin buckled.
Commander's Licence:	Student Pilot Licence
Commander's Details:	Male, aged 46 years
Commander's Flying Experience:	210 hours of which 54 were on type
Information Source:	Owner of EI-EHC

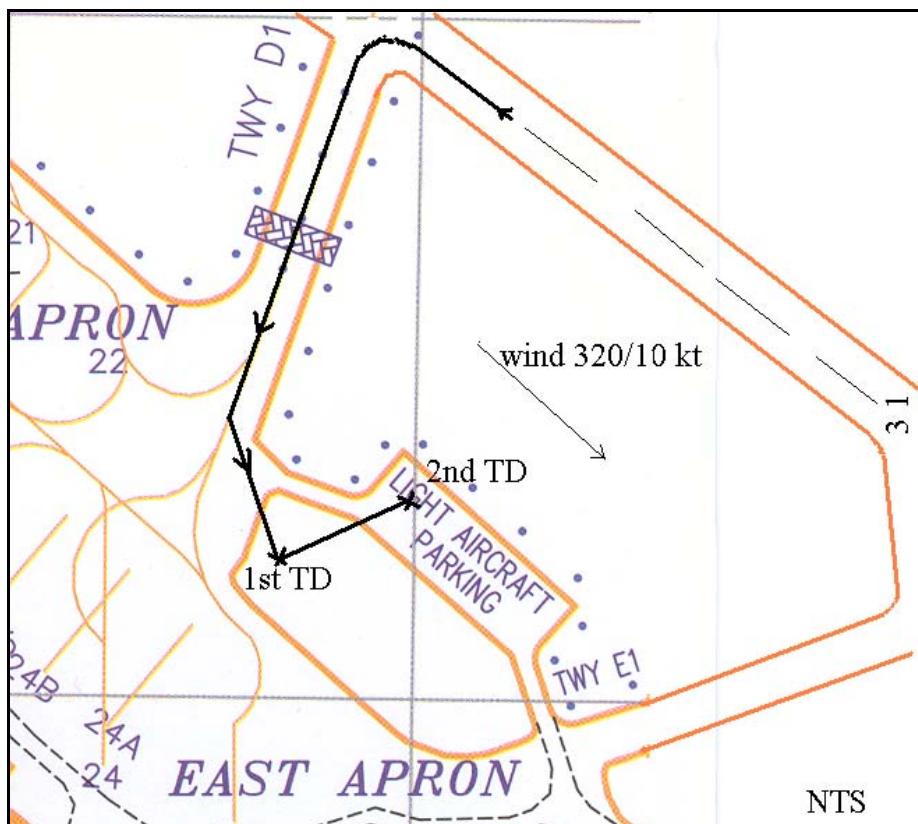
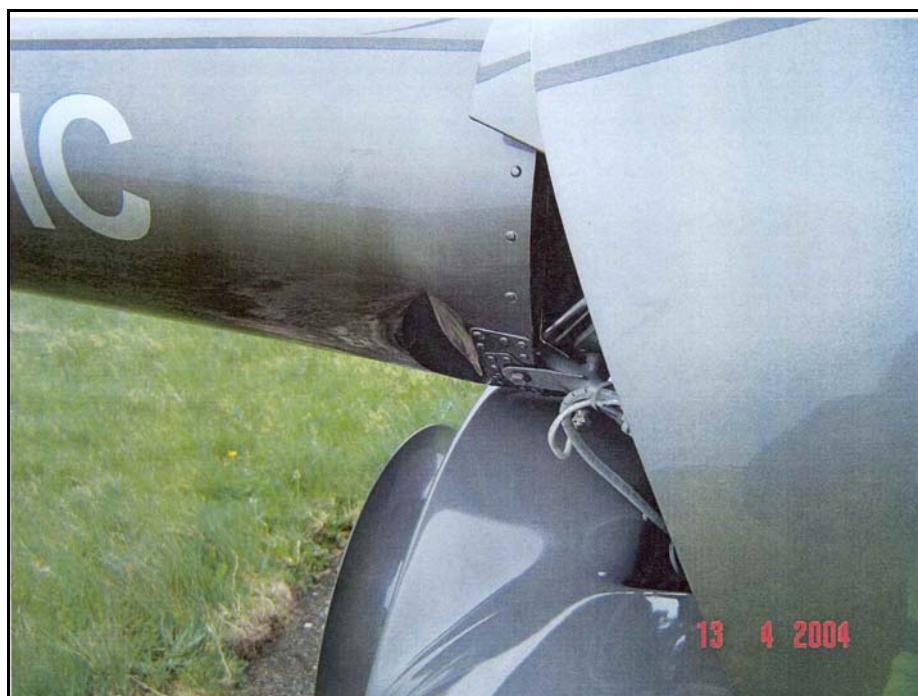
APPENDIX A

Following communication with the tower, he subsequently lifted the helicopter from this position, and continued to hover taxi to the right in a 4 o'clock direction to let down in the light aircraft park. He then shut down the helicopter and made a normal exit. Following inspection of the aircraft he discovered a small paint scratch at the lower end of the stinger and a crease in the tail boom on the starboard side of the tail just aft of the right hand mounting bolts (See **Appendix A**).

The helicopter manufacturer's experience from other R22 hard landing accidents shows that the initial failure of the tailcone is due to compression buckling of the forward skin similar to this case. The compressive force acting at the tailcone 4 o'clock position (as viewed from the rear) was the resultant of a vertical downward force, caused by the momentum of the tail rotor assembly, and the lateral sideways trust of the tail rotor at the moment of touchdown.

Buckling of the skin caused by compressive forces on the tailcone.
(i.e. the skin is pushed in)

As required by the helicopter Maintenance Manual, the tailcone assembly was sent to the manufacturers for repair. The assembly was repaired, returned and re-installed by the owners
