FINAL REPORT

AAIU Synoptic Report No: 2005-010
AAIU File No: 2005/0005
Published: 30/05/05

Aircraft Type and Registration:	Cessna 150 K, EI-CIN
No. and Type of Engines:	1 x TCM 0-200- A
Aircraft Serial Number:	15071728
Year of Manufacture:	1970
Date and Time (UTC):	15 February 2005 @ 12.30 hrs
Location:	Derrinturn, near Edenderry, Co Offaly
Type of Flight:	Aerial Work
Persons on Board:	Crew - One Passengers - One
Injuries:	Crew - Nil Passengers - Nil
Nature of Damage:	Nil
Commander's Licence:	Commercial Pilot's Licence
Commander's Details:	Male, aged 44 years
Commander's Flying Experience:	1,100 hrs (of which 375 were on type)
Information Source:	Operator reported incident. AAIU Incident Report Form submitted by pilot.

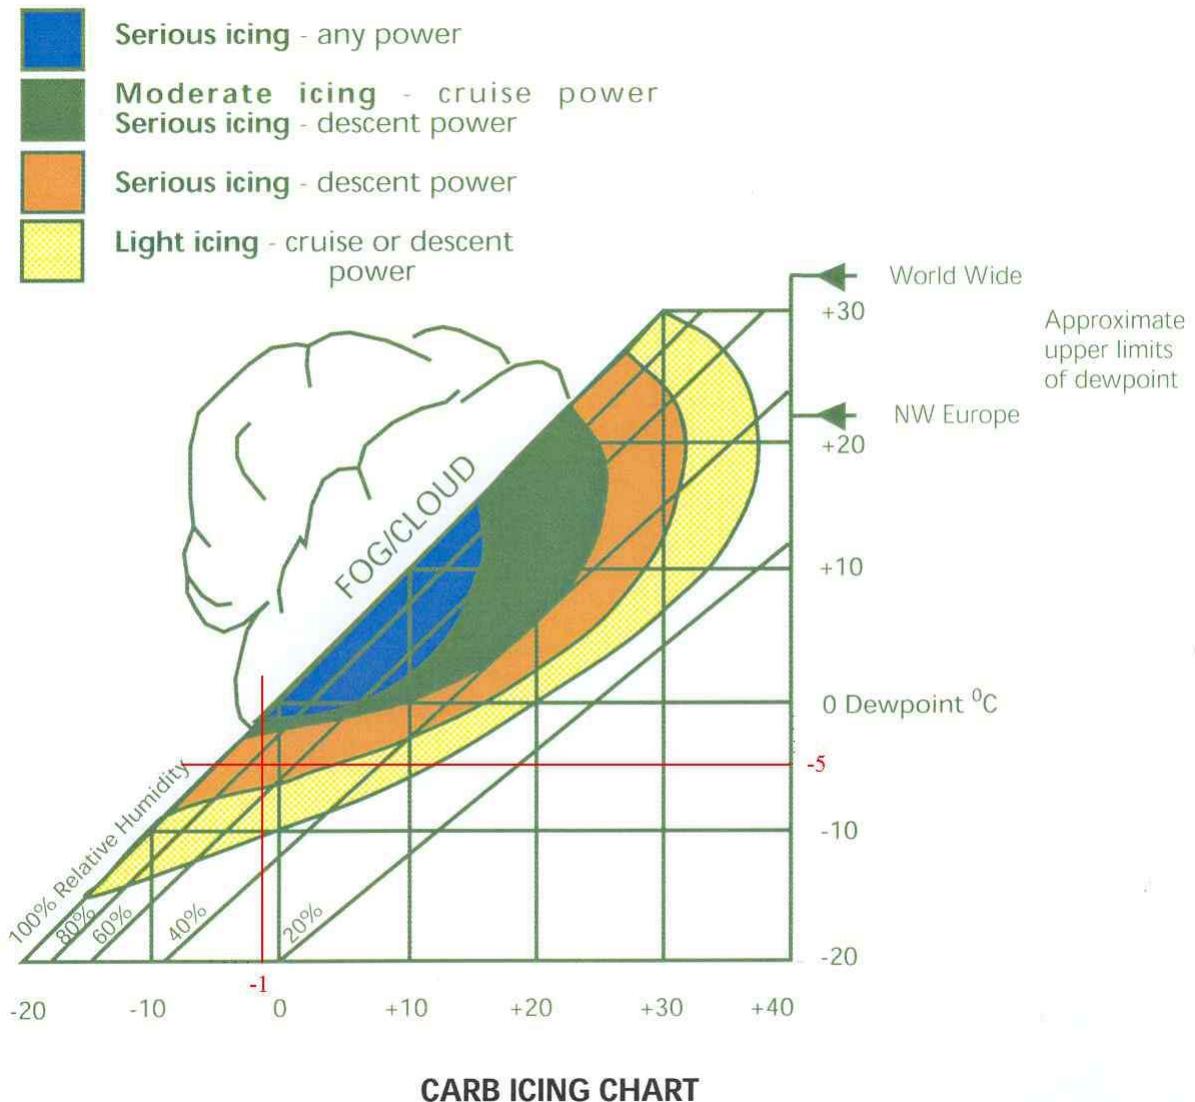
APPENDIX A

The chart at **Appendix A** shows the wide range of ambient conditions conducive to the formation of induction system icing for a typical light aircraft piston engine. This chart is reproduced from the General Aviation Safety Sense Leaflet 14A, which is a UK CAA publication. It is also issued in similar form in Aeronautical Information Circular NR 11/97, published by the IAA. Both are based on research carried out by the National Research Council of Canada (NRCC). Flight tests have produced serious icing at descent power with the ambient temperature above 30° C even with a relative humidity as low as 30%.

Analysis, by the Aviation Division of Met Eireann, of the tephigrams around the time of the incident suggests that the temperature and dew point were approximately -1°C and -5°C respectively at 3,000 ft. These figures, applied to the Appendix A Chart, show that the engine, operating in conditions of reduced power, was likely to lead to serious carburettor icing.
