FINAL REPORT

AAIU Synoptic Report No: 2005-012

Aircraft Type and Registration:	Cessna 150, EI-COP
No. and Type of Engines:	1 x Continental 0-200-A
Aircraft Serial Number:	1058
Year of Manufacture:	1974
Date and Time (UTC):	19 December 2004 @ 1300 hours.
Location:	Milltown Pass, Private Airfield, Co Westmeath
Type of Flight:	Private
Persons on Board:	Crew - One Passengers - One
Injuries:	Crew - Nil Passengers - Nil
Nature of Damage:	Damaged beyond economic repair
Commander's Licence:	Australian Private Pilot (Aeroplane) Licence,
Commander's Details:	Male, aged 39 years
Commander's Flying Experience:	170 hours (of which 12 were on type)
Information Source:	AAIU Accident Report submitted by Pilot. AAIU Field Investigation.

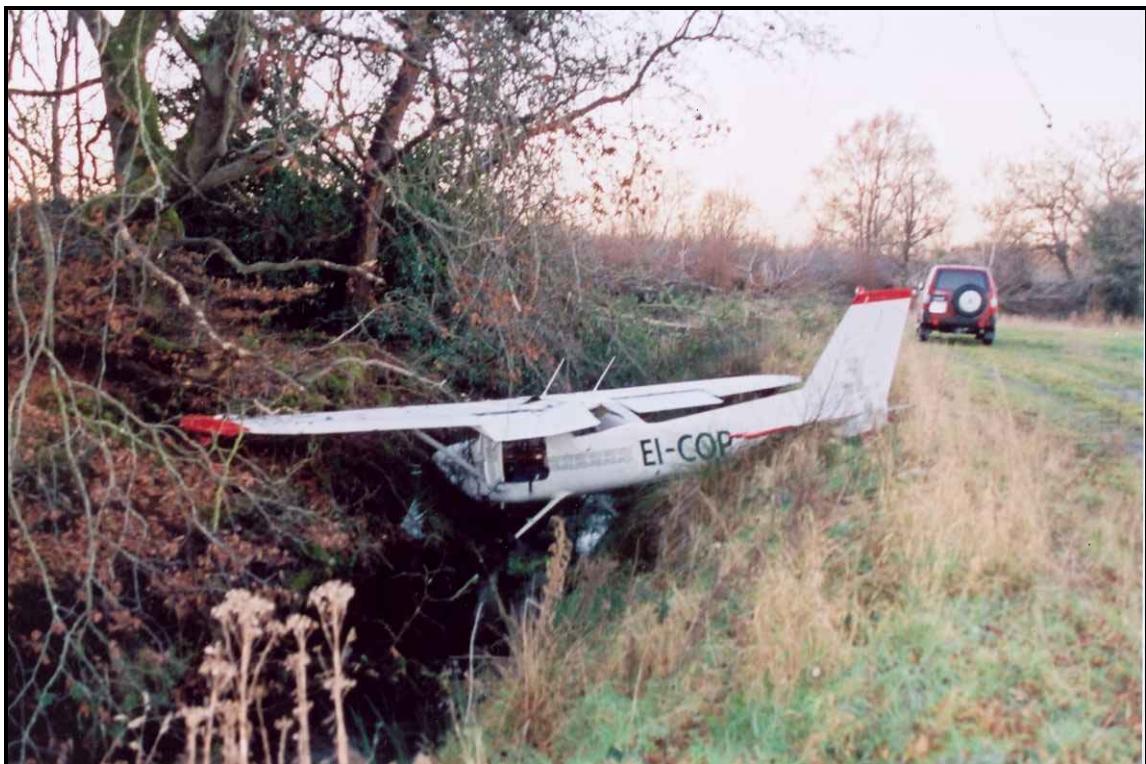
The pilot, in his recall of events, said that as he landed too far down the westerly runway he knew he had to stop or apply power for a go-around. He quickly realised that the go-around was not going to work in time and commenced braking action. However, with the grass wet and the ground soft, the breaking action was not effective and the aircraft exited the runway and taxied into a wide and deep cut airfield boundary stream. The pilot and passenger quickly exited the aircraft. There was no fire and no injuries reported to either man. The aircraft was structurally seriously damaged and the engine shock loaded.

The investigation noted that the initial touchdown ground marks were approximately 180 metres into the runway and that the windsock indicated a following light easterly wind.
