## FINAL REPORT

**AAIU Synoptic Report No: 2005-027**  
**AAIU File No: 2004/0056**  
**Published: 5/12/05**

<b>Aircraft Type and Registration:</b>	Fournier RF3, D-KMDP
<b>No. and Type of Engines:</b>	1x Rectimo 1200
<b>Aircraft Serial Number:</b>	37
<b>Year of Manufacture:</b>	1964
<b>Date and Time (UTC):</b>	15 October 2004 @ 15.30 hrs
<b>Location:</b>	Galway Airport
<b>Type of Flight:</b>	Private
<b>Persons on Board:</b>	Crew - 1      Passengers - Nil
<b>Injuries:</b>	Crew - Nil      Passengers - Nil
<b>Nature of Damage:</b>	Undercarriage damaged
<b>Commander's Licence:</b>	Irish Private Pilots Licence
<b>Commander's Details:</b>	Male, aged 39 years
<b>Commander's Flying Experience:</b>	236 hours (of which 110 were on type)
<b>Information Source:</b>	Watch Manager, Galway Airport ATC

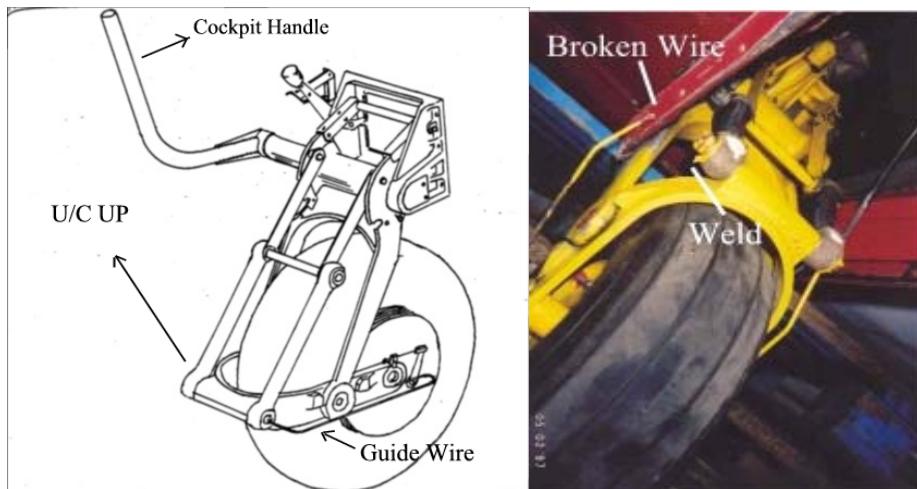
## APPENDIX A

The Investigation examined the aircraft and found the guide wire on the starboard side of the wheel had broken at its forward end (see **Appendix A**). This had broken at a point where the wire was welded to a fixing washer. There was evidence of some corrosion at the weld. There were marks on the starboard undercarriage door. An inner cowling was also found loose.

The undercarriage would not lock in the up position because the loose guide wire impinged on the door during the retracting attempt and prevented the wheel from being fully retracted. The aircraft had not been flown since the tyre had been replaced 3 months prior to this incident. Thereafter, when the brake was applied during taxi, the aircraft went into vertical ground oscillations, which would only cease on release of the brake. It is possible that the guide wire was weakened during wheel replacement and broke loose during the subsequent oscillations.

Drawing of complete undercarriage system, photo of fractured weld and broken guide wire.

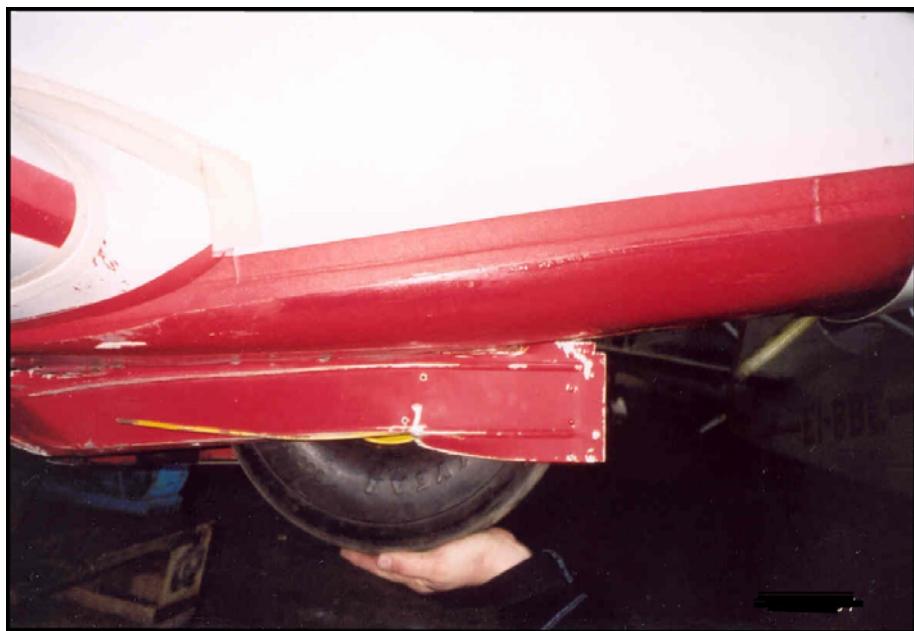
The wheel starboard guide wire fractured prior to retraction and, on retraction, impinged on the wheel door, which prevented the undercarriage from locking in the up position. The guide wire fouled the door, which prevented full extension of the undercarriage.

Photo showing guide wire impinging on undercarriage door thus preventing full retraction.
