FINAL REPORT

AAIU Synoptic Report No: 2005-029

Aircraft Type and Registration: A/C No. 1: Bombardier CL-600-2B16, C-FSJR
A/C No. 2: Gates Learjet 45, G-OLDR

Location: Light Aircraft Park Bravo, North Apron, Dublin Airport (EIDW)

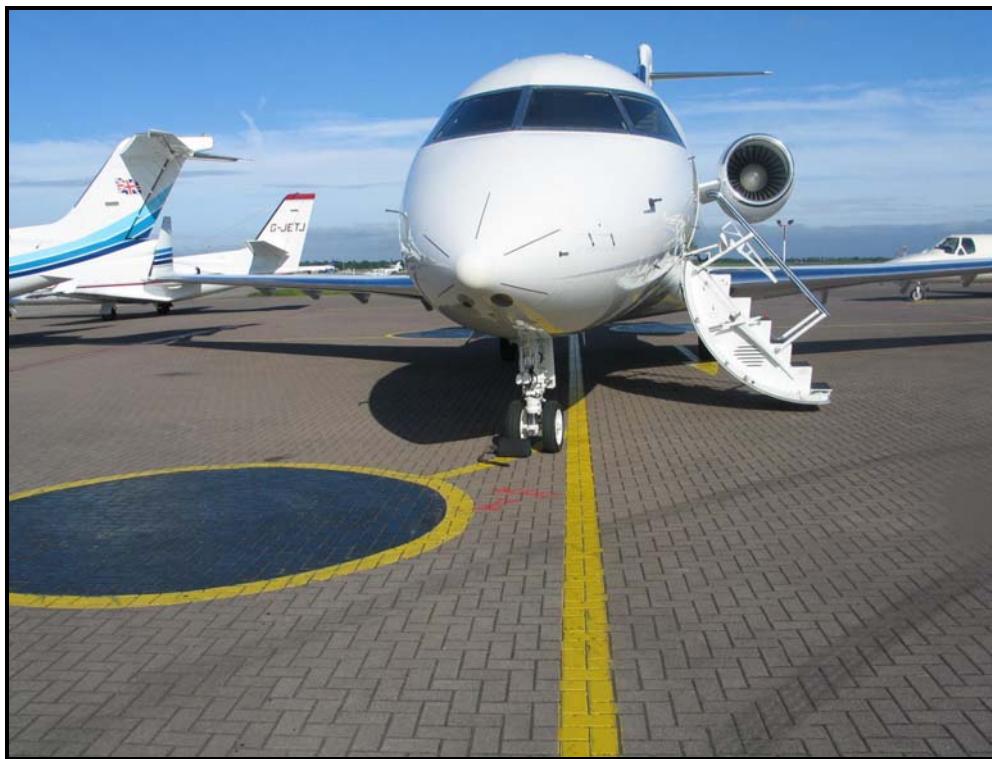
C-FSJR was found on a heading of approximately 130°M with its nose wheel on the yellow taxi line leading into the parking spot (See **Photo No 1**). The port winglet was protruding approximately 0.5 metres across the red line and into the left-hand side parking area. The starboard winglet had impacted the tail cone of G-OLDR and two static wicks that were located on the trailing edge of the rudder (See **Photo No 2**). The tail cone of G-OLDR was protruding approximately one metre into the taxi lane from the right-hand side parking area. Its entire empennage was protruding approximately two metres into the taxi lane from the right-hand side. The nose of G-OLDR was right up to the forward red line extremity of the parking area facing out to the North Apron taxi lane.

Photo No 1. Final resting position of C-FSJR. Note blanked out stand numbers

Immediately following this particular event, the DAA removed all yellow markings on the LAPB, and limited its use to Code A aircraft only. Code B and C are now assigned to commercial stands adjacent to the LAPB.

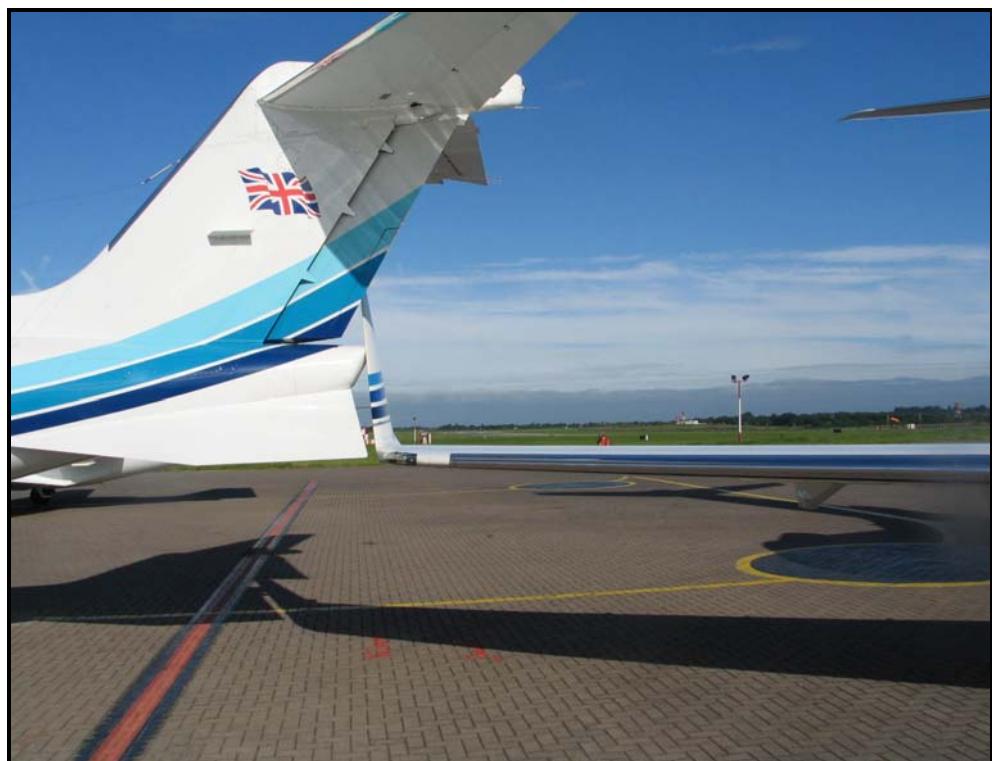
Following separation of both aircraft, it was determined that, C-FSJR suffered some minor scuffing to the protective tape on the leading edge of the starboard winglet, and the Learjet 45 (G-OLDR) suffered two broken static wicks and a hole in the fibreglass tail cone measuring approximately 7 cm by 7 cm. The tail cone and static wicks were subsequently replaced. There was no other damage.

Photo No 2. Starboard winglet impact with tail cone of G-OLDR

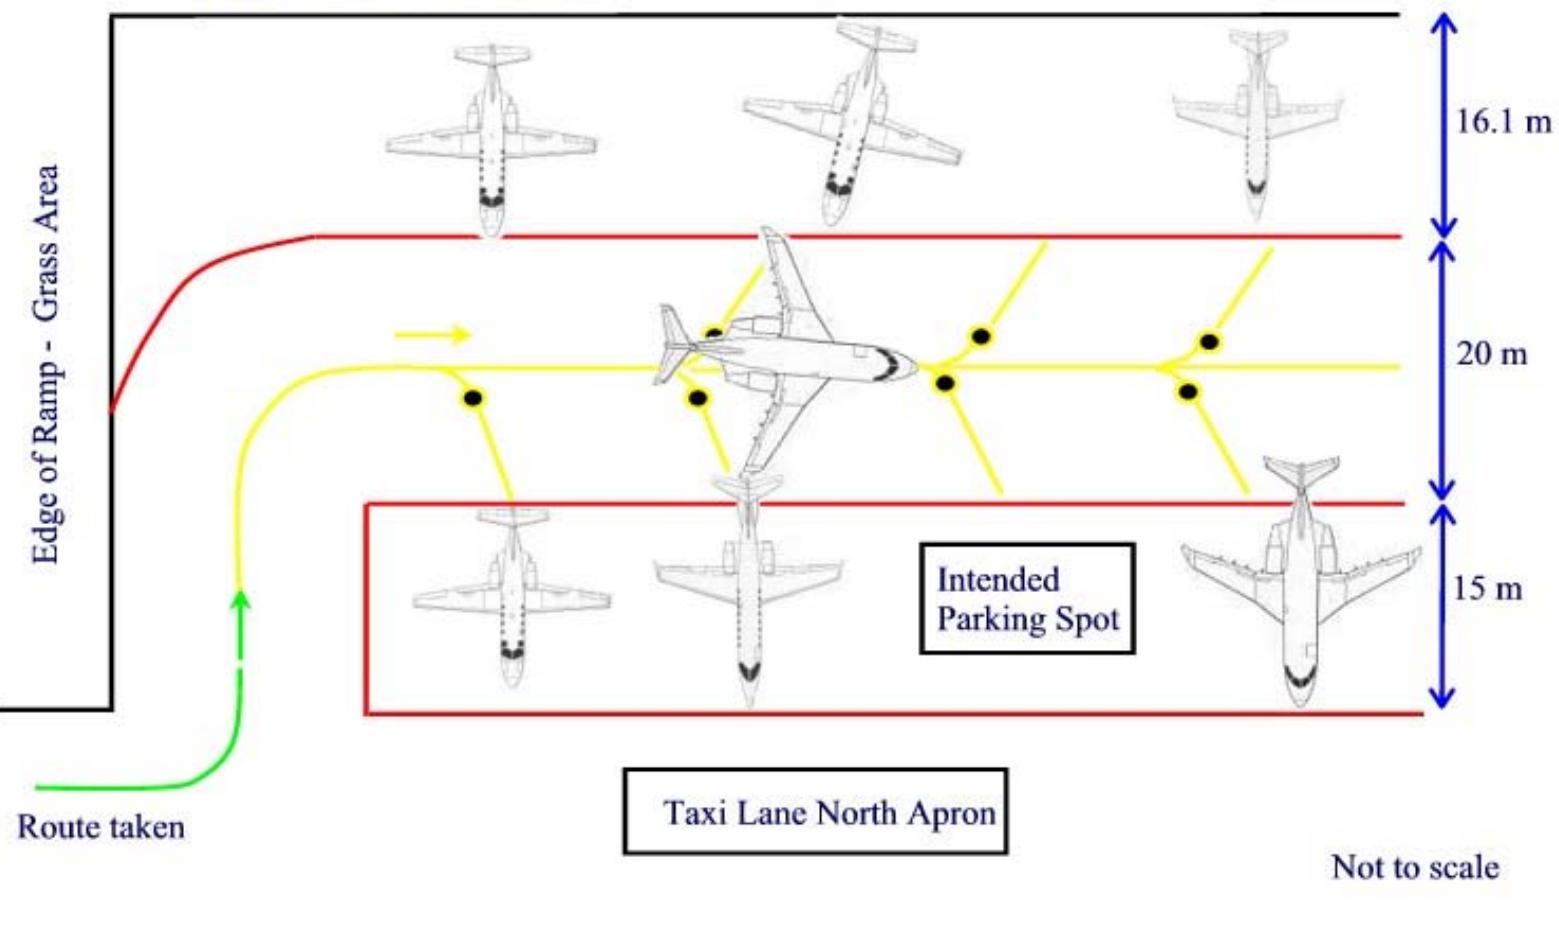
Appendix A

The parking area was made up of two rows of parked aircraft with a taxi lane running between the two rows and marked by a central yellow line (See **Appendix A**). The allocated position for C-FSJR was the third spot on the right-hand side of the front row.
