FINAL REPORT

AAIU Synoptic Report No: 2005-030

| Aircraft Type and Registration: | Airbus A320, EI-DEA | |

On final approach to Runway (RWY) 35 at Cork Airport, the Commander observed a large flock of birds lifting off the ground and elected to carry out a go-around. During this manoeuvre a number of birds struck the aircraft. A normal approach and landing was subsequently completed.

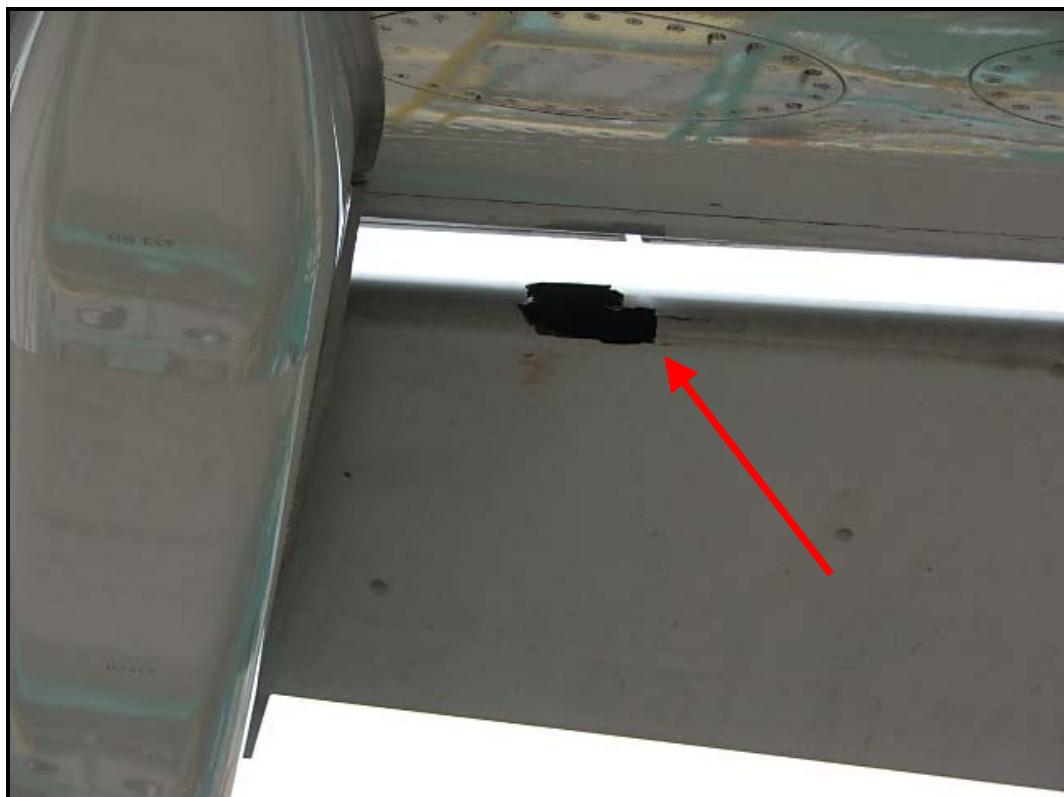
After landing, several carcasses of seagulls were found on the runway and the adjacent grass by the Airport Fire Services (AFS). Post flight examination of the aircraft showed that several birds were ingested into No. 2 engine and a hole was punctured in the leading edge of one of the trailing edge flaps (see **photo**). Impact bloodstains were also present in the nose gear bay, right leading edge and No. 2 engine cowl. The aircraft remained grounded for 24 hours while necessary inspections and temporary repairs were effected by the Operator.

The damage was caused by multiple bird strikes on the airframe. It is noteworthy that bird-scaring activities were being carried out by the AFS while the aircraft was on approach, albeit in a different part of the airfield (north of the RWY 35/25 intersection). The aircraft was advised by Air Traffic Control (ATC) that it was cleared to land and would have done so in normal circumstances. However, the apparent sudden appearance of this flock in the aircraft's flight path necessitated a go-around, demonstrating, not for the first time, that in spite of bird scaring activities by AFS personnel and preventative techniques being regularly employed, absolute bird strike prevention is impossible to achieve due to the unpredictable nature of birds themselves. The work to prevent bird strikes at our airports is necessarily ongoing and unrelenting.
