FINAL REPORT

1 **AAIU Synoptic Report No: 2006-002**
2 **AAIU File No: 2004/0055**
3 **Published: 27/02/06**

Aircraft Type and Registration:	X-AIR 582 (5) Microlight, G-CBFT	
No. and Type of Engines:	1 x Rotax 582/48-2V	
Aircraft Serial Number:	BMAA/HB/190	
Year of Manufacture:	2001	
Date and Time (UTC):	4 August 2004 @ 16.40 hrs	
Location:	Mullingar, Co. Westmeath	
Type of Flight:	Private	
Persons on Board:	Crew - one	Passengers - one
Injuries:	Crew - Nil	Passengers - Nil
Nature of Damage:	None	
Commander's Licence:	UK National Private Pilots Licence	
Commander's Details:	Male, aged 47 years	
Commander's Flying Experience:	302 hours, of which 48 were on type	
Information Source:	Phone call to the AAIU from the Pilot of the aircraft.

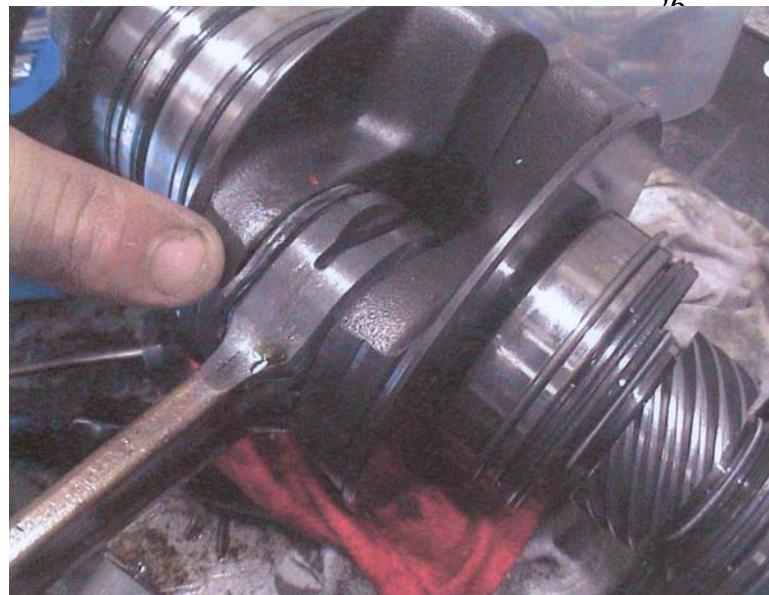
29 Following the engine removal from the aircraft and a subsequent strip down of the engine,
30 failure was found to be due to a No.1 big-end bearing failure (see **Appendix A**). The engine was
31 subsequently overhauled and a new crankshaft, set of pistons, cross shaft, and a new top and
32 bottom case installed.
33

12 Lubrication in a two-stroke engine using Mogas fuel is through the normal fuel/oil mixture.
13 Normal lubrication of the engine can be interfered with if an oil other than the recommended oil
14 type is used. The use of such oils can lead to a rapid deterioration of the bearing surface leading
15 to eventual bearing failure.
16

17 Running the engine at successively high RPM on start-up before the mixture has had time to
18 warm up could also lead to eventual bearing failure in service.
19

28 Failure of the engine was due to big-end bearing failure.
29

The thumb points to the engine connecting rod and associated big-end bearing which failed in service on G-CBFT.
