FINAL REPORT

AAIU Synoptic Report No: 2006-004
AAIU File No: 2005/0013
Published: 20/03/06

Aircraft Type and Registration:	Lambada UFM-11, EI-DGT	
No. and Type of Engines:	1 x Jabiru 2200	
Aircraft Serial Number:	14/11	
Year of Manufacture:	2000	
Date and Time (UTC):	5 March 2005 @ 12.30 hrs	
Location:	Abbeyshrule, Co.Longford	
Type of Flight:	Private	
Persons on Board:	Crew - One	Passengers - Nil
Injuries:	Crew - Nil	Passengers - Nil
Nature of Damage:	Nose gear assembly collapsed and propeller tips damaged	
Commander's Licence:	PPL	
Commander's Details:	Male, aged 59 years	
Commander's Flying Experience:	3,080 hours, of which 570 were on type	
Information Source:	Pilot of aircraft contacted the AAIU.

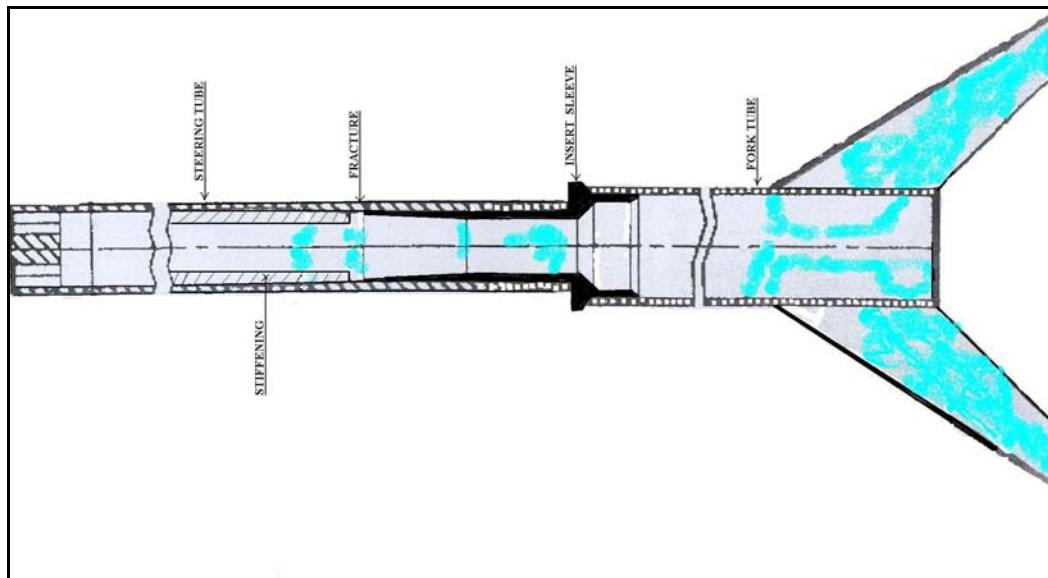
APPENDIX A

The nose wheel is held in a fork unit, similar to that on a bicycle (see **Appendix A**). The fork tube is attached to the steering tube through an internal 35 mm long sleeve, which is plug welded to the steering tube at three circumferential locations. A second internal tube (stiffening) extends up the steering tube for about 100 mm, and is held in place by an adhesive.

stresses in the steering tube. The weakest point of the fork/steering tube attachment is along the circumference of the tube where the three plug welds are located. This location is also where the 35 mm internal sleeve meets the 100 mm internal stiffening tube. This is, in fact, where the steering tube fractured on impact. This construction facilitates fracture at this location, in the event of possible overload, in order to reduce damage to the front structure and composite skin.

Above sketch shows a cross-section of the nose wheel strut

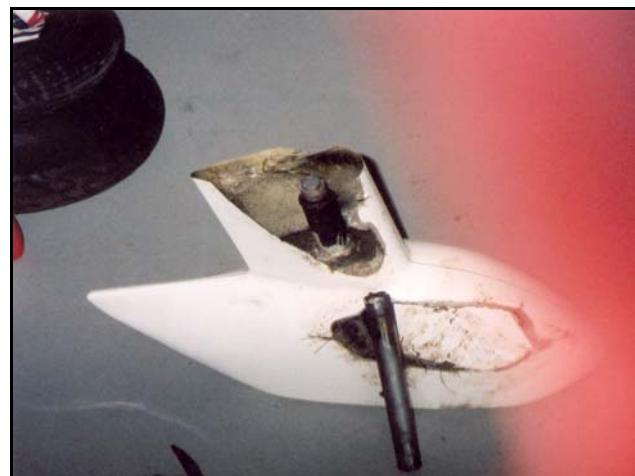
The steering tube of the nose wheel bent rearwards following wheel impact on landing. This allowed the spat, complete with wheel, to rub off the runway surface as the aircraft landed. The wooden propeller blade tips contacted the tarmac surface during the landing and were also damaged.

Localised bending was observed in the steering tube adjacent to the fracture, consistent with sideways loading. Examination of the fracture surfaces with the aid of a stereomicroscope revealed fracture features typical of single event overload failure, with no indication of any pre-existing defect, cracking or corrosion. Some slight lack of penetration/fusion of the plug welds was observed at the edges of two of the holes in the steering tube.

The abnormal loads caused the nose steering tube to fracture at its designed weakest point.

The fractured nose wheel strut from EI-DGT
