FINAL REPORT

AAIU Synoptic Report No: 2006-005

Aircraft Type and Registration:	Cessna P210N, N6593W with a Supplementary Type Certificate (STC).
No. and Type of Engines:	1 x Allison 250-B17F/2.
Aircraft Serial Number:	P210000801.
Year of Manufacture:	1982.
Date and Time:	12 August 2005 @ 15.01 hrs local approximately.
Location:	Brittas House Airfield, Co. Limerick.
Type of Flight:	Not resolved (See Section 1.7.2).
Persons on Board:	Crew - 1 Passengers - 3
Injuries:	Crew - Nil Passengers - Nil
Nature of Damage:	Extensive to left wing.
Commander's Licence:	USA CPL-IR Single/Multi-engine airplane with Instructor rating.
Commander's Details:	Male, aged 49 years.
Commander's Flying Experience:	1,059 hours of which 98 were on type.
Information Source:	Report submitted by Aircraft Commander AAIU Field Investigation.

SYNOPSIS

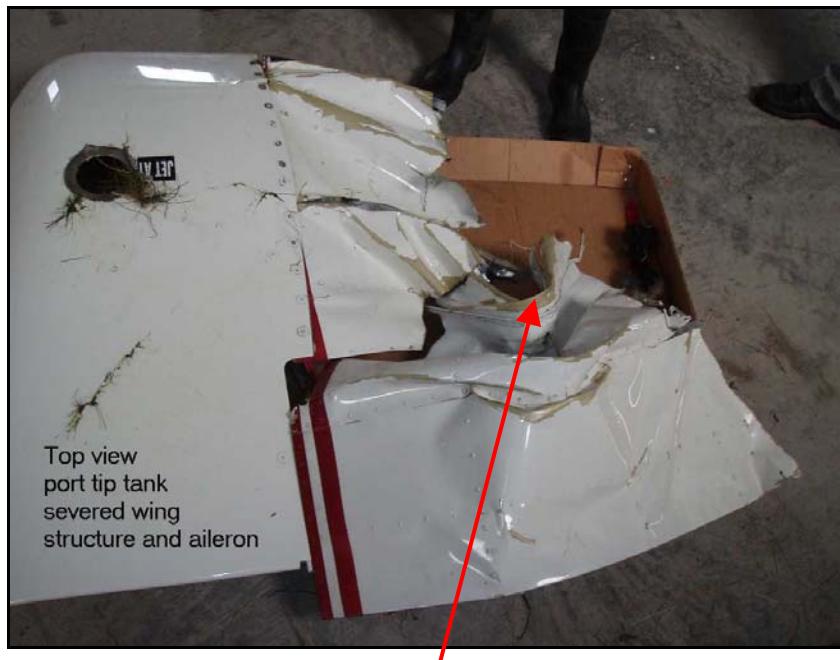
The tree sliced through the port wing at a point approximately 30 cm in from the line of rivets, which joined the tip tank to the original wing. The impact with the tree cut through the leading edge and outer spar section and ripped the aileron in half, causing the outer hinge bracket to rupture. Both the wing tip tank and the outer portion of the aileron separated from the aircraft. **Photo No 1** shows the line of impact through the wing structure. Analysis of the damage indicates that the aircraft's impact angle with the tree was approximately +20 degrees. The damage to the wing was extensive and will probably require its complete replacement on the aircraft.

Photo No 1. Indentation made by tree

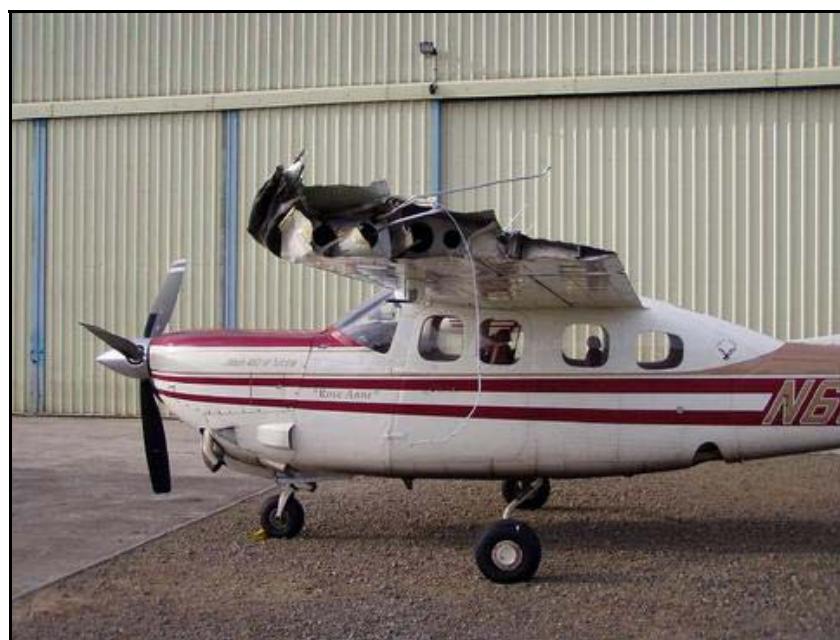
Photo No 2.

The severed end of the wing was pushed backwards and upwards as can be seen at **Photo No 2** and **No 3** below.

Photograph, No 2, No 3 and No 4, clearly demonstrates that because the damage was deflected upwards at the extremity of the port wing, the impact damage was not visible from inside the aircraft. The aircraft was reported to have flown normally after the event, thereby giving no immediate indication to the PF or the passengers that it had suffered impact damage.

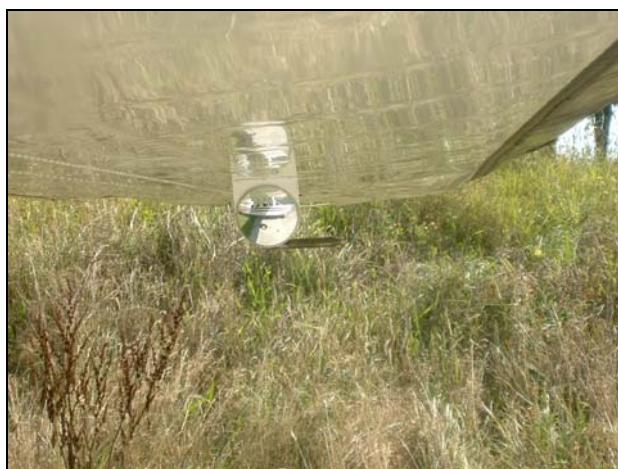
All persons onboard the aircraft described how they were not aware of any damage on the port wing until it was discovered on landing at Jersey. Viewed through the forward port window (**Photo No 4.**) it is clear that no damage is evident on the wing tip. The mirror, positioned halfway out the underside of the wing, is used to view the condition/position of the undercarriage. Viewed through the forward starboard window (**Photo No 5.**) the wing tip is obscured by the radar pod, thereby making it impossible to make any comparison between both wingtips.

Photo No 4. Port wing view

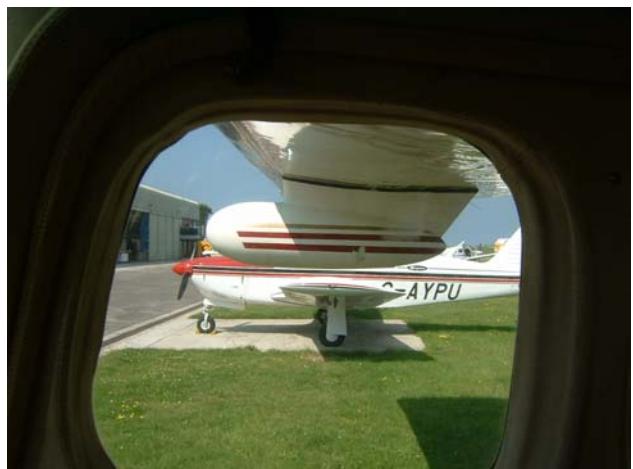
Photo No 5. Starboard wing view

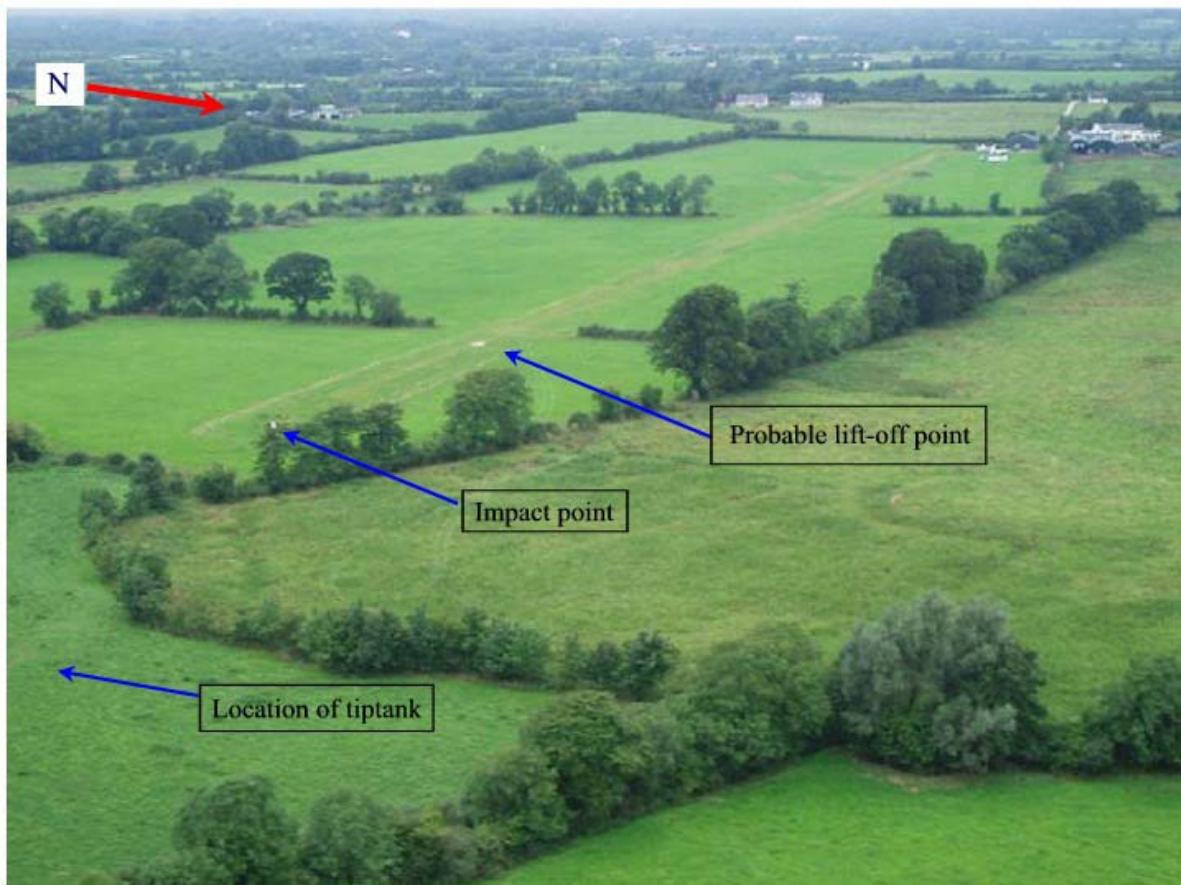
A tree lined boundary hedge, on the left side of the runway, runs down to the left hand corner of the boundary hedge at the end of the runway. A large pine tree measuring approximately 50 ft high (pre-impact) is located in this left hand corner of the field. The runway ends several metres short of the boundary hedge and the distance and position of the impacted tree, from the centre-end of the runway, is approximately 40 metres and offset approximately 45° left of centreline.

Photo No. 6 Aerial view Brittas House Airfield (Provided by Operator)
