FINAL REPORT

1 **AAIU Synoptic Report No: 2006-006**
2 **AAIU File No: 2004/0029**
3 **Published: 24/4/06**
4

Aircraft Type and Registration:	Airbus A330-301, EI-JFK
No. and Type of Engines:	2 x GE CF6-8OE1A2
Aircraft Serial Number:	086
Year of Manufacture:	1994
Date and Time (UTC):	4 June 2004 @ 10.07 hrs
Location:	On take off from RWY 28, Dublin Airport
Type of Flight:	Scheduled Public Transport
Persons on Board:	Crew - 12 Passengers - 303
Injuries:	Crew - Nil Passengers - Nil
Nature of Damage:	No damage to aircraft
Commander's Licence:	ATPL
Commander's Details:	Male, aged 44 years
Commander's Flying Experience:	15,000 hours of which 110 were on type
Information Source:	Operator informed AAIU

1. FACTUAL INFORMATION

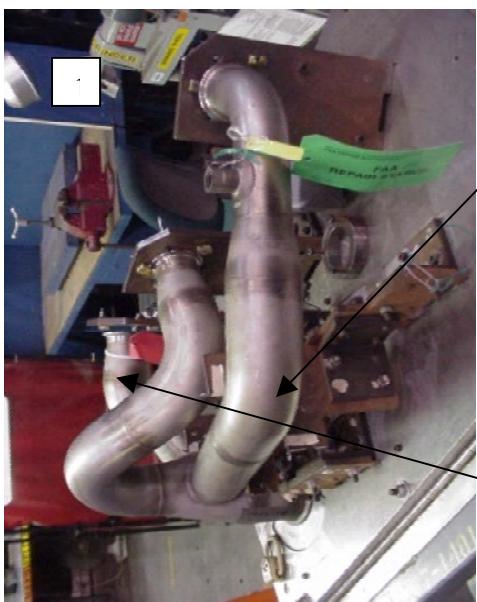
2
3 The manifold was returned to the manufacturer for examination. It was placed in the
4 production tooling for a conformity check. The following observations were made:
5

- 6 • Upper tube flange out by 17/32 inches.
- 7 • Lower tube flange out by 5/8 inches.
- 8 • PRSOV (Pressure Relief Valve) tube out by 7/32 inches.

1 *The 14th stage manifold-to-port mismatch observed on the engine, and the deviation to the*
2 *alignment features when installed in the tool, was attributed to manifold distortion resulting*
3 *from pressure application with the manifold unrestrained at the port.*

Photo 1: The 14th Stage Manifold on a tool rig
Photo 2: The failed manifold coupling position
Photo 3: The fractured clamp

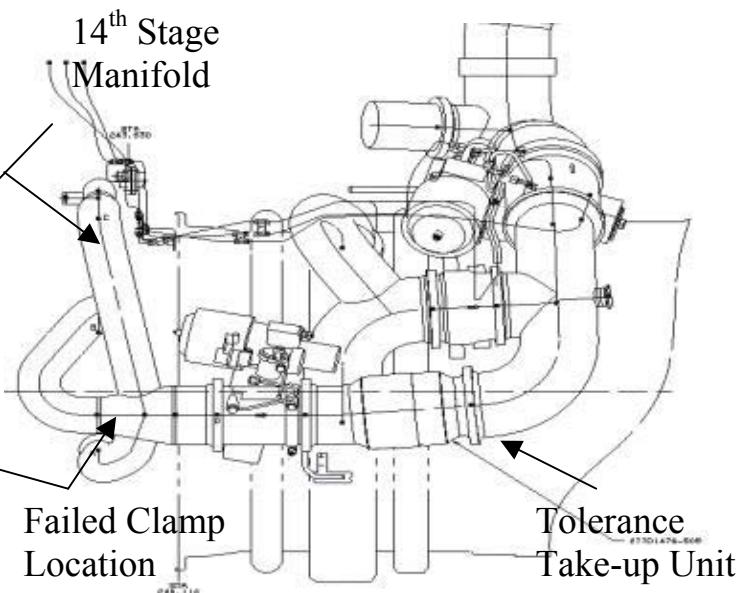
18 Engineers inspected the engine and confirmed they located a pneumatic duct leak. A full post
19 event inspection revealed that a V-band clamp at the 14th Stage Manifold lower engine port had
20 detached, allowing hot air (greater than 600°C) to bleed into the engine core compartment.
21 There was a circumferential split along one of the V-band clamp segments. Localised heat
22 distress was noted over an area of 12 square inches particularly to the electrical harness outer
23 jackets. It was also noted that there was misalignment of the manifold at one of its ports. The
24 tolerance take up (TTU) adjustment sleeves had separated and its inner duct suffered distortion
25 (see **Appendix A**).

26 Three V-band couplings attach the manifold to the engine ports. The coupling at the lower port
27 had failed. A portion of this coupling was recovered and sent to the manifold manufacturer. The
28 remainder of the coupling was discovered during the subsequent engine shop visit.

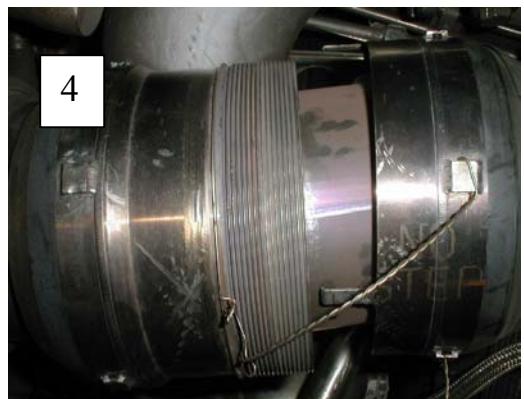
- 17 • Broken TTU adjustment sleeve lockwire.
- 18 • Disengagement of the adjustment sleeves.
- 19 • Distortion of the inner duct confirmed.
- 20 • Over-extension stops deformed and worn by 50% of new stop dimension.
- 21 • Witness marks on TTU adjustment sleeves resulting from contact with over
22 extension stops.
- 23 • Flange sealing surfaces damaged
- 24 • Races worn beyond limits

32
33 *The lockwire securing the TTU adjustment sleeves in the adjusted position failed, allowing in-*
34 *service rotation of the adjustment rings. The adjustment rings rotated in a direction that*
35 *extended the TTU to the point of maximum extension. The over-extension tab deformation and*
36 *wear identified during the examination of the TTU, permitted continued rotation of the*
37 *adjustments sleeves beyond the mechanical stops. The TTU adjustment sleeves continued to*
38 *extend to the point of thread disengagement.*

39
40 *The disengaged TTU adjustment sleeves permitted unrestrained extension of the inner duct.*
41 *Additionally, the disengagement of the adjustment sleeves compromised the HPV/intersect duct*
42 *support structure that is normally provided by the TTU. The inner duct distortion identified*
43 *during inspection of the TTU, was the result of duct deflection around the inner duct bellows.*

Photo 4: The detached TTU of EI-JFK
Photo 5: A serviceable TTU

8 On the 10th February 2005 the Manufacturer issued an All Operator Letter (AOL-CF6-80E-
9 NAC-012) advising operators of a requirement to inspect the lockwire installation on the TTU
10 duct. This document also referenced this event as background information.

12 A Service Bulletin (CF6-80E1-NAC-71-039) was also issued which, besides directing
13 attention to the TTU wirelocking and duct length adjustment, also provides recommended
14 maintenance procedures and adjustment checks to the engine bleed system hardware
15 installation.
