## FINAL REPORT

**AAIU Synoptic Report No: 2006-009**  
**AAIU File No: 2005/0074**  
**Published: 13/06/2006**

<b>Aircraft Type and Registration:</b>	Beech Queen-Air 70, N70AA
<b>No. and Type of Engines:</b>	2 x Piston Lycoming 480
<b>Aircraft Serial Number:</b>	LB35
<b>Year of Manufacture:</b>	1971
<b>Date and Time (UTC):</b>	20 December 2005 @ 0945 hrs
<b>Location:</b>	Sligo Airport
<b>Type of Flight:</b>	Cargo
<b>Persons on Board:</b>	Crew - Two      Passengers - Nil
<b>Injuries:</b>	Crew – None      Passengers - Nil
<b>Nature of Damage:</b>	Undercarriage damage
<b>Commander's Licence:</b>	UK CPL
<b>Commander's Details:</b>	Male, aged 62 years
<b>Commander's Flying Experience:</b>	10,208 hours of which 83 were on type
<b>Information Source:</b>	Airport Manager, Sligo Airport. AAIU Incident Report Form submitted by pilot.

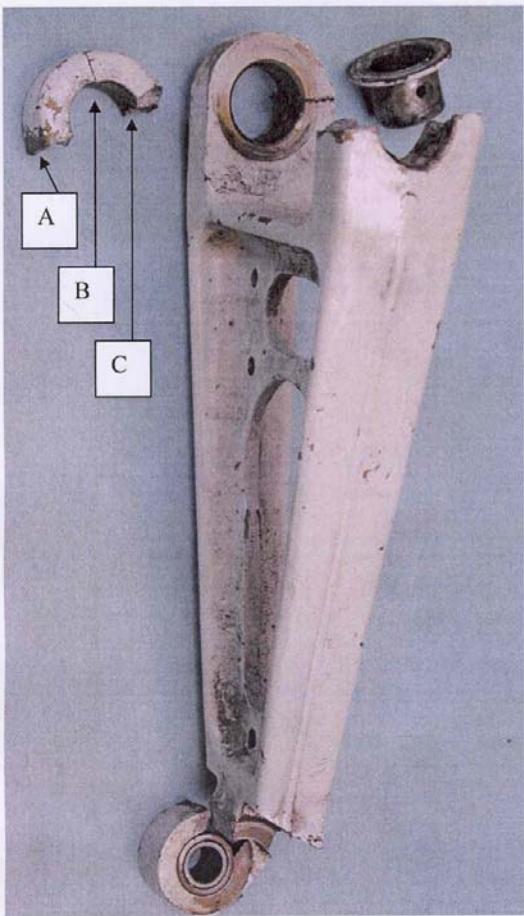
Figure 1

The AAIU commissioned an examination of the Left Hand (LH) Main Torque Link of N70AA. The link is shown in *Figures 1 and 2*.

The examination noted that the link had failed at two of the attachment points to the leg (one upper and one lower) and the other upper and lower attachment points were cracked. The joint in the link had also failed.

The fracture surfaces were referenced A to D ( as indicated in *Figures 1 and 2* ) for ease of identification. These surfaces were cleaned with acetone to reveal bright fracture features in all cases, indicative of single event overload failure with no indication of any pre-existing defect.

The metallurgical examination showed that the fractures in the torque link were caused by single event overload. No evidence of any pre-existing cracks or other defects was found. The only mechanism by which an overload can be applied to such a main wheel torque link is by means of the application of a rotational torque loading being applied to the link. There are two circumstances which can apply such a rotation torque to the link.
