FINAL REPORT

AAIU Synoptic Report No: 2006-011
AAIU File No: 2006/0046
Published: 3/07/2006.

Aircraft Type and Registration:	Searey Amphibian, EI-SEA
No. and Type of Engines:	One, Rotax 912S
Aircraft Serial Number:	1 DK359C
Year of Manufacture:	2006
Date and Time (UTC):	04 June 2006 @ 1753 hrs.
Location:	Sligo Airport
Type of Flight:	Private
Persons on Board:	Crew - One Passengers - Nil
Injuries:	Crew - None Passengers - Nil
Nature of Damage:	Left main undercarriage wheel collapsed.
Commander's Licence:	UK PPL
Commander's Details:	Male, aged 49 years
Commander's Flying Experience:	230 hours (including 8.25 on type).
Information Source:	Manager, Sligo Airport. AAIU Incident Report Form submitted by the Pilot.

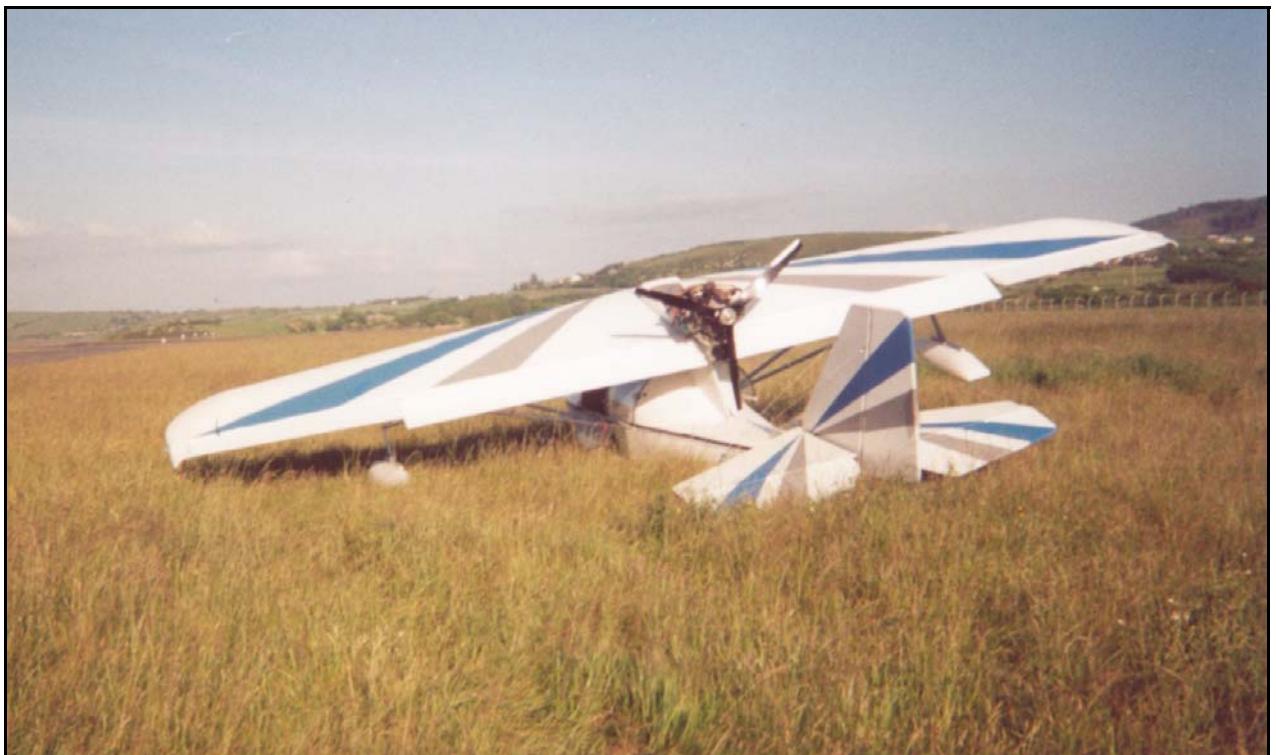
On one earlier landing he momentarily went off the runway onto the grass near taxiway Alpha. On the incident flight, and after a normal landing, he powered up to take-off again when the left main wheel collapsed and the aircraft slid in an arc onto the grass area adjacent to the runway.

On assessing the cause of this collapse the pilot admitted that he had failed to lock down the landing gear, that, *"I had failed to push lever home, listen for click and lock down"*. The pilot conceded that, with his enthusiasm for his new aircraft, and the physical act of levering the undercarriage up and down for each circuit, his concentration may have lapsed on the final circuit.

There was very minor damage to the aircraft.

Final resting position of EI-SEA
