## FINAL REPORT

**AAIU Synoptic Report No: 2006-0020**  
**AAIU File No: 2006/0003**  
**Published: 25/09/06**

<b>Aircraft Type and Registration:</b>	Sikorsky S 61 N, EI-SAR.	
<b>No. and Type of Engines:</b>	2 x General Electric CT58-140-2.	
<b>Aircraft Serial Number:</b>	61143.	
<b>Year of Manufacture:</b>	1962.	
<b>Date and Time (UTC):</b>	17 January 2006 @ 11.10 hrs.	
<b>Location:</b>	Conningbeg Lightship, 5 nm south south west of the Saltee Islands, Co Wexford.	
<b>Type of Flight:</b>	Training.	
<b>Persons on Board:</b>	Crew - 5	Passengers - Nil
<b>Injuries:</b>	Crew – 1 (Minor)	Passengers - Nil
<b>Nature of Damage:</b>	Extensive to two main rotor blades and cockpit canopy.	
<b>Commander's Licence:</b>	Irish ATPL(H).	
<b>Commander's Details:</b>	Male, aged 36 years.	
<b>Commander's Flying Experience:</b>	3,980 hours of which 2,225 hours were on type.	
<b>Information Source:</b>	Pilot Report Form and Reports submitted by SAR crew.

### **SYNOPSIS**

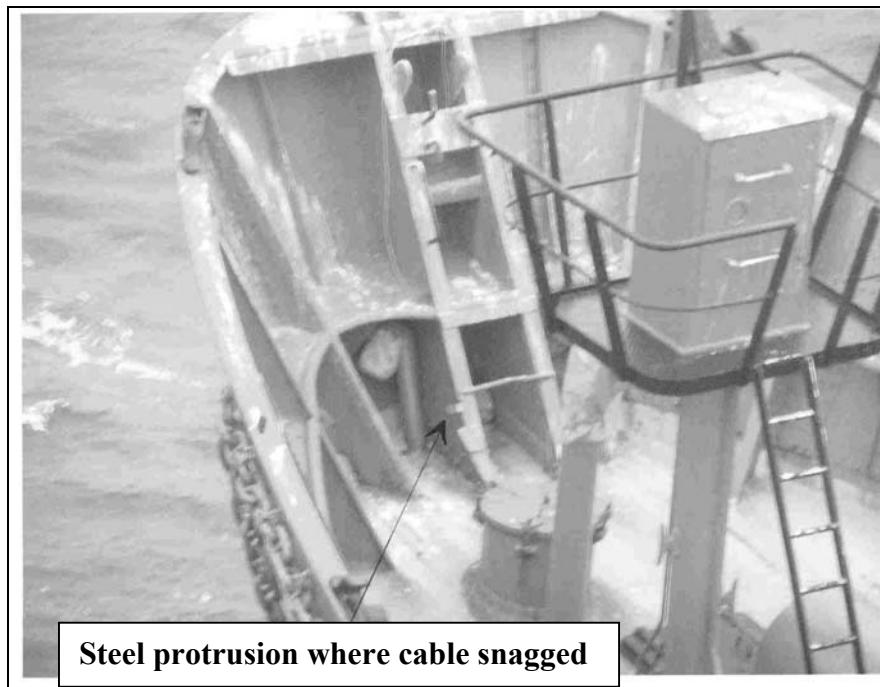
Photograph No. 1

The Winchman was lowered to the deck and landed facing the foot of a steel ladder in the very bow of the ship where the sides are raised to provide a sheltered deck. The vessel was rising on a 2-metre swell and, as the Winchman attempted to release from the hoist hook, he was thrown off balance by the falling bow. To steady himself, the Winchman had to grasp the ladder with one hand, while at the same time trying to release from the hoist hook. During this process, a coil of cable looped around a small steel protrusion welded to the side of the ladder (**Photograph No 1**).

On seeing that the Winchman had disconnected, the Winch Operator started to winch in the cable. At the same time, the bow of the ship pitched down, load was put on the unseen snagged cable and the cable sheared just above the hook attachment point.

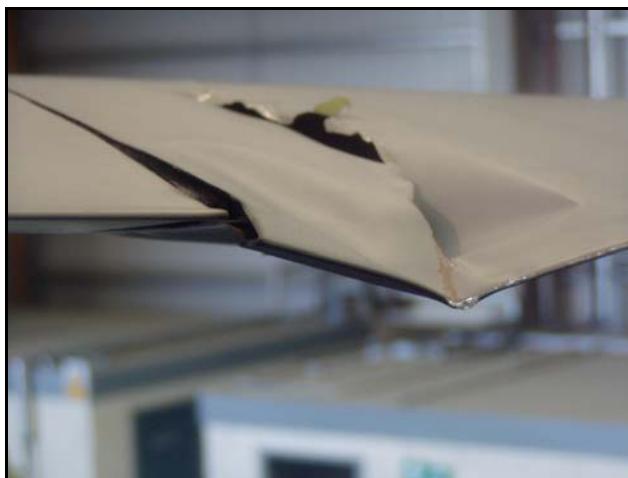
The white blade (S. No 61-M-3886-3355) had extensive damage to pocket 17 and 18. Scoring was found to the leading edge spar forward of pocket 17 and 18. A tear was also found in the pocket up to the rear of the blade spar (**Photograph No. 2**).

Due to the extent of the damage, the blades were returned to an overhaul facility for further examination and repair.

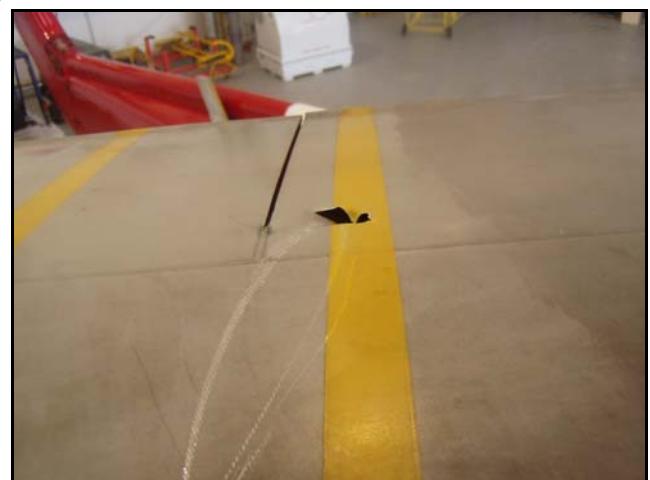
The black blade (S. No 61-M-3860-3637) had a hole/tear on its upper surface at pocket 21 up to the rear of the blade spar. There was some scoring at the leading edge of the spar and on the upper surface of the spar in the same area (**Photograph No. 3**).

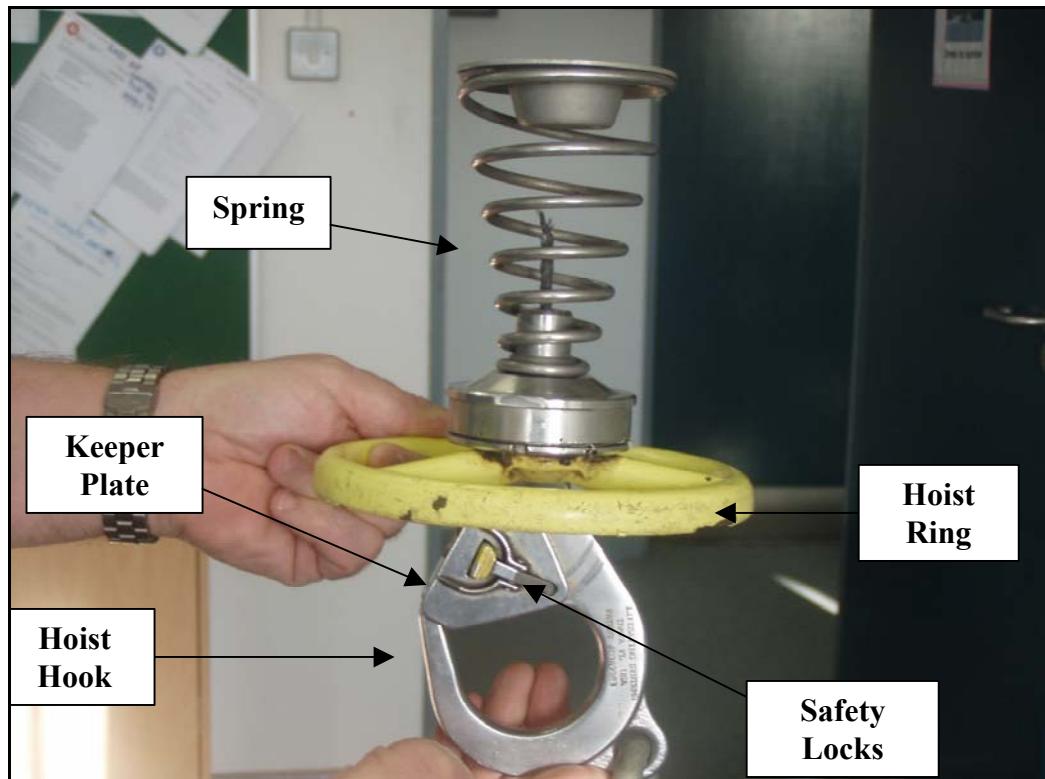
Photograph No 4 - Hoist Hook Assembly.

The winch hook is made up of a stainless steel hook, a keeper plate with safety locks on either side, a hoist ring, and an end of travel hoist spring/weight (**Photograph No. 4**).

One factor that can hinder quick single-handed operation of the hoist hook is the obstruction caused by the hoist ring. The ring can impede easy access to the hook as the hook can only be grasped from below the ring. This spoils the natural grip on the hook and latches, and although appearing as a minor matter, it may be critical in a situation where fractions of seconds count. The ring also increases the profile of the hook assembly, creating a larger snagging hazard in confined areas.

In discussions with the Operator, it has been confirmed that the Company has reviewed the matter of the hoist ring and have decided to standardise all hoists (to a ring-less hook) within their fleet. The Investigation is supportive of this initiative.
