FINAL REPORT

AAIU Synoptic Report No: 2006-022

Aircraft Type and Registration:	Piper Pacer PA 20/22 G-APYI	
No. and Type of Engines:	1 x Lycoming O-290-D2	
Aircraft Serial Number:	22-2218	
Year of Manufacture:	1954	
Date and Time (UTC):	21 August 2005 @ 17.45 hrs	
Location:	Ballyboy, Athboy, Co.Meath	
Type of Flight:	Ferry Flight	
Persons on Board:	Crew - 1	Passengers - Nil
Injuries:	Crew - Nil	Passengers - Nil
Nature of Damage:	Propeller tip damage, starboard main wheel spat and damage to wing surfaces	
Commander's Licence:	Commercial Pilots Licence	
Commander's Details:	Male, aged 50 years	
Commander's Flying Experience:	2,000 hours of which 500 were on type (tail dragger)	
Information Source:	AAIU accident report form submitted by Pilot.

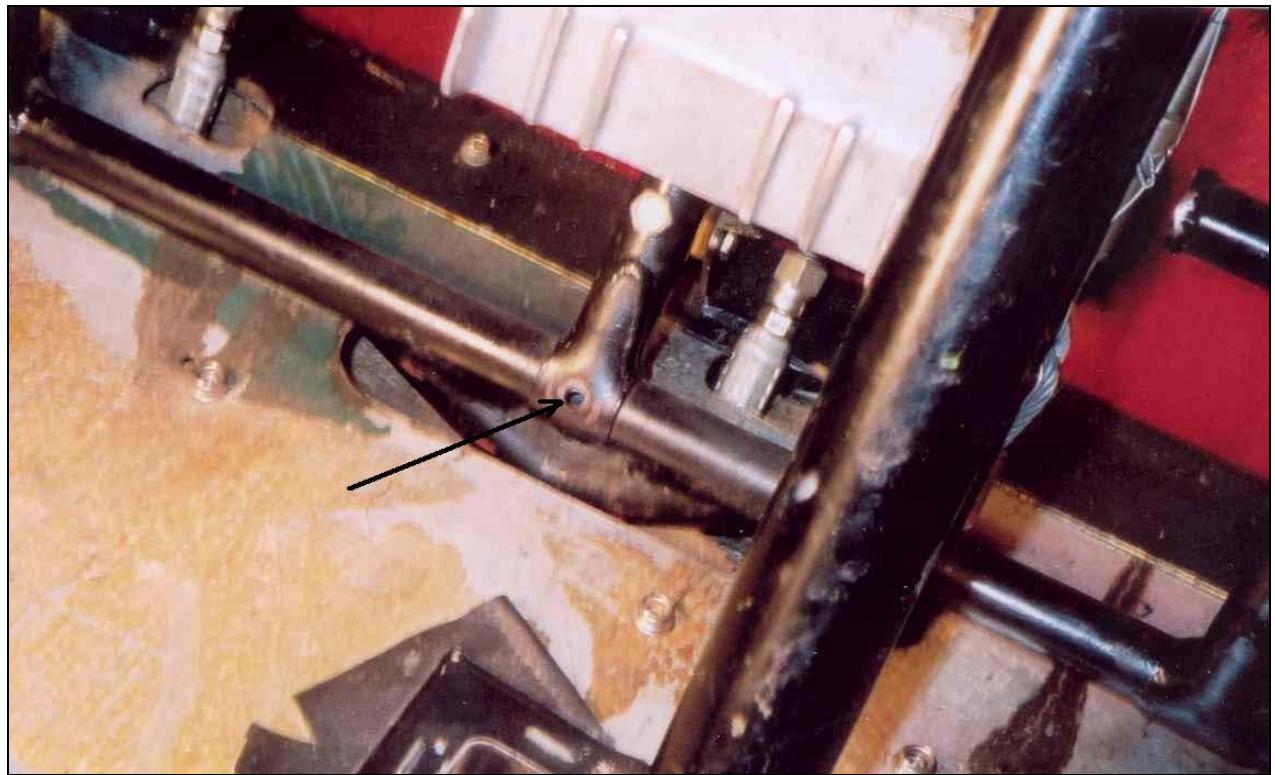
Further investigation revealed that although the bolt was of the correct size, the hole into which it fitted in the torque tube had become elongated and oversize, resulting in considerable play in the pilots right rudder pedal system.

There was excessive play between the pilot's right pedal and the torque tube due to elongation of the bolt hole in the tube.

A view of the pilot's RH pedal showing the elongated hole with the bolt removed

It is of interest to note that in 1992 the FAA issued approval for modification kits STC SA8334SW and STC SA45RM, both to include dual brake system, new linkages and new torque tubes. This would have been a better option than the modification carried out previously. Due to the time gap between the incident date, the aircraft inspectors visit and the commencement of the Investigation it is not possible to ascertain with certainty the reason for the deterioration in play between the pedal bolt and the torque tube.
