## FINAL REPORT

**AAIU Formal Report No: 2006-023**

**Manufacturer:** Avions Robin

**Model:** Jodel DR 250 - 160

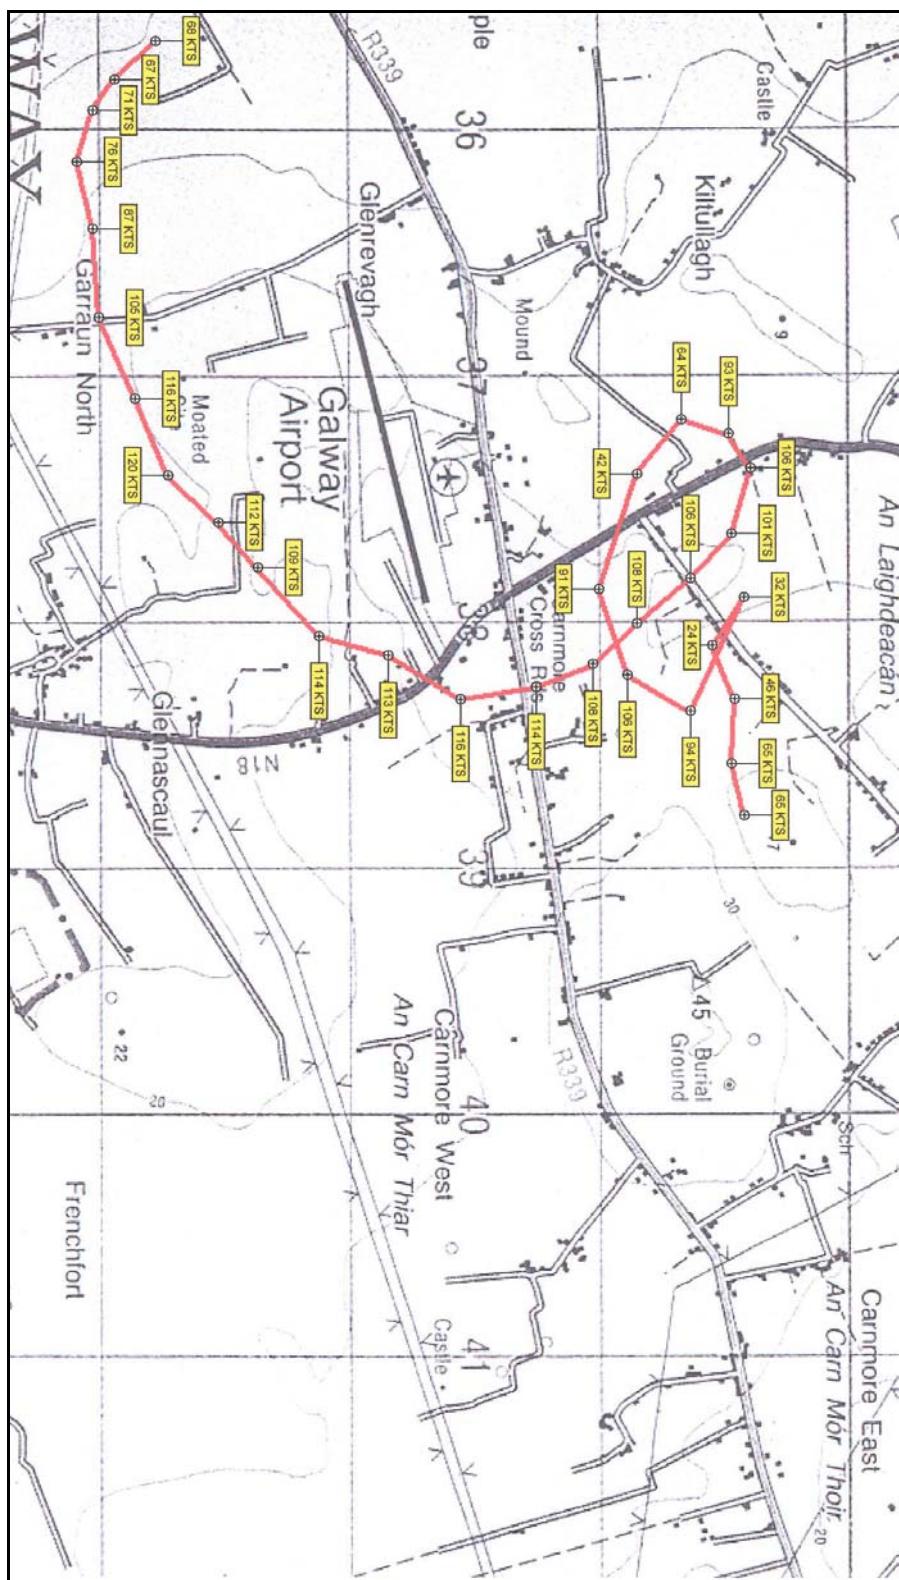
## Most likely “Track Made Good” as depicted by Shannon Radar

The radar returns show OO-TYP initially turning towards Birr, following a left turnout off RWY 26. However, the gentle left hand climbing turn is continued around the general area of the airport and onwards towards the north. The Tower Controller told the Investigation that when he saw OO-TYP nearing the cloud base, he amended the clearance to Special VFR in the Zone as he considered that under the prevailing weather conditions VFR was not sustainable. The Controller then lost sight of OO-TYP just south of the field.

The gradual climbing left turn towards the north, as recorded on the radar plot, does give the appearance that the aircraft was under control. Therefore it is possible that the Pilot was flying close to the cloud base with poor horizontal visibility, but with some visual reference with the ground. Failure to maintain the heading for Birr (115°M) could have resulted from the Pilot concentrating on maintaining visual references and therefore not being aware of the changing heading.

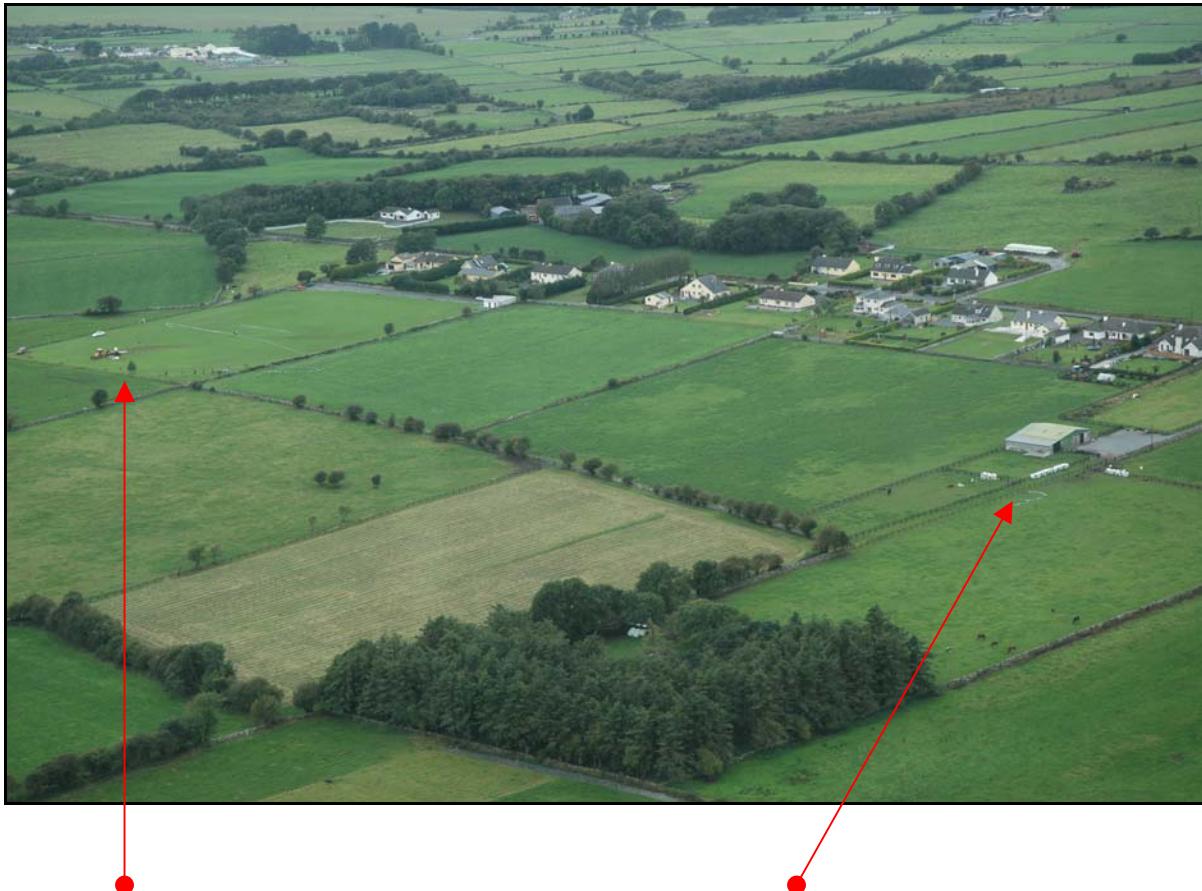
### General Aerial View Of Accident Site

Primary Impact Site

Secondary Site Where wing section was located

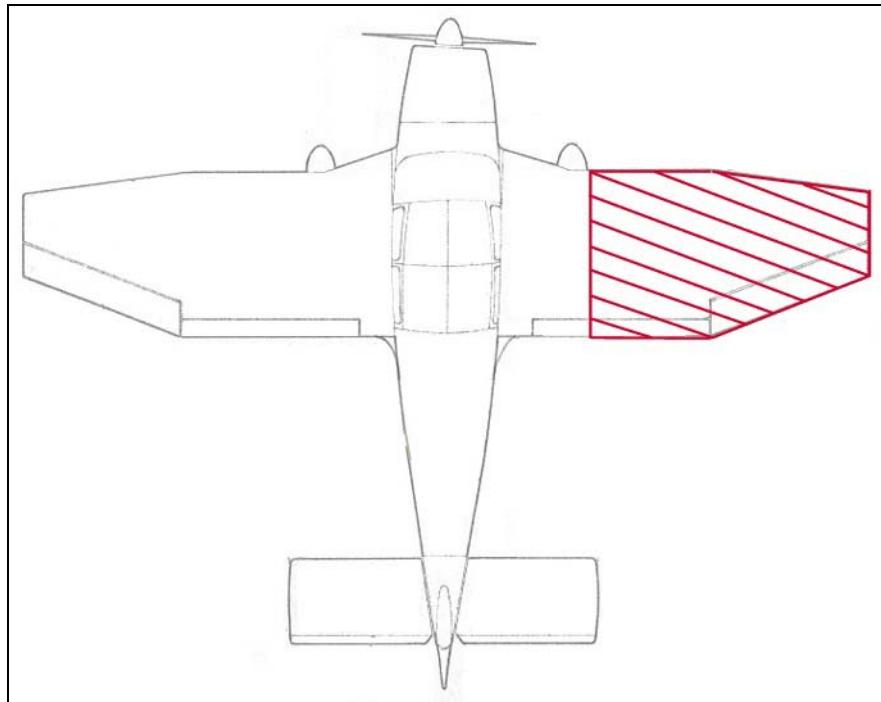
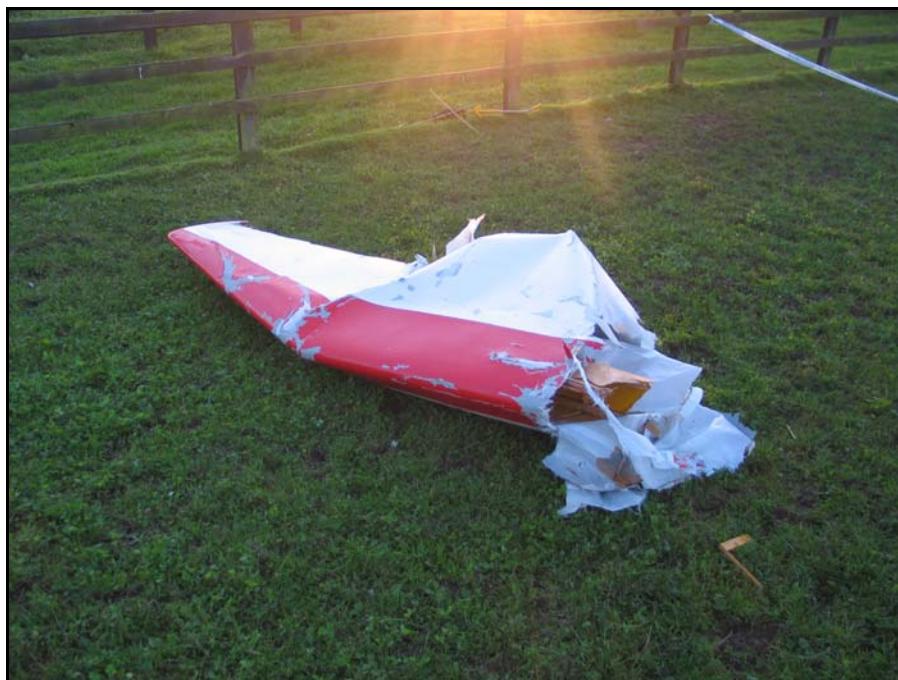
## Appendix F

The outer RH wing section had separated in flight (**Appendix F**). Because of its bulky but light construction, it floated somewhat gently to ground. It struck a fence, but remained largely intact with its aileron still attached. Examination of this wing section showed it to be well constructed and the materials used as per the approved materials and practices in force today. No evidence was found of any significant repairs or water penetration, which might have weakened any part of the wing.

A rough fibre test was carried out on the spar boom material and it was comparable with a recent certified piece of Sitka Spruce. There was no sign of disease or brittleness. The wing suffered severe impact, yet most of the breakages in the boom were splits with ratios of up to 20 to 1 and there was no evidence found of glue failure. In conclusion, the wing was well constructed and maintained. There was no evidence to suggest that any pre-existing defects existed within the wing structure prior to its failure. Therefore it is likely that the wing failed in upload following a gross overload of the wing.

An examination of the failed right hand (starboard) wing section, found no evidence to suggest that any pre-existing defects were present within the structure, prior to its failure. The likely cause of the wing failure, which occurred just outboard of the right hand fuel tank and undercarriage attachment point was that, the wing section failed in upload, following a gross single event overload of the wing in flight.

11. The starboard wing section, just outboard of the wing fuel tank and undercarriage attachment point, failed as a result of a gross overload of the wing section in upload.

Section of wing that separated from aircraft

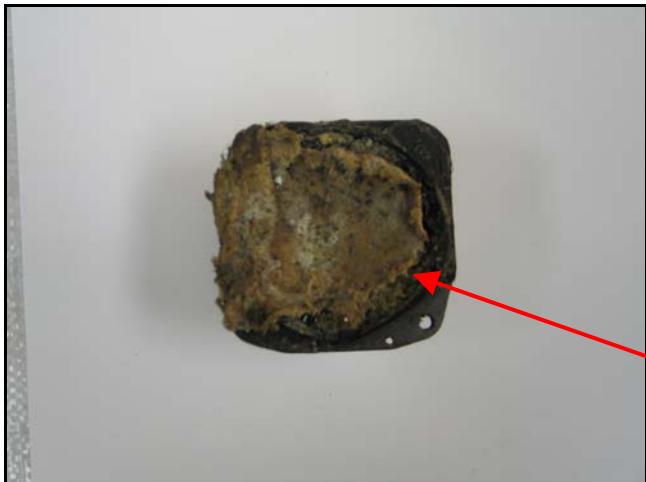
This altimeter (No. 1) was found loose within the wreckage. It was noted that a cardboard blanking cover had been placed over the face of the altimeter and secured by the mounting screws that would have held it in place on the instrument panel.

Altimeter No. 1 was also found loose within the wreckage. However, this particular altimeter had a cardboard blanking cover secured to its face, by means of the mounting screws. Following post accident examination, the general overall condition of the instrument indicated that this altimeter was secured to the instrument panel. This is supported by the fact that the mounting screws, which were still attached to the instrument, had sheared.

Altimeter No. 1 with face covered

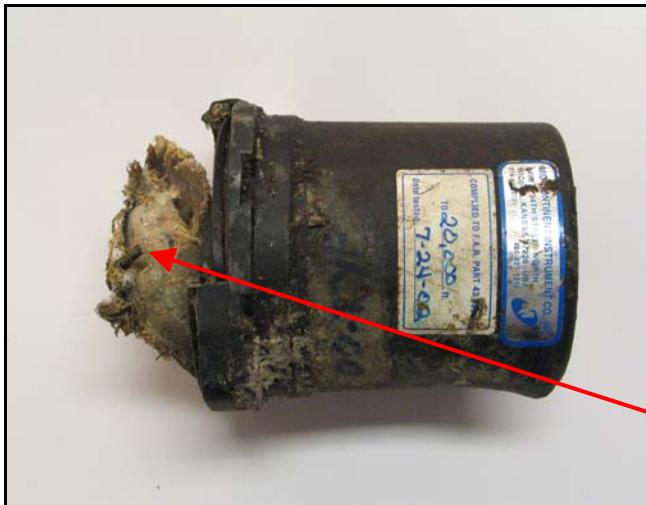
Two of the three mounting screws were found on the altimeter. However, these had sheared at the back plate of the mounting attachment. The casing was broken at the static line attachment port and the altimeter had significant deposits of soil on it. The pressure sub scale was set at 1013 hPa.

Altimeter No. 1 with broken mounting screw

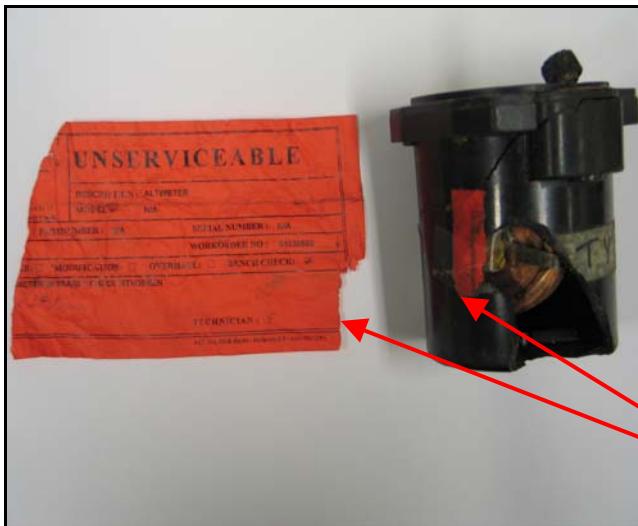
A red unserviceable label had partially detached itself from the altimeter and was lying on the ground within the wreckage. The other part of this label was still attached to the altimeter casing (**See Appendix G**). No Part or Serial Number was found on this label. However, it did reveal a Work Order No 01030603 and a note on the label identifying that it was, “*Out of Tolerance*” and therefore unserviceable. It was later identified as a Kollsman, however, the part number and serial number were missing. Further research on the Work Order Number determined the following:

In June 2003, a 2-yearly bench check (Examination) had been carried out on the altimeter and on a Blind Encoder (NARCO AR-850 No 33553). The bench check revealed that the part and serial number was missing and that the altimeter was, “*Out of Tolerance*” at the higher altitudes and therefore unserviceable.

Altimeter No. 2 was found loose in the wreckage with a red unserviceable label, which had detached from the altimeter, lying in close proximity to the instrument. The altimeter was certified out of tolerance, unserviceable, and therefore not suitable for use.

Altimeter No. 2 with unserviceable label
