**AAIU Synoptic Report No: 2006-027**

<b>Aircraft Type and Registration:</b>	BAe 146-200, EI-CWA	
<b>Aircraft Serial Number:</b>	E2058	
<b>Year of Manufacture:</b>	1986	
<b>Date and Time (UTC):</b>	21 February 2005 @ 15.30 hrs	
<b>Location:</b>	Dublin Airport	
<b>Type of Flight:</b>	Ferry Flight	
<b>Persons on Board:</b>	Crew - 2	Passengers - Nil
<b>Injuries:</b>	Crew - Nil	Passengers - Nil
<b>Nature of Damage:</b>	Broken LH undercarriage door hinge	
<b>Commander's Licence:</b>	Airline Transport Pilot's Licence	
<b>Commander's Details:</b>	Male, aged 42 years	
<b>Commander's Flying Experience:</b>	10,200 hours, of which 5,700 were on type	
<b>Information Source:</b>	ATS Dublin (Report No. DA 031/05)

The aircraft was on a positioning flight to Paris CDG following maintenance for a suspected Main Landing Gear indication problem at Dublin. On retraction of the gear following the take-off, a red "gear unlocked" and "gear in transit" warning light, was observed by the crew. The "abnormal" checklist detail was then carried out and the gear activated in an effort to clear the problem. The crew requested a quick return (QRF) to Dublin. On the approach the warning indications cleared and

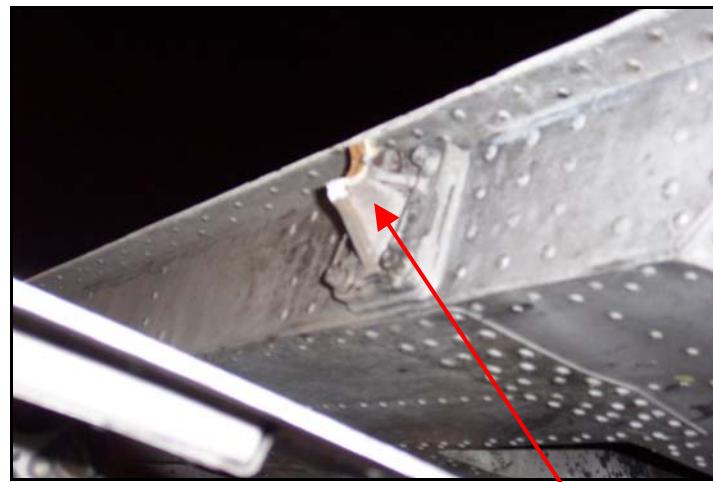
The corrosion evidenced in the attached photographs at **APPENDIX A** was very severe but might not have been readily visible in situ. There was obviously a problem with the door during the previous flight. Maintenance could not find the fault probably due to the fact that in the hangar there were no aerodynamic forces acting on the door pulling it in a lateral direction. The hinge may have been fractured at that stage.

1. The failure of the door forward hinge was due to corrosion. Failure of the hinge, in turn, prevented the up-lock from engaging due to lateral aerodynamic forces on the door.

**Photo No. 1:** The broken half-hinge attached to the undercarriage door.

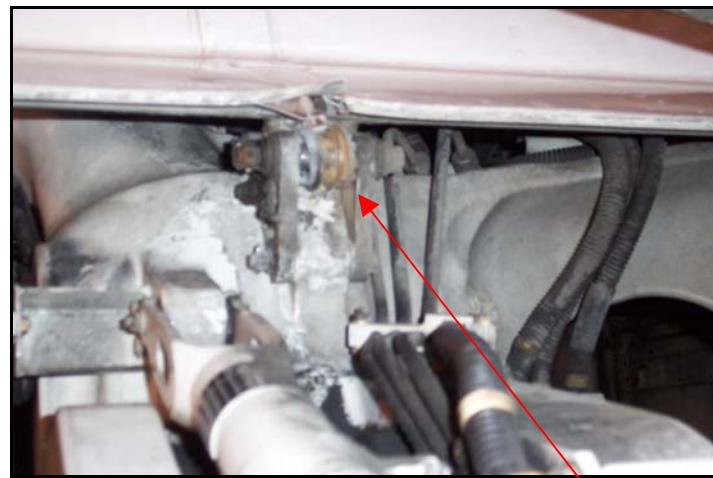
**Photo No. 2:** The corresponding half fixed to the undercarriage strut showing the corrosion on the bearing housing.

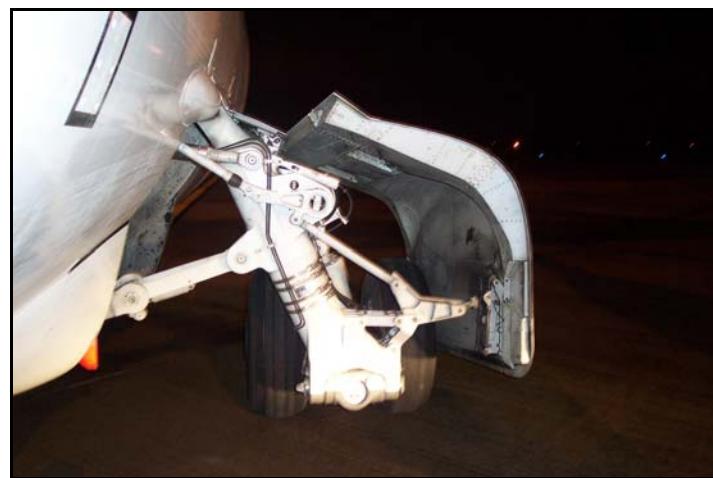
**Photo No. 3:** General view of the LH undercarriage and door.
