FINAL REPORT

AAIU Synoptic Report No: 2007-001

Aircraft Type and Registration:	Aerospatiale AS 350 B, EI-CGQ	
No. and Type of Engines:	1 x Turbomeca Arriel 1B	
Aircraft Serial Number:	2076	
Year of Manufacture:	1988	
Date and Time (UTC):	25 June 2005 @ 10.05 hrs	
Location:	Weston Airport	
Type of Flight:	Private Flight	
Persons on Board:	Crew - One	Passengers - Nil
Injuries:	Crew - Nil	Passengers - Nil
Nature of Damage:	Major damage to tail boom, including TR blades and TR head. Skid damaged	
Commander's Licence:	CPL (H)	
Commander's Details:	Male aged 40 years	
Commander's Flying Experience:	4,117 hours, of which 12 were on type	
Information Source:	Operator

SYNOPSIS

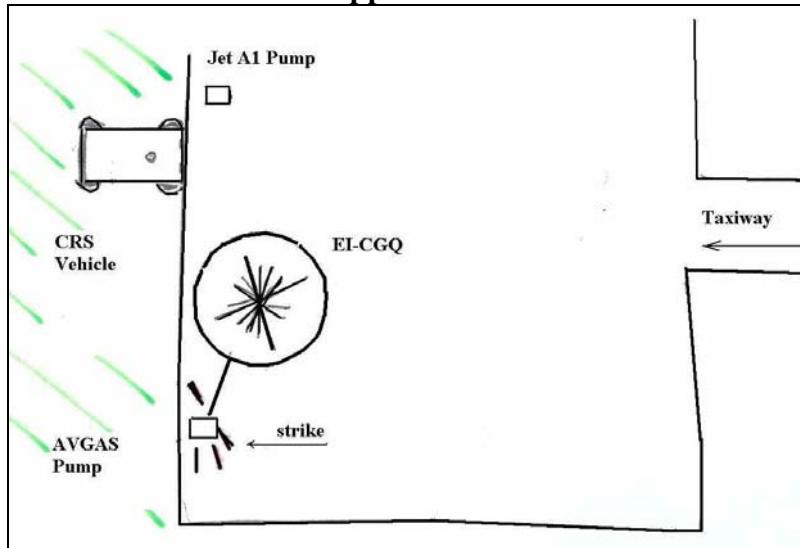
Appendix A

While in the hover the pilot turned the tail to port and not wishing to impede the CRS vehicle backtracked along the edge of the ramp. The pilot looked left and confirmed that he was still over the tarmac ramp area and clear of the grass verge. During this manoeuvre ATC contacted the pilot to confirm his identity. The pilot said he then heard a thud followed by an uncontrollable yawing motion. It appeared that the helicopter rotated about its yaw axis for at least one and a half rotations. The helicopter pitched nose up and he saw debris being thrown outwards. He immediately retarded the fuel control lever. The aircraft descended and landed heavily on the skids. The pilot turned the fuel shut off lever to the OFF position, switched off the battery and vacated the helicopter in the normal way. A sketch of the general accident site as prepared by the pilot is reproduced at (**Appendix A**).

Reproduction of pilot's sketch of refuelling area

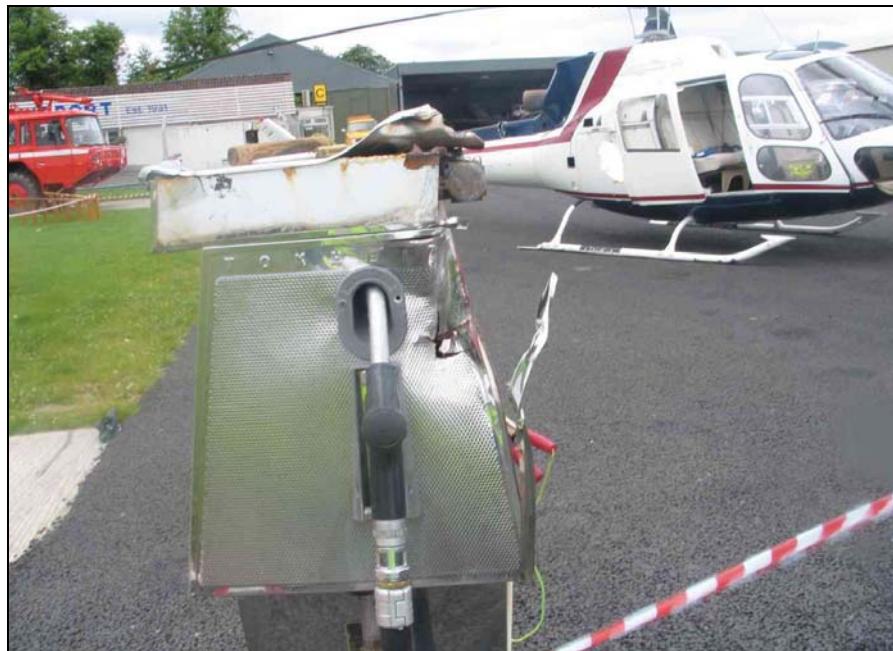
Appendix B

The outer metal surrounds of the Avgas dispenser were damaged due to contact with the tail rotor and tail rotor blades. The pump was out of commission for some time following this accident and was eventually replaced.

This Avgas fuel storage installation at the aerodrome consists of an over-ground fuel tank with an underground feed pipe to a standard forecourt petrol dispenser (**See Appendix B**). The dispenser, which is adjacent to the aircraft parking area, is sited on the tar macadam ramp at about 1 metre in from the grass verge. The fuel outlet from the dispenser feeds an adjacent fuel filter and from there, to the refuelling nozzle via a 30 metre loose hose.

At the time of this accident involving EI-CGQ, it was evident to the Investigation that adequate markings were not in place following the Islander incident.

There were inadequate ground safety markings in the immediate area of the fuel dispensers.

The above photo shows the scene at the time of the accident. The Avgas dispenser is in the foreground, with the helicopter and CRS vehicle in the background.

It is envisaged in the airport plan that all fixed wing and helicopter operations will move to the north side of the main runway. However, in the meantime, if refuelling in this area continues it would be appropriate to paint the ground around the pumps with alternate yellow/black markings so that the danger zone is clearly visible.

1. Whilst the fuel dispensers continue to be used, the Airport Management should ensure that the Fuelling Zones are marked in accordance with DSEAR regulations. [\(SR 01 of 2007\)](#)
2. All refuelling hose should be installed on a reel. [\(SR 02 of 2007\)](#)

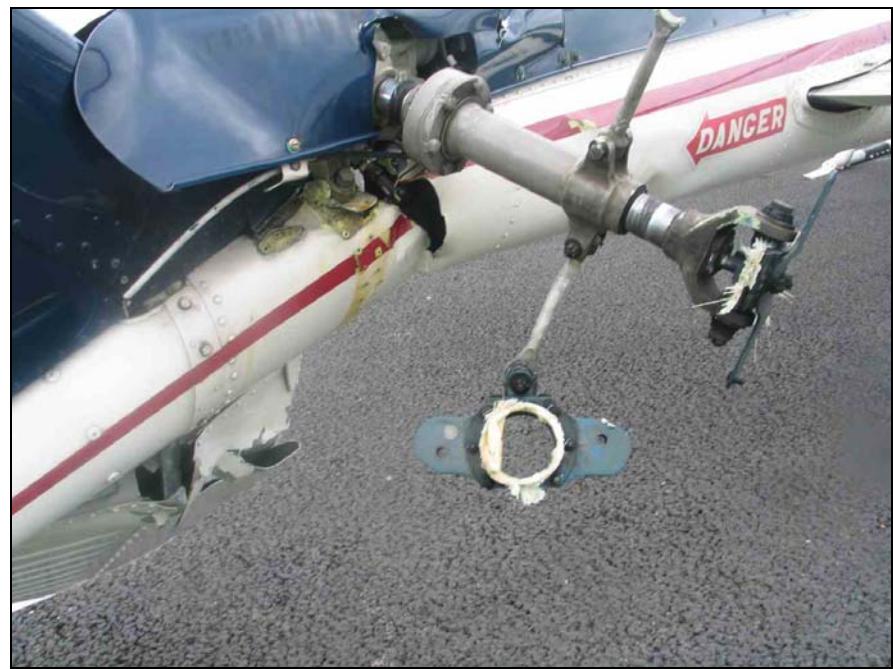
There was severe damage to the tail rotor, and the tail rotor blades disintegrated on impact with standard commercial petrol dispenser. The tail rotor head, rear fuselage and tail rotor skid were damaged. The drive shaft came apart at front and rear flexible couplings and burst the boom skin at these points. The hard landing damaged the rear skid support and possible further damage to the underneath helicopter structure. The RHS horizontal stabilizer was also damaged.

The tail rotor struck the Avgas Fuel dispenser whilst the helicopter was positioning to refuel at the Jet A1 dispenser.

Failure to assure adequate clearance whilst manoeuvring in close proximity to the static fuel dispenser.

Damage to the tail, tail rotor head and blades of EI-CGQ.
