AAIU Synoptic Report No: 2007-002

AAIU File No: 2006/0051

Aircraft Type and Registration:	B737-800, EI-DCT
No. and Type of Engines:	2 x CFM 56-7B
Aircraft Serial Number:	33813
Year of Manufacture:	2004
Date and Time (UTC):	4 June 2006 @ 16.49 hrs
Location:	Cork Airport
Type of Flight:	Public Transport
Persons on Board:	Crew - 6 Passengers - 128
Injuries:	Crew - None Passengers - None
Nature of Damage:	None
Commander's Licence:	Airline Transport Pilot's Licence (ATPL Germany)
Commander's Details:	Male, aged 46 years
Commander's Flying Experience:	11,780 hours.
Information Source:	AAIU Field Investigation.

SYNOPSIS

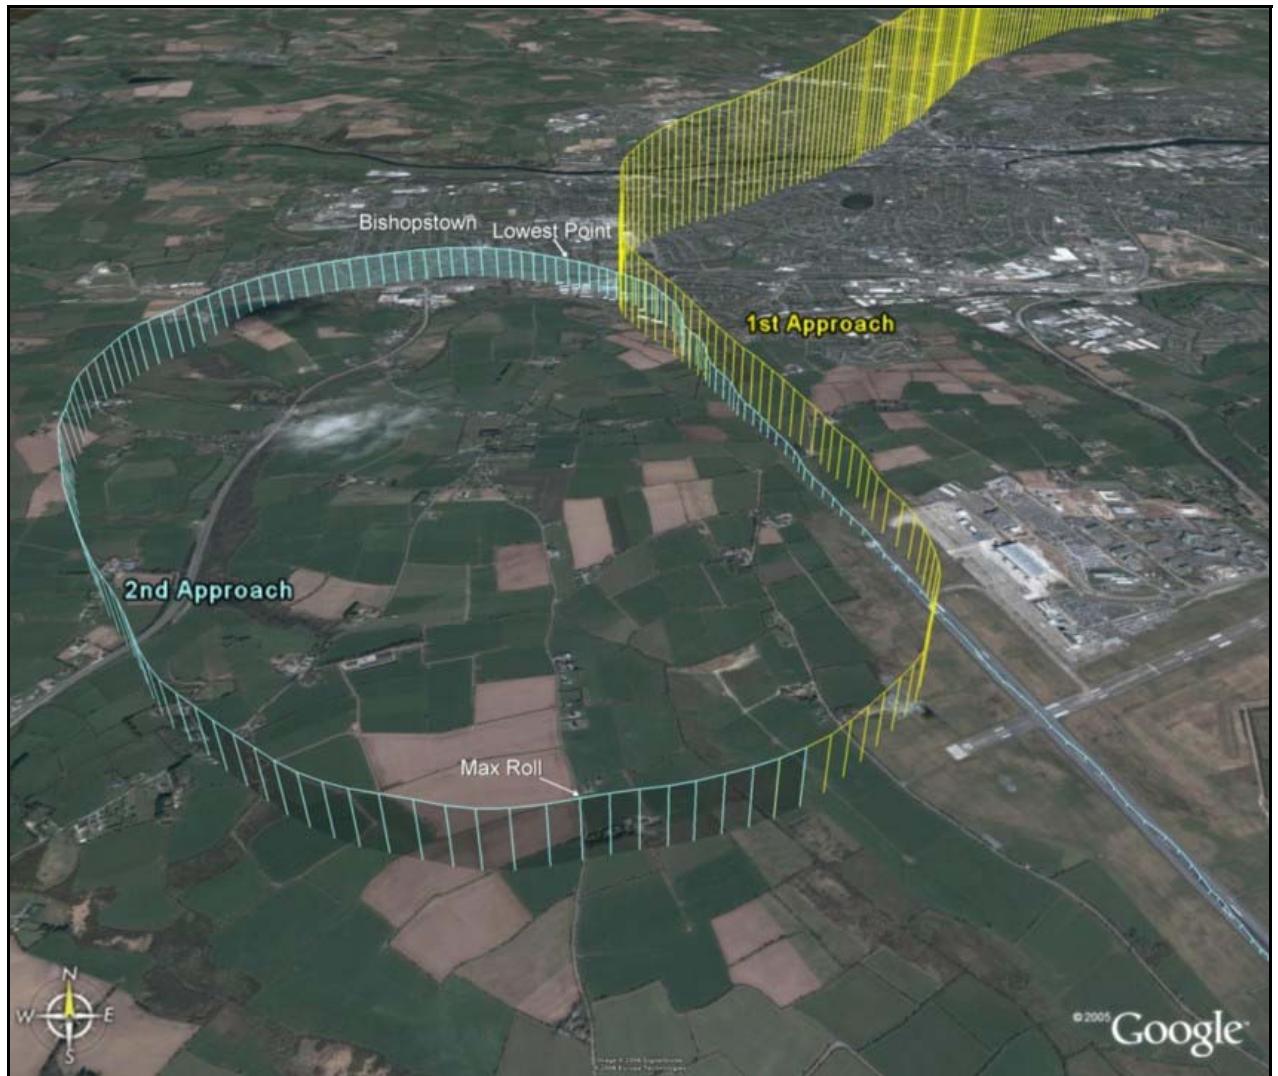
Appendix A

Radar returns show that the aircraft climbed initially to 1100' ASL (visual maneuvering height) at the commencement of the orbit, $\frac{1}{2}$ NM west of the airfield at 140 kt IAS. A momentary bank angle exceedence of 31.99 deg occurred about this time (30 deg being the bank angle limit). Gradually the speed built up to a maximum of 153 kt IAS, but altitude was lost during this orbit. The lowest altitude recorded was 553' ASL, which is 51' above the airport elevation. The lowest radio altimeter (RADALT) recorded height was 425' above ground level (AGL). Part of the downwind and base leg of this orbit took the aircraft over the residential Bishopstown area of Cork City. This area, northwest of the airport, is considerably lower than the airport elevation of 502' ASL. From Bishopstown the ground gradually rises southward from the valley of the River Lee in the direction of the airport. The flight of the aircraft in this area was witnessed and reported on to the Cork Airport Authority by at least sixteen upset residents, whose independent and consistent complaints, submitted by phone and in writing, referred to noise and how low the aircraft was being flown. The PNF recalled hearing two EGPWS “*Too low*” Glide Slope CAUTIONs during the latter part of the orbit and that these annunciations were silenced by the PF. He also recalled that there were 4 reds indicated on the PAPI’s on final approach. DFDR data also indicated a 1 to 1.5 degree glide slope and an EGPWS alert. After a normal landing and post-flight discussion on events the PF conceded to the PNF that maybe a standard Go-around would have been a better decision in the circumstances. At a later debrief neither pilot considered fatigue a factor in this event. See **Appendix A** of DFDR generated aerial view of the two approaches and **Appendix B** for extract of DFDR readout.

6. The base leg of the second approach to RWY 17 was flown fully configured for landing over the Bishopstown area of Cork City at altitudes at or below 500' AGL while in a constant right hand turn.

DFDR generated aerial view of the two approaches

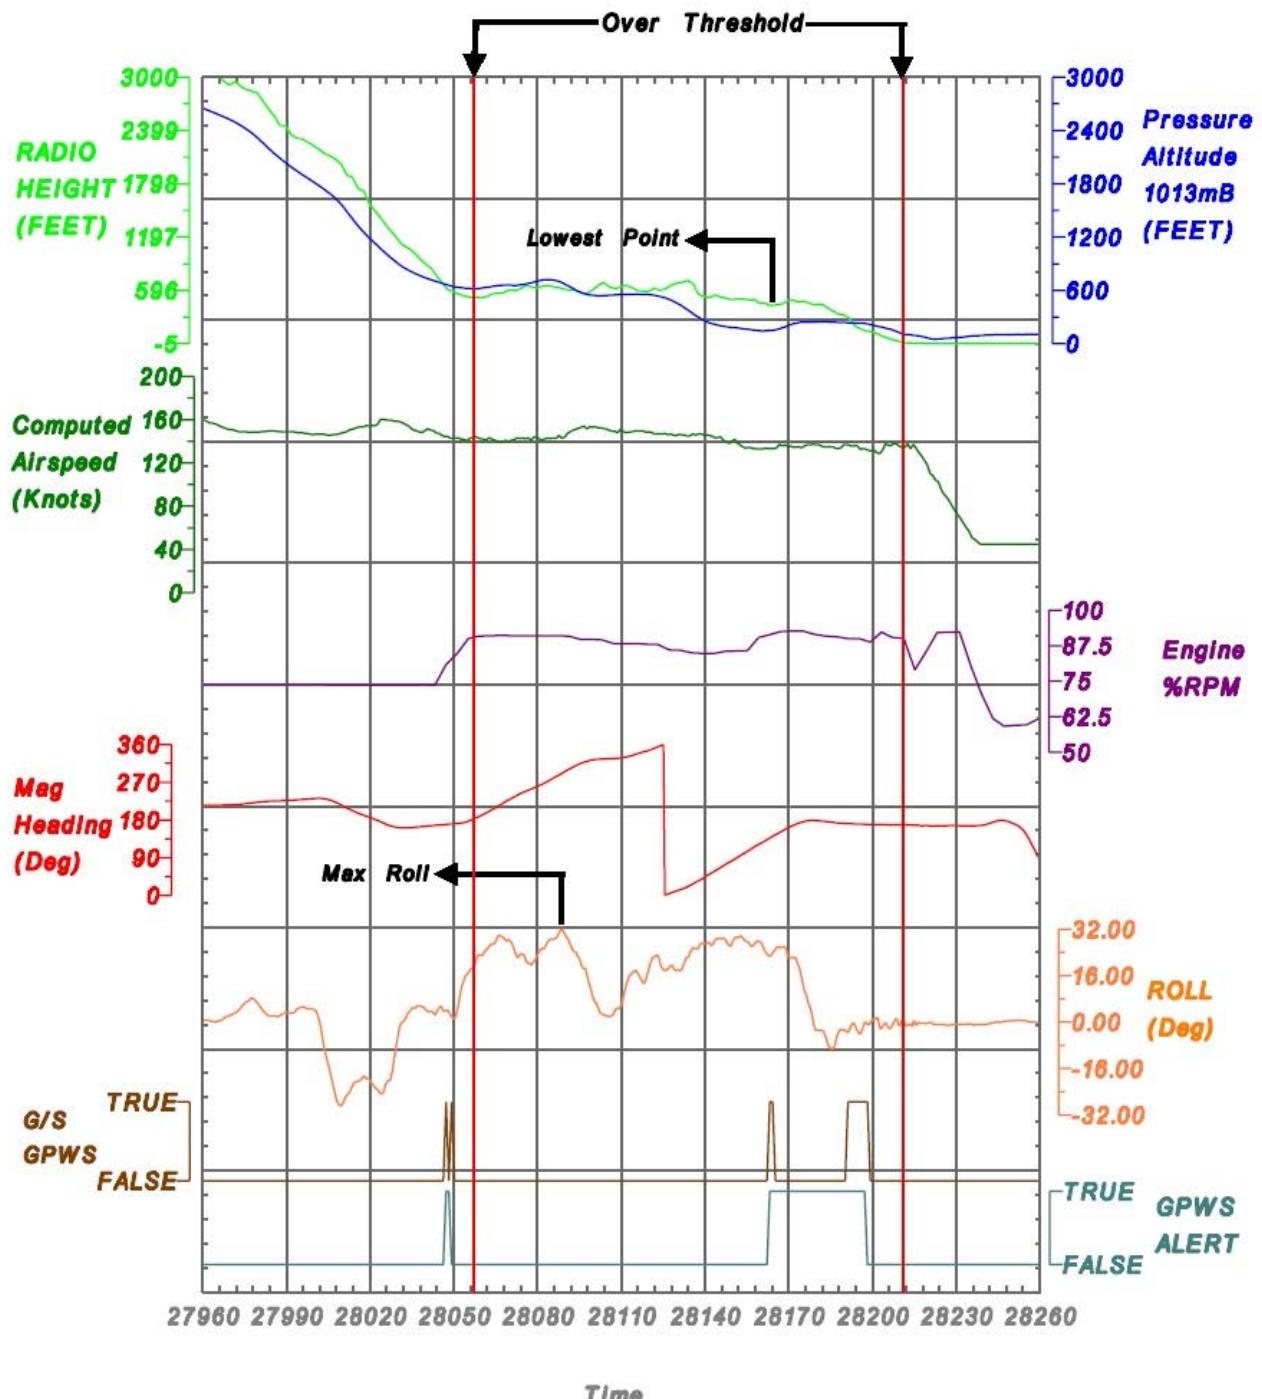
Appendix B

Extract of DFDR for EI-DCT
