**AAIU Synoptic Report No: 2007-004**

**AAIU File No: 2006/0063**

<b>Aircraft Type and Registration:</b>	Glider - Centrair Pegase 101A EI-162
<b>No. and Type of Engines:</b>	N/A
<b>Aircraft Serial Number:</b>	101A0346
<b>Year of Manufacture:</b>	1989
<b>Date and Time (UTC):</b>	07 August 2006 @ 16.15 hrs
<b>Location:</b>	Clonegal, Co. Wexford
<b>Type of Flight:</b>	Private
<b>Persons on Board:</b>	Crew - 1      Passengers - Nil
<b>Injuries:</b>	Crew - Nil      Passengers - N/A
<b>Nature of Damage:</b>	Substantial damage to wings, fuselage and tail
<b>Commander's Licence:</b>	N/A
<b>Commander's Details:</b>	Male, aged 48 years
<b>Commander's Flying Experience:</b>	95 hours, of which 49 were on type
<b>Information Source:</b>	Accident Report Form submitted by Owner/Pilot

### **SYNOPSIS**

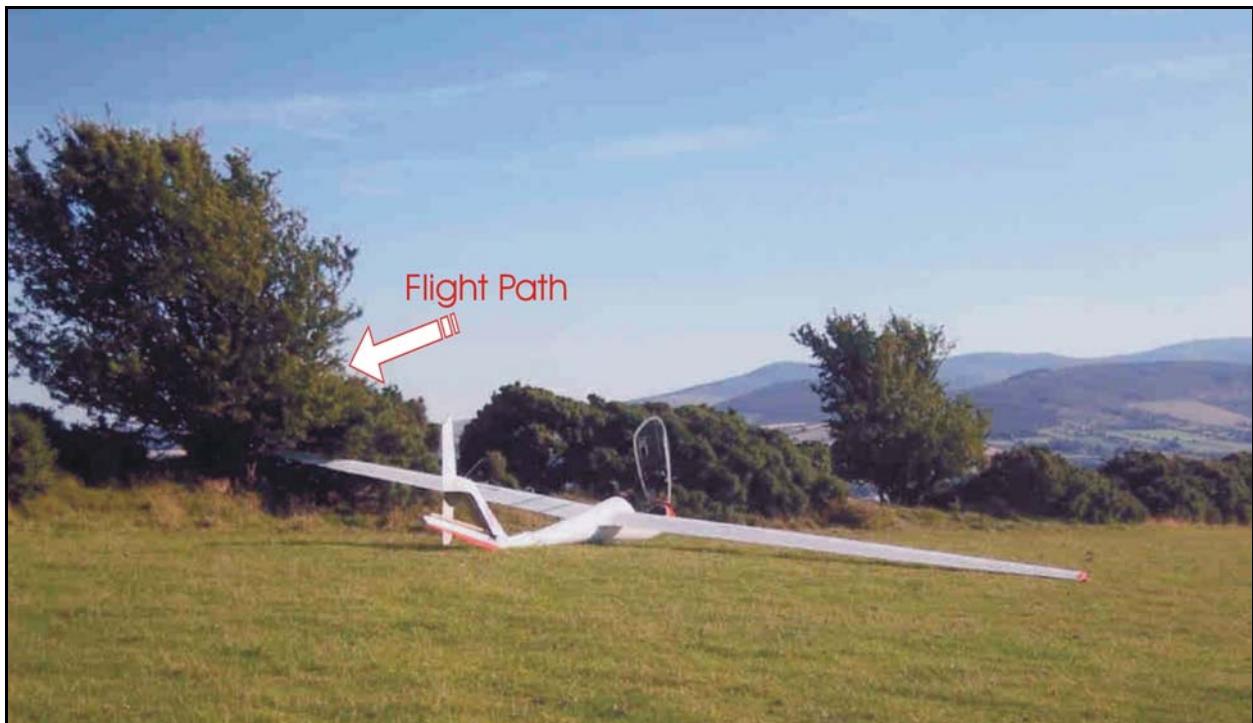
During his approach to land the pilot overshot the intended field at a low altitude and low speed. He cleared the boundary hedge at the far end of the field and turned right to avoid a tree. While crossing a further hedge the starboard wing contacted a tree on that hedge twisting the glider through 270 degrees. This rapid turn resulted in the tip of the port wing also hitting the tree as the glider fell from a height of approximately 10 ft. The pilot was unhurt but damage to the glider was substantial (see **Photo No. 1**).

**Photo No. 1: Final resting position of EI-162**

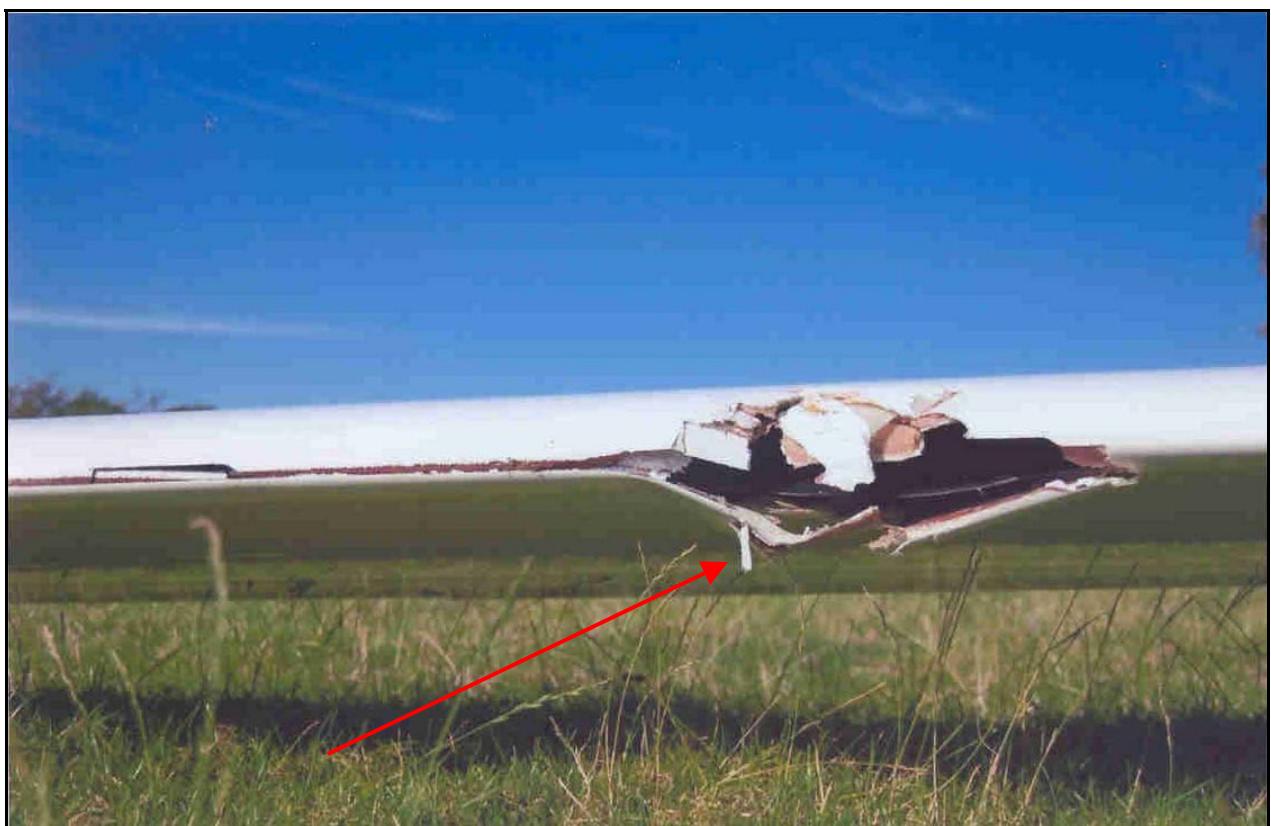
The right wing leading edge had an impact point at mid span with partial opening of the leading edge outboard from that point, the right wing root was bent aft (see **Photo No 2**). The left wingtip, though fractured, was still attached. Most damage was to the tail area, its boom and the T-tail fin assembly. The boom was fractured, tail assembly distorted and fin opened. It is probable that ground impact distorted the T-tail fin assembly and snapped the tail boom approximately half way along its length.

**Photo No 2: Initial impact point on mid-section of starboard wing.**
