FINAL REPORT

AAIU Synoptic Report No: 2007-005

Aircraft Type and Registration: Mainair Blade 582, Microlight, EI-DRH

Location: Rathcoole Airfield, Co. Cork

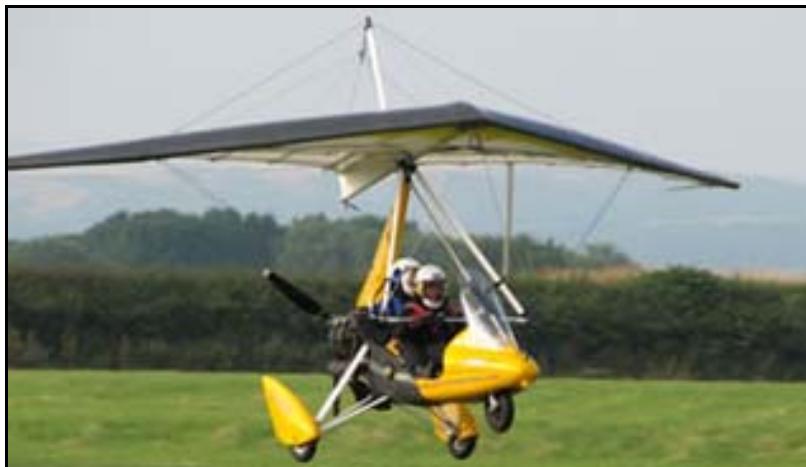
Photo No. 1: Mainair Blade - Photograph source manufacturer.

The Mainair Blade (See **Photo No. 1**) is a flex-wing, two seat pod unit with three wheels. This type of aircraft is commonly known as a trike. The engine is mounted behind the rear seat and coupled to a four bladed, carbon composite pusher propeller. Consequently, anything that comes loose in the cockpit or its vicinity will be sucked into the propeller, if the engine is under power.
