FINAL REPORT

AAIU Synoptic Report No: 2007-009
AAIU File No: 2007/0030
Published: 31/05/2007

Aircraft Type and Registration:	Robinson R22 Beta II, G-CCGF
No. and Type of Engines:	1 x Lycoming 0-360J2A
Aircraft Serial Number:	3454
Year of Manufacture:	2003
Date and Time (UTC):	10 April 2007 @ 15.00 hrs
Location:	Skinstown, Ballyragget, Co. Kilkenny
Type of Flight:	Private
Persons on Board:	Pilot - One
Injuries:	Pilot - None
Nature of Damage:	Substantial damage to Tail rotor/Tail boom
Commander's Licence:	UK PPL (H)
Commander's Details:	Male, aged 62 years
Commander's Flying Experience:	200 hours approximately, (all on R22)
Information Source:	Pilot informed AAIU and submitted AAIU Accident Report Form

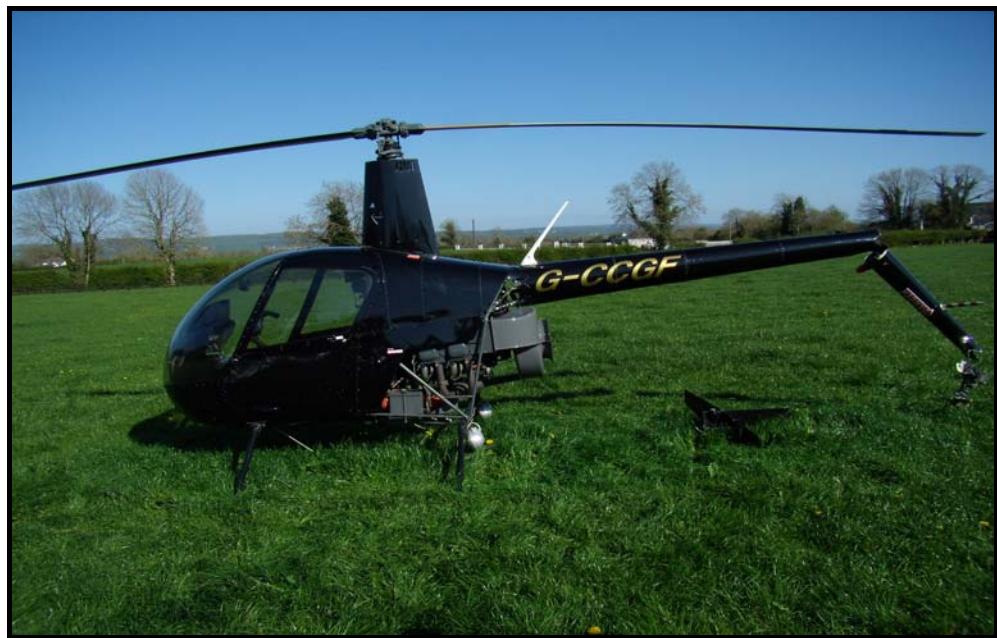
In the Pilot's words, once he got the helicopter into the hover, he "*decided to go back a bit*", but overreacted on the controls as he gained more height and the helicopter developed a "seesaw motion", striking the ground with the tail rotor, and, later, the right hand skid. He dropped the collective lever and came to a rest back on the ground and shut down the engine. He was uninjured. There was no fire. Post accident inspection showed that the tail rotor blades had disintegrated, damage was caused to the tail rotor gearbox as a result of severance of the tailboom, the right skid was damaged and rivets popped on the main gearbox fairing assembly (**See Photo**).

Final resting position of G-CCGF
