## FINAL REPORT

**AAIU Synoptic Report No: 2007-010**  
**AAIU File No: 2006/0071**  
**Published: 05/06/2007**

<b>Aircraft Type and Registration:</b>	Beech 65-A90 King Air, N712DB	
<b>No. and Type of Engines:</b>	2 x PT6A-20	
<b>Aircraft Serial Number:</b>	LJ311	
<b>Year of Manufacture:</b>	1967	
<b>Date and Time (UTC):</b>	22 August 2006 @ 15.39 hrs	
<b>Location:</b>	Ireland West Airport Knock	
<b>Type of Flight:</b>	Private	
<b>Persons on Board:</b>	Crew - 2	Passengers - Nil
<b>Injuries:</b>	Crew - Nil	Passengers - Nil
<b>Nature of Damage:</b>	Distortion of wings and tailplane	
<b>Commander's Licence:</b>	See 1.4 Personnel Information	
<b>Commander's Details:</b>	Male, aged 48 years	
<b>Commander's Flying Experience:</b>	753 hours of which 95 were on type	
<b>Information Source:</b>	AAIU Field Investigation

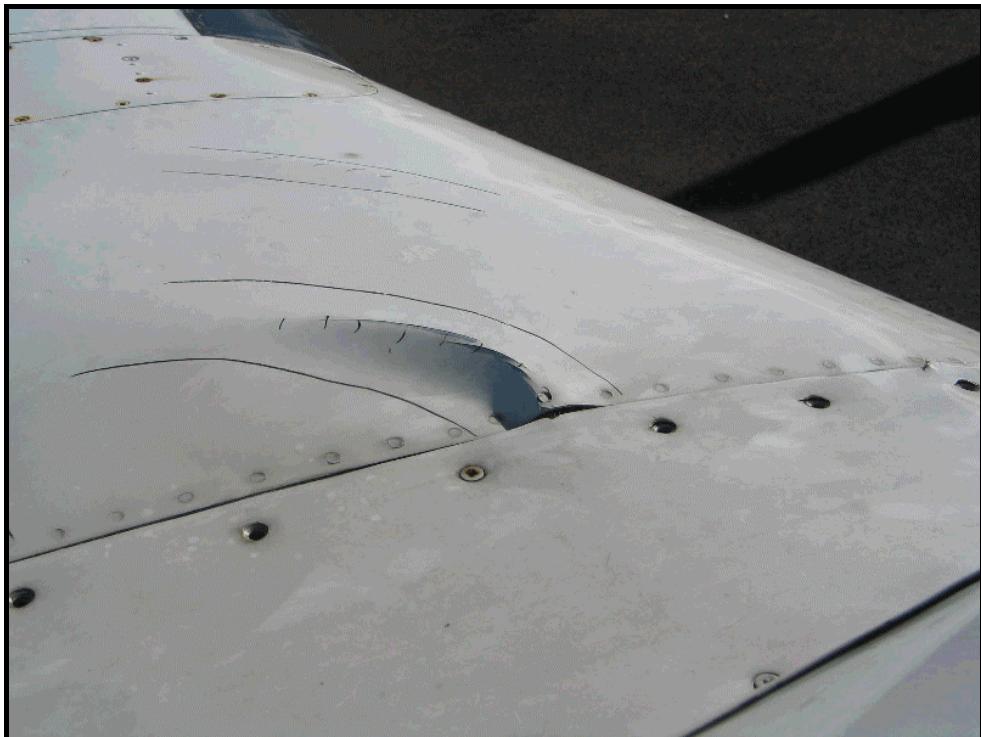
The skin on the top wing surface of both port and starboard wings was found buckled at the outer panel joint (**Photo 1**). The outer panel joint is a production joint, just outboard of the engines, where the outer section of the wing is bolted to the stub wing section. In addition ripples on the upper skin of both wings extend outboard from the joints (**Photo 2**).

The skin buckling at the outer panel joint on top wing surface is more significant on the port (**Photo 1**) than the starboard wing. This is consistent with concurrent application of right roll and high G. This buckling is termed “compression buckling” and is caused by wing overload.

In view of the age of the aircraft, the fact that both wings are buckled at the production joints and more critically with distortion in the stub wing, it is probable that the aircraft was damaged beyond economical repair.

**Photo 1**  
**Buckling on port wing at outer wing panel joint**

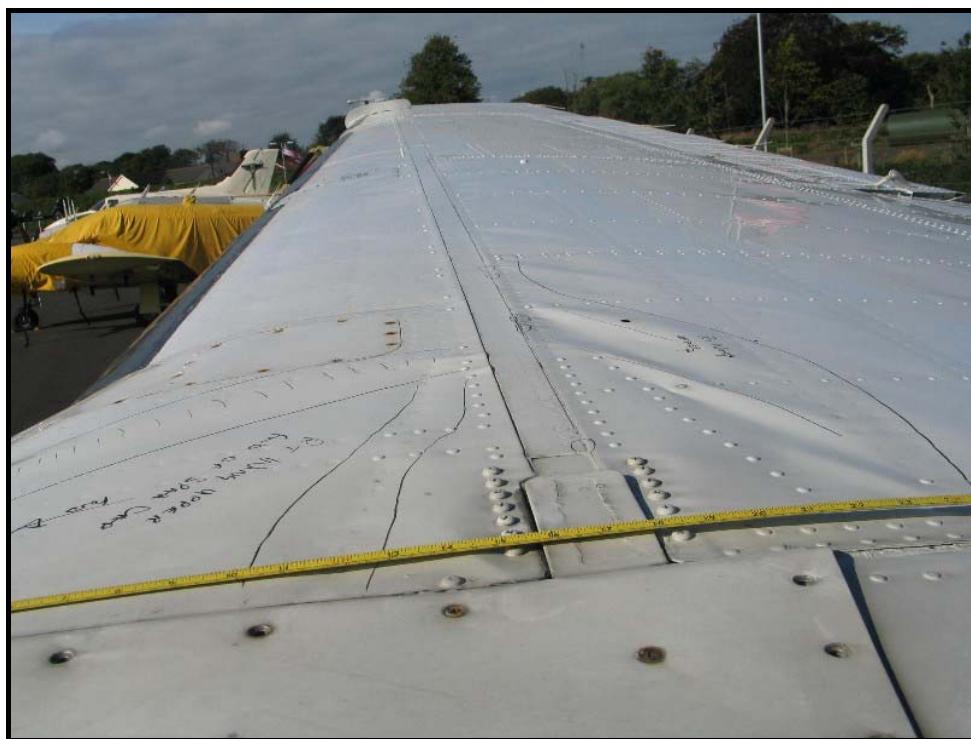
The upper skin ripples in **Photo 2** that extend outboard from the joint on both wings are symptomatic of gross over speed and occurs as aerodynamic forces push the wings up and aft. In this case drag would have been particularly high as the flaps were partially extended at the time of the occurrence. With a VFe of 174 knots and a possible speed reached between 280-300 kt this damage is not surprising as the exceedence could be in excess of 160% of VFE.

**Photo 2**  
**Upper skin rippling on starboard wing outside outer wing panel joint**
