FINAL REPORT

AAIU Synoptic Report No: 2007-011

Aircraft Type and Registration:	A330-301, EI-CRK	
No. and Type of Engines:	2 x CF6-80E1A2	
Aircraft Serial Number:	070	
Year of Manufacture:	1994	
Date and Time (UTC):	18 August 2005 @ 15.15 hrs	
Location:	53N 15W (MALOT)	
Type of Flight:	Scheduled Public Transport	
Persons on Board:	Crew 2 + 10	Passengers - 225
Injuries:	Crew - Nil	Passengers - Nil
Nature of Damage:	Nil	
Commander's Licence:	ATPL(A)	
Commander's Details:	Male, aged 49 years	
Commander's Flying Experience:	17,500 hours	
Information Source:	The Operator, AAIU Investigation.

SYNOPSIS

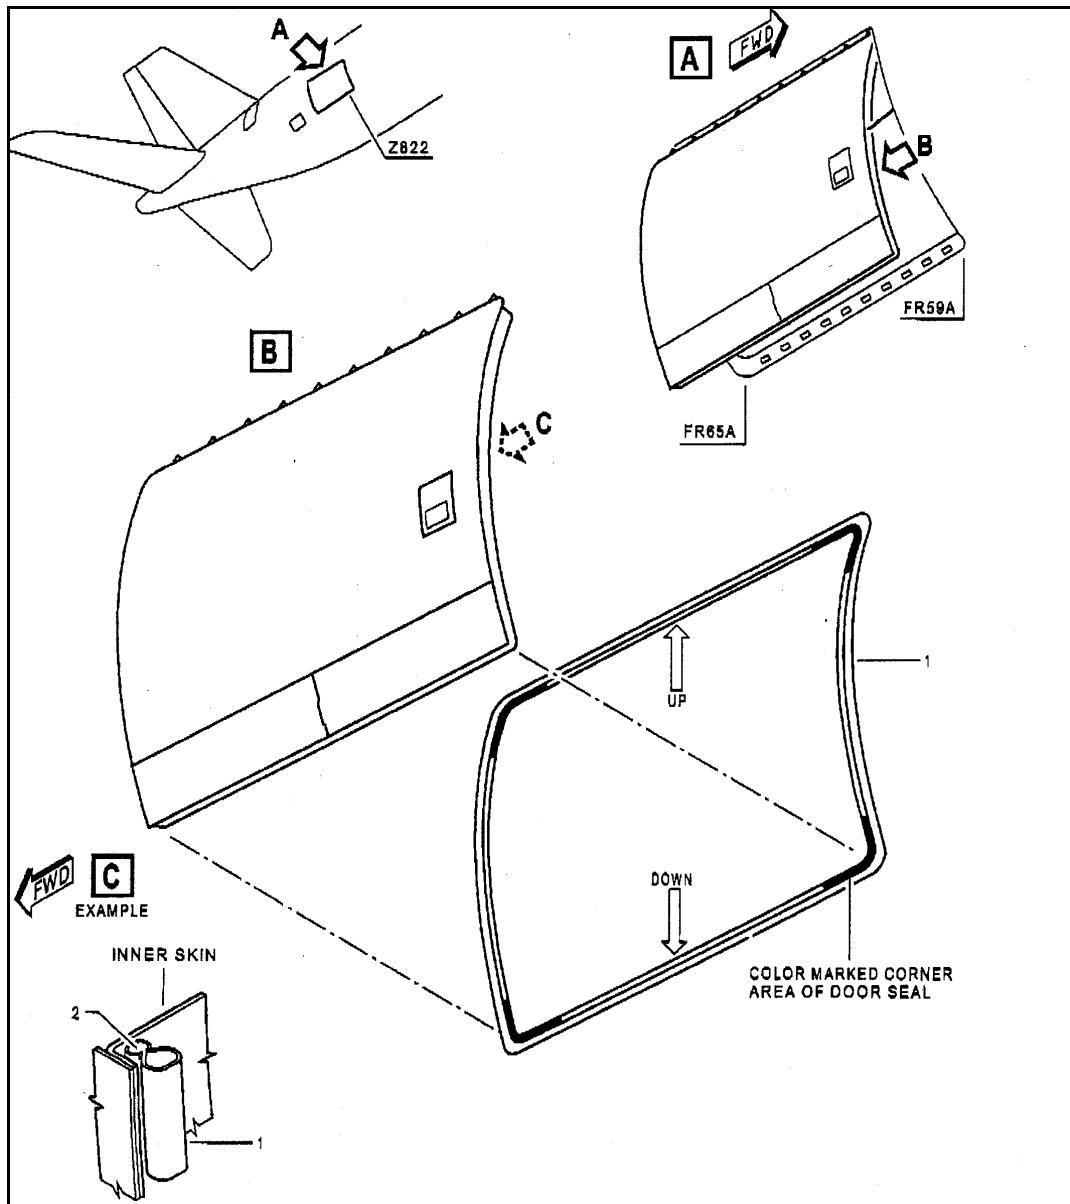
Page 6 of Task 52-32-18-400-801 issue Jul 01/05

Instructions for the installation of the door seal is covered in the Aircraft Maintenance Manual Ch. 52-32-18-400-801. There is a note on page 2 indicating that the installer should make sure that the areas on the seal marked UP and DOWN are put in the correct position (**APPENDIX A**). There is no reference to the correct positioning of the 2 mm inflation holes situated on the top and sides of the seal. In practice, neither the indications of UP and DOWN or the colour markings on the corners of the seal were clearly visible (**APPENDIX B**).

Page 2 of the above Task issue Jul 01/05 includes the following:

"Put the colour marked corner areas of the replacement door seal (1) in the upper and lower corners of the retainers (2).

Note: Make sure that the areas marked with UP and DOWN are in the correct position.

Install the flat part of the door seal (1) into the retainer (2) with a suitable tool."

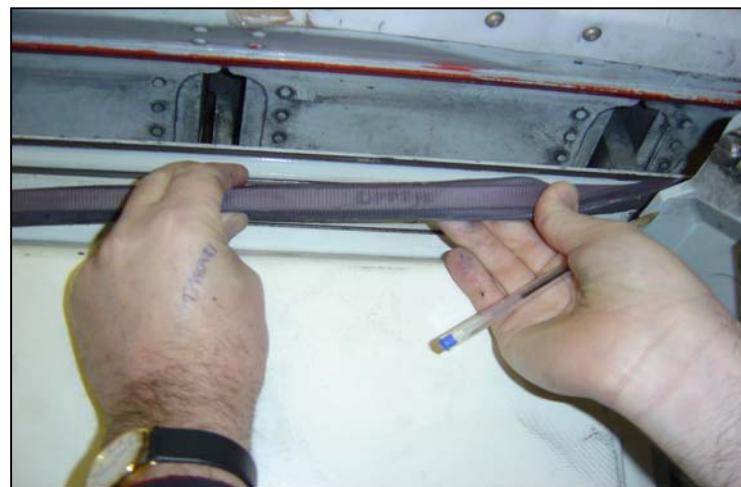
The Upper Marking

He stated that he had not viewed the colour markings on the seal himself but had noted the reference to them in the AMM. The Crew Leader made no reference to the mechanics in relation to the "Upper" and "Lower" markings. He had not seen these particular markings which were also highlighted in the AAM.

“Drawing F523 71011 of the subject seal was modified with domestic Mod 54211 to define the seal marking UP/DOWN and the corner areas in white colour in order to improve its visibility.”
