FINAL REPORT

AAIU Synoptic Report No: 2007-013

Aircraft Type and Registration:	Piper PA 34-200T Seneca II, EI-CMT	
No. and Type of Engines:	2 x Continental TSIO-360E	
Aircraft Serial Number:	34-7870088	
Year of Manufacture:	1978	
Date and Time (UTC):	3 March 2007 @ 17.23 hrs	
Location:	Runway 25 at Cork Airport	
Type of Flight:	Training	
Persons on Board:	Crew - 2	Passengers - Nil
Injuries:	Crew - Nil	Passengers - Nil
Nature of Damage:	Damage to main tyres and brakes	
Commander's Licence:	Commercial Pilot's Licence	
Commander's Details:	Male, aged 30 years	
Commander's Flying Experience:	1,850 hours, of which 40 were on type	
Notification:	Cork Airport Authority	
Information Source:	AAIU Incident Report Form submitted by the pilot

SYNOPSIS

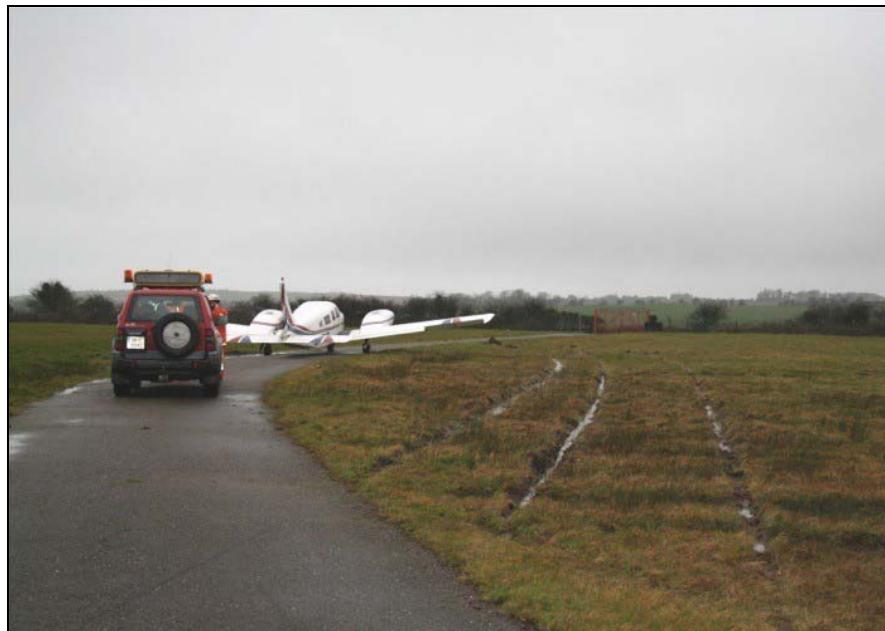
Photo 1

With the aircraft failing to decelerate adequately when well past the intersection of RWY 17/35 the Student pilot (in the left-hand seat) applied hard braking. This decelerated the aircraft but then caused both main wheels to lock up and skid. With both main wheels not rotating the main gear tyres wore through and deflated, resulting in the loss of effective braking capability. Both main tyres left considerable rubber deposits on the runway. The aircraft departed the paved surface of RWY 25 at a speed of approximately 40 knots and proceeded a further 30 metres before coming to rest in the grass area beyond (**Photo 1**). Three units of the Airport Fire Service responded immediately to the scene, two from the main station on the ramp, and one from the Flying Club area adjacent to RWY 35. The two occupants were unhurt, and having secured the aircraft, evacuated.

Overrun marks (aircraft recovered to paved area)

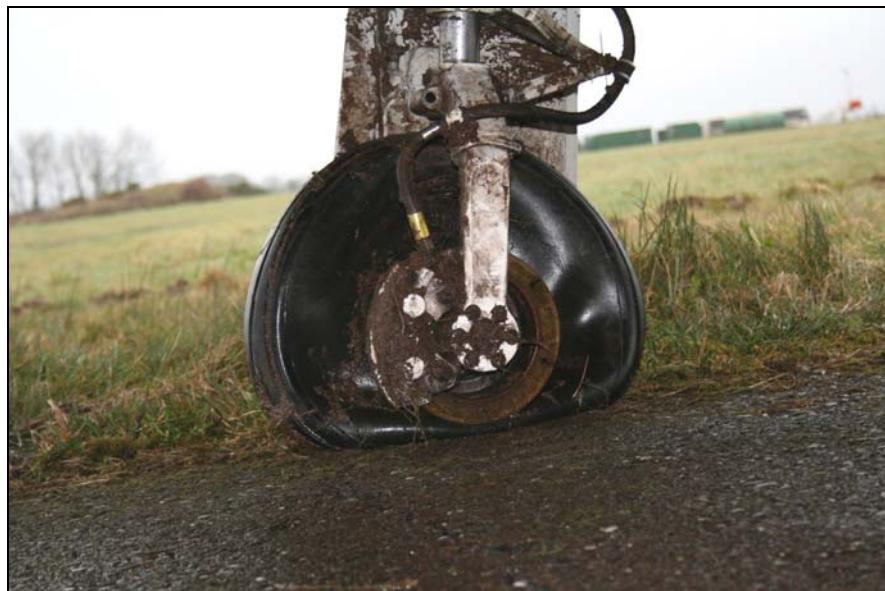
Photo 2

After the scene was photographed, the AAIU gave permission to move the aircraft to an adjacent paved area to facilitate inspection of the landing gear (**Photo 2**).

The aircraft was towed to a hangar adjacent to the Operator's facility for examination of the braking system. The brake bleed fittings on both main wheel brake assemblies were found damaged due to contact with the paved surface after the main tyres deflated. The bleed seat on the left brake assembly was sheared, necessitating replacement of the brake assembly calliper unit. The bleed screw on the right brake assembly was found bent but still essentially intact. The left brake assembly and right bleed screw were replaced and brake functionality tested. Operation of the brakes from the left seat was found satisfactory. Brake function from the right seat was only restored after considerable bleeding of the (left-pedal) brake master cylinder and its associated lines.

Right main landing gear brake assembly

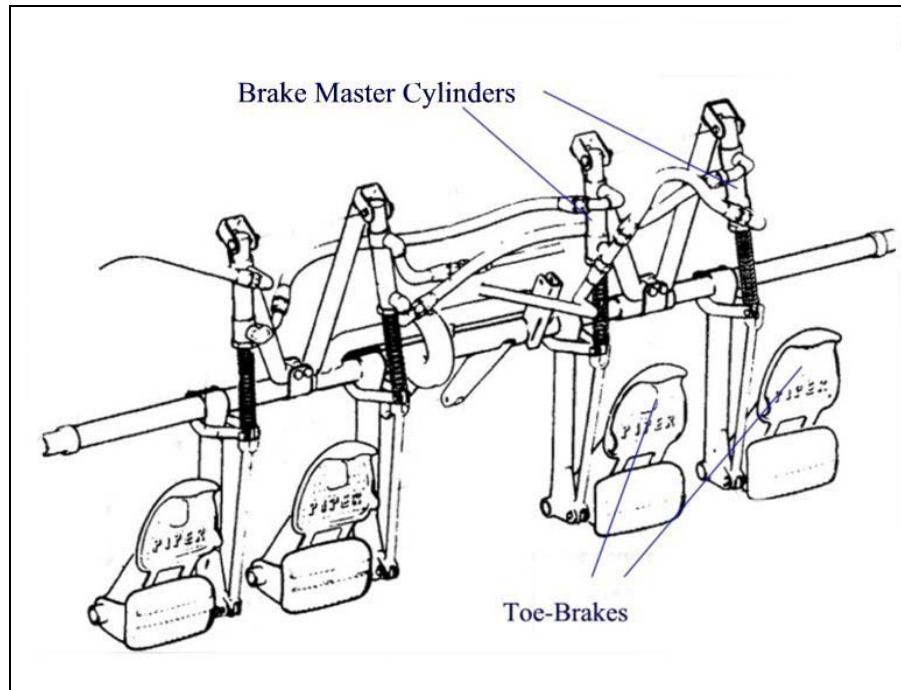
APPENDIX A

The wheel brake assembly on the Seneca II consists of two single-disc, double puck brake assemblies³, one located on each main landing gear. These are actuated by toe-brake pedals mounted on both the pilot and co-pilot's rudder pedals, that pressurise hydraulic fluid through individual brake master cylinder assemblies. A brake system hydraulic reservoir is located behind a panel in the rear top of the nose baggage compartment (**APPENDIX A**).

Due to the amount of bleeding required of the braking system it is clear that some air had entered the system between the master cylinder of the left rudder pedal (right seat) and wheel brake assembly on the left main landing gear unit. Any air present in the hydraulic fluid will tend to collect, which becomes compressible upon application of brake. Due to the design of the brake master cylinders, any air that enters the system will tend to collect above the brake cylinders reducing braking effectiveness. As the master cylinders and associated seals were found in good condition when inspected, it is probable that a small amount of air entered the braking system through one or more of the brake assembly seals during normal application of brakes.

Toe-Brakes and Master Cylinder Assemblies (*Piper Aircraft Corp*)

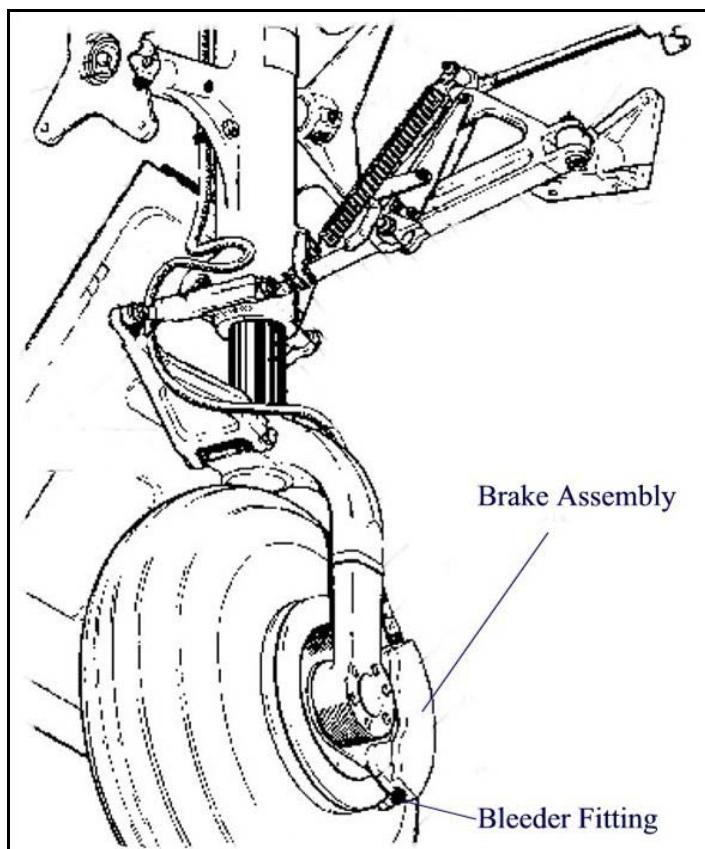
Left Main Landing Gear Unit (*Piper Aircraft Corp*)
