FINAL REPORT

AAIU Synoptic Report No: 2007-016

Aircraft Type and Registration:	Grob G.115A, EI-DJY	
No. and Type of Engines:	1 x Avco Lycoming O-235-H2C	
Aircraft Serial Number:	8048	
Year of Manufacture:	1988	
Date and Time (UTC):	1 August 2006 @ 09.37 hrs	
Location:	Cork Airport	
Type of Flight:	Training	
Persons on Board:	Crew – 2	Passengers – Nil
Injuries:	Crew – Nil	Passengers – Nil
Nature of Damage:	Main landing gear and ventral fin	
Commander's Licence:	JAR Commercial Pilot's Licence (Spanish)	
Commander's Details:	Male, aged 24 years	
Commander's Flying Experience:	550 hours, of which 60 were on type	
Notification:	Cork Airport Authority	
Information Source:	AAIU Incident Report Form submitted by the pilot

Grob G.115A registration EI-DJY was engaged on a local training detail at Cork Airport. The aircraft experienced a hard landing on Runway (RWY) 35 following a '*simulated engine failure after take-off*' (EFATO) exercise. Following the hard landing, EI-DJY completed another circuit and landed on RWY 35. During the landing roll the left main landing gear leg collapsed and the aircraft sank on the runway incurring further damage. There were no injuries.

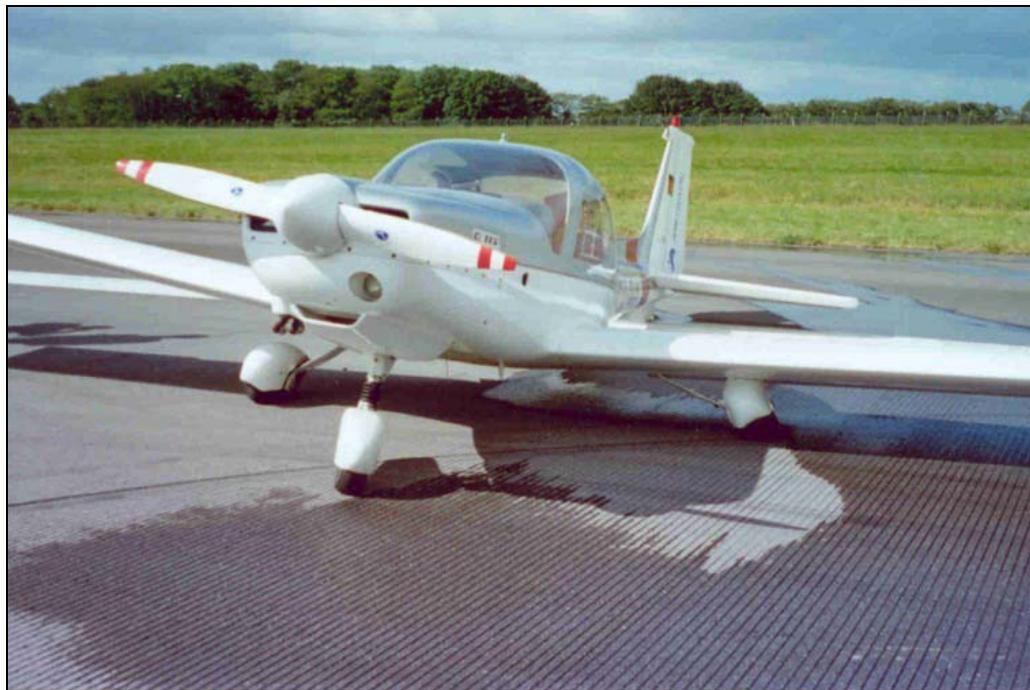
Damage was caused to the left main gear strut, which subsequently failed. Hydraulic fluid from the ruptured left braking system line leaked under pressure as brakes were applied during the final landing rollout. The structure of the ventral fin was damaged due to contact with the runway surface (**APPENDIX A**).

Final position of EI-DJY on RWY 35

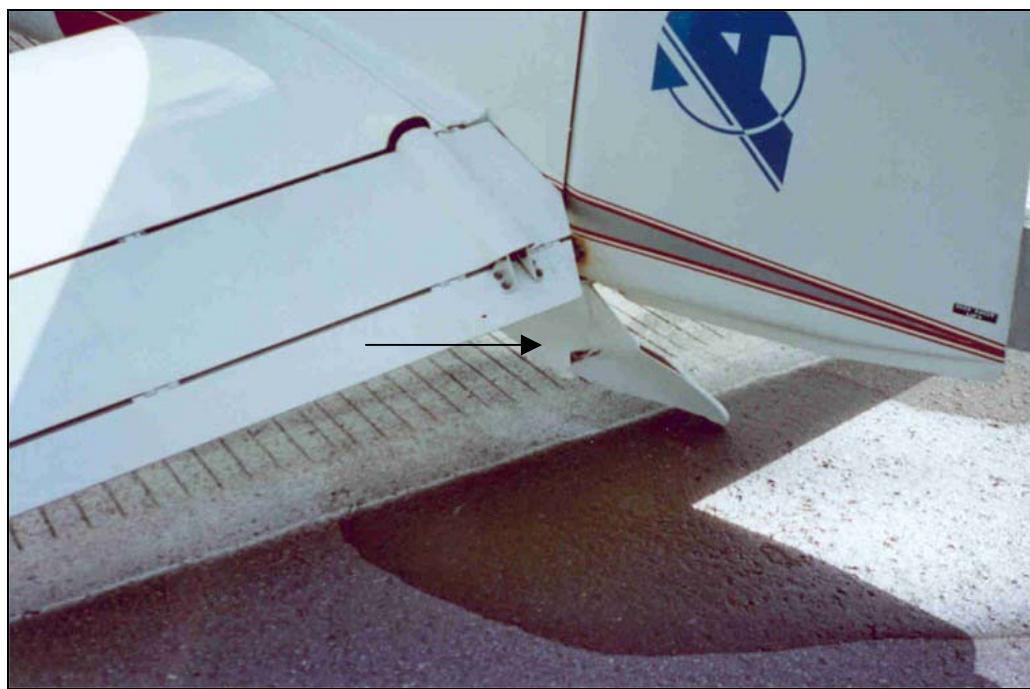
Arrow indicating damage to ventral fin assembly
