## FINAL REPORT

**AAIU Synoptic Report No: 2007-018**

| <b>Aircraft Type and Registration:</b> | Airbus A330-202, EI-DAA |

### **SYNOPSIS**

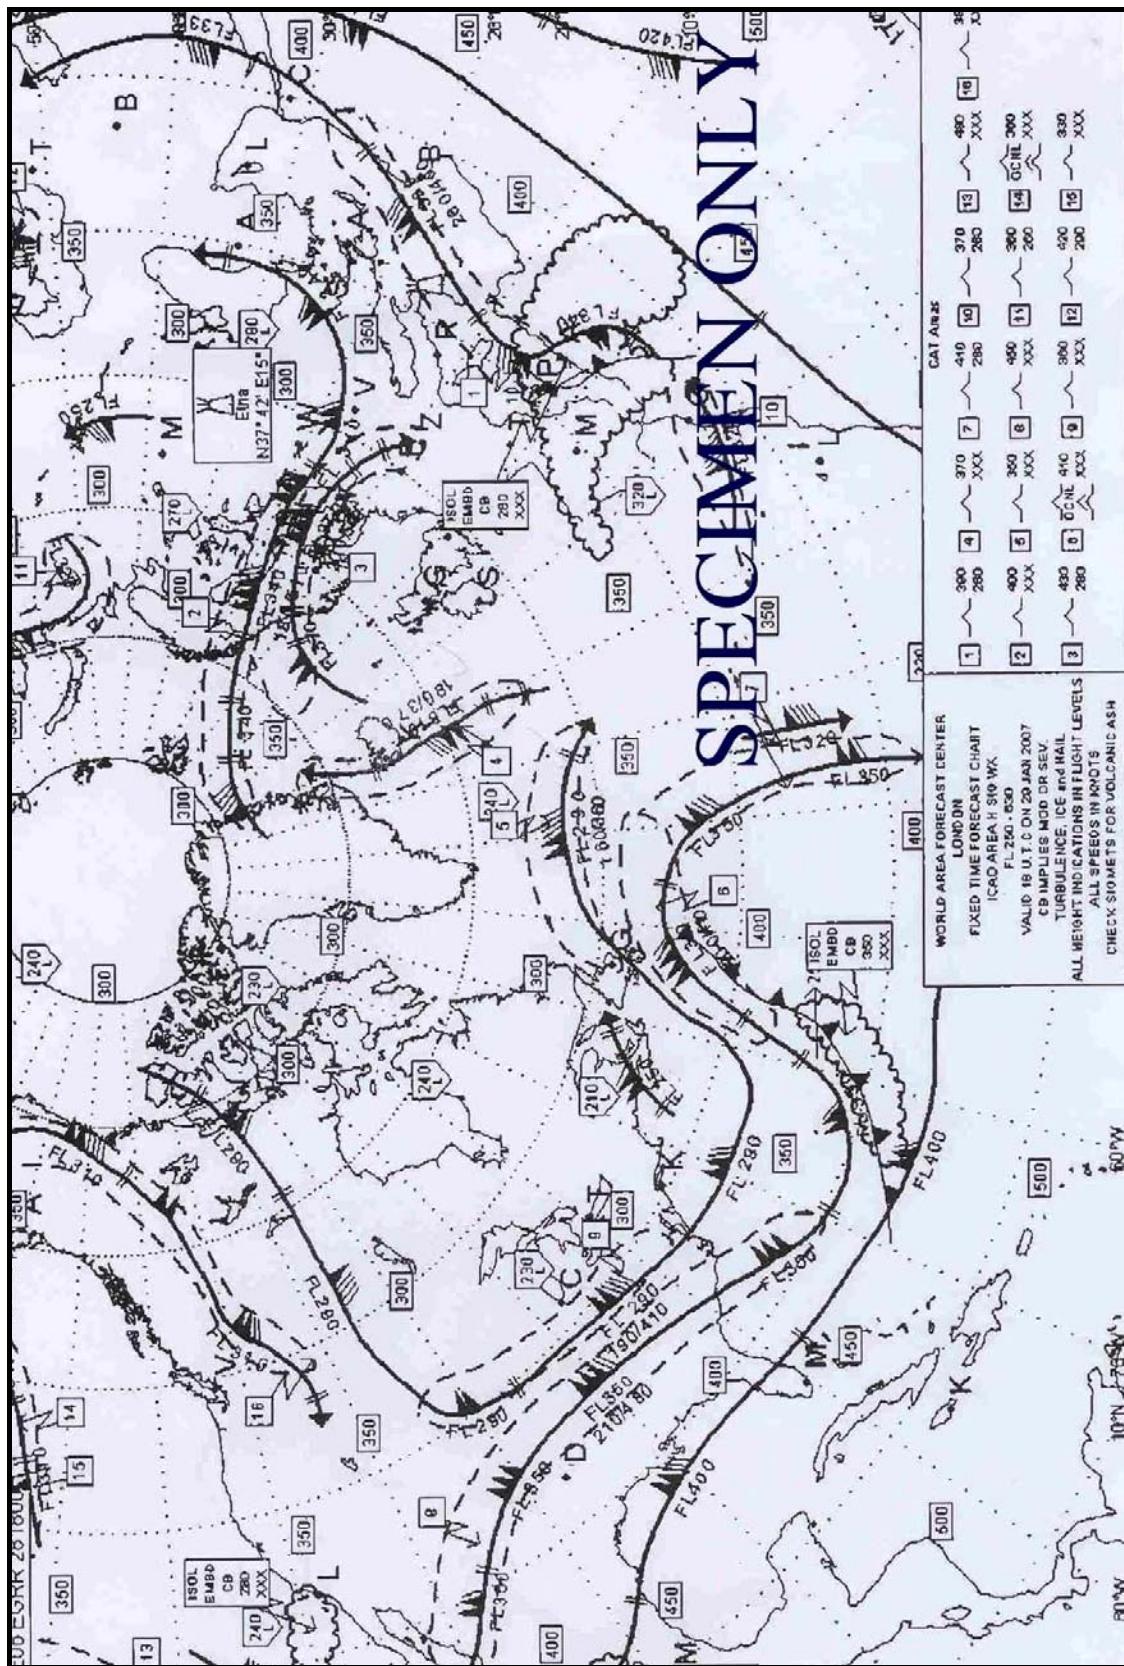
## APPENDIX A

The Captain of the aircraft is briefed on the en-route weather prior to departure. He is given two forecast charts devised by the World Area Forecast Centre, London. One of these, (**Appendix A**), shows flight levels at which jet stream turbulence might be encountered along with wind speed and direction at those locations. Only moderate or severe turbulence is forecast on this chart. The other, (**Appendix B**), shows the upper wind and temperature for FL 340 over the North Atlantic. However, both charts cover a very wide area whereas a larger scale map for this region might be more appropriate. Turbulence due to convective currents (storms) in which there is a high level of moisture is detectable by airborne weather radar. However, CAT occurs in clear air and cannot be seen on the radar. Although one cannot see CAT visually, a close scrutiny of the weather charts or the forecasted turbulence factor on the flight plan, could usually warn pilots of possible affected areas on the route. In the event of severe turbulence being forecast the flight is normally rerouted around the area. In this particular incident, the Captain said that the clear air turbulence was not indicated on the furnished weather charts for their particular Flight Level.

World Area Forecast Center - Fixed Time Forecast Chart

The Operator should consider providing flight crews with a Fixed Time Forecast Chart for the flight whose scale would be more appropriate to the North Atlantic area. **(SR 14 of 2007)**

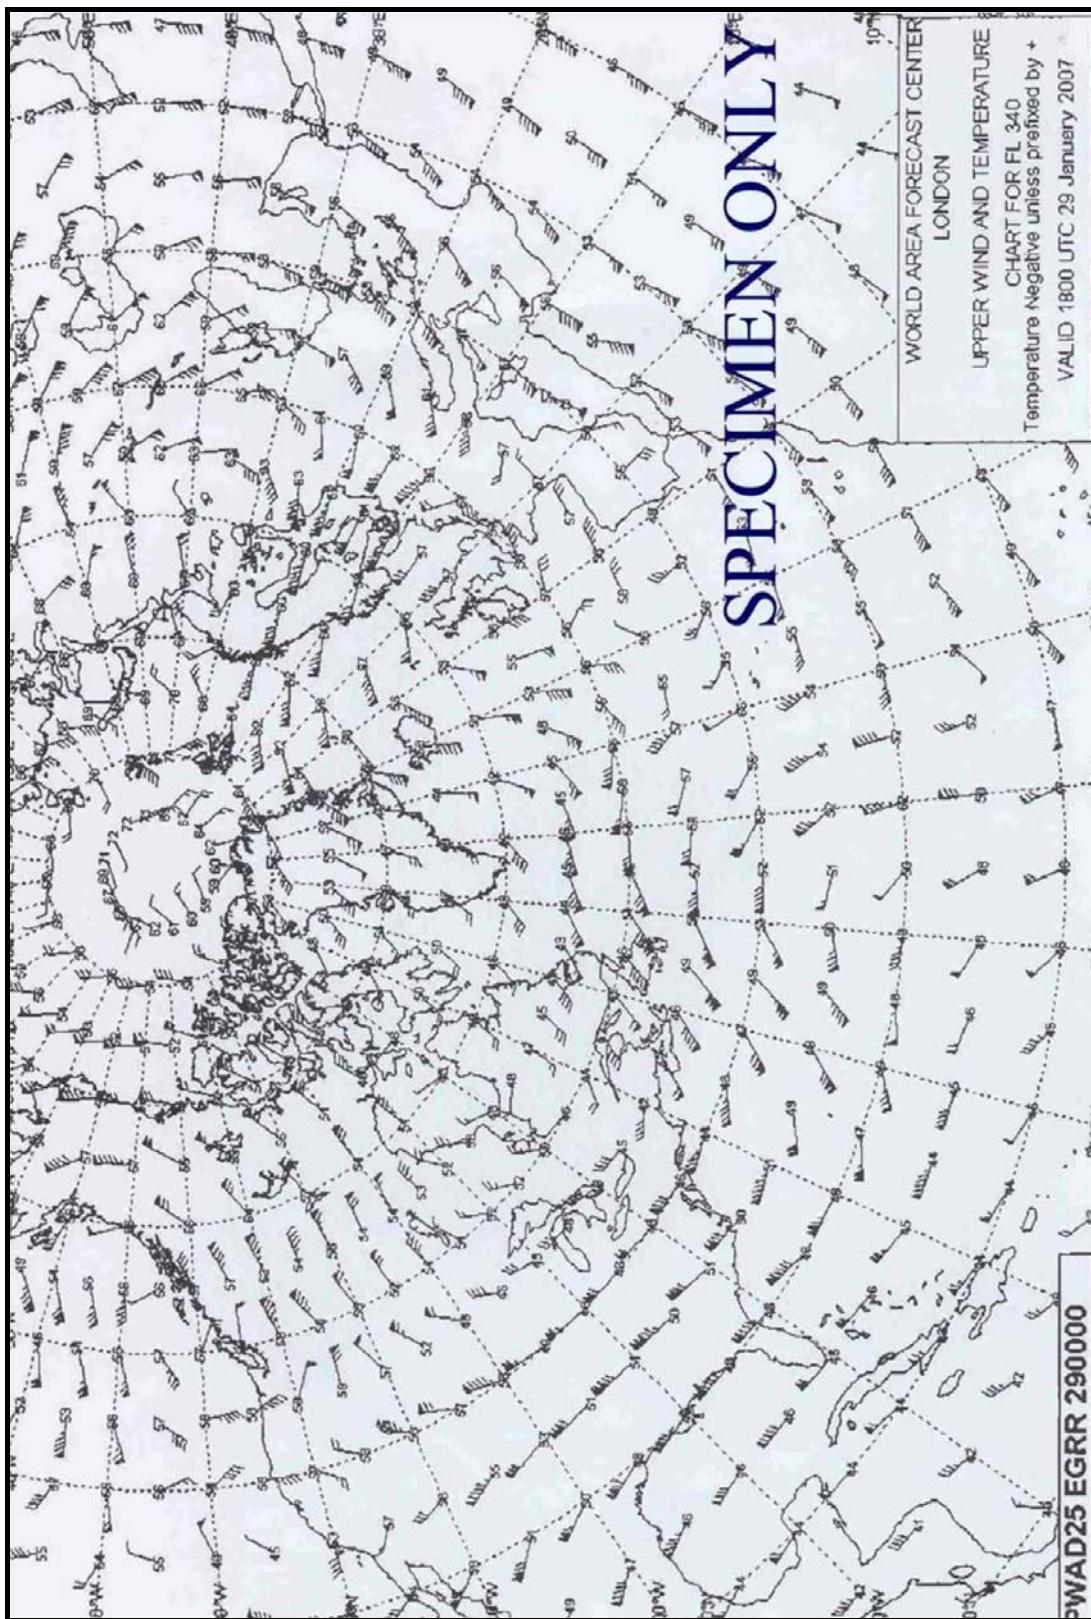
## APPENDIX B

World Area Forecast Center - Upper wind and temperature Chart for FL 340

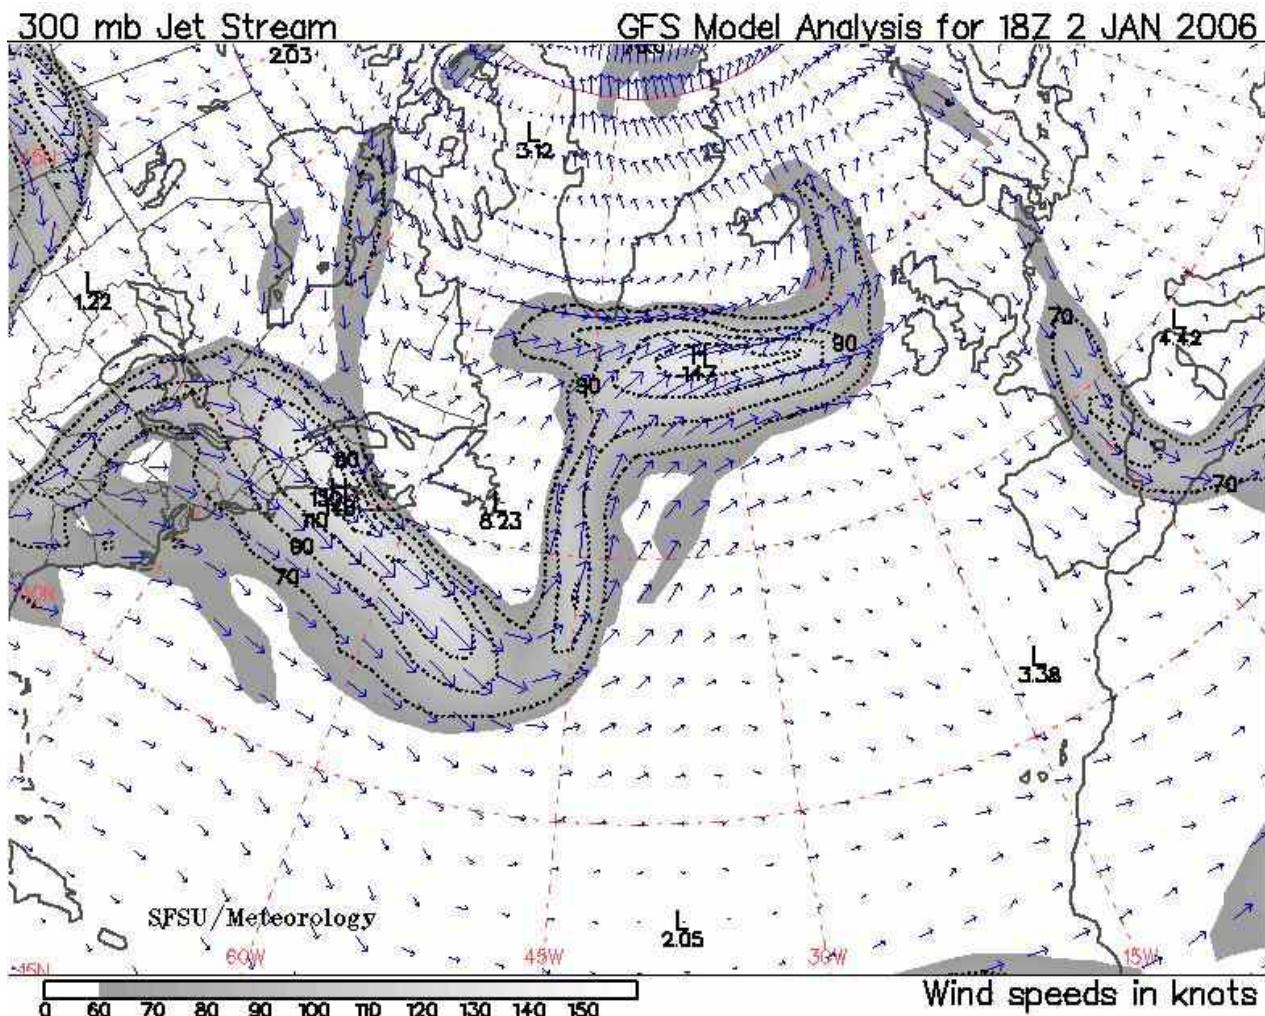
## APPENDIX C

A Jet Stream map for the North Atlantic for the time and date in question is shown at **Appendix C**. The map, presented by the [California Regional Weather Server](#) (CRWS) archive, shows clearly the pattern of winds in the upper troposphere, on the 300mb pressure surface (which corresponds roughly to FL 320). This is very roughly the level where winds in the upper atmosphere are typically strongest. At the time of the incident, the influence of the west-east Jet Stream was predominant over a large area of the North Atlantic. The critical areas are where the airspeed contours (Isotachs) are close together indicating high-speed gradients and possible clear air turbulence.

This mass of moving air can extend to a depth of 5,000 to 15,000 ft so that if the aircraft was at 35° West Longitude at 18.00 Z, then there was some chance that it would encounter turbulence at FL 380. However, that said, the atmosphere is a complicated place where generalisations cannot be made.

The above server offers a 6 to 72 hour forecast prior to departure, which would be helpful to pilots on the North Atlantic. A forecast chart such as at **Appendix C** gives at a glance, a much clearer picture of the position of the Jet Stream at the time of flight. Its scale is also more appropriate to the North Atlantic.

A Jet Stream Map from the archives of the Californian Regional Weather Server (CRWS) for the date and time of this incident. Contours of wind speed (Isotachs) are colour-filled in shades of grey, at intervals of 10 knots, starting at 60 knots. Superimposed on these colour-filled contours are black, labelled, dashed-line contours at intervals of 20 knots, starting at 70 knots. Local maximum wind speeds ("jet streaks") are marked with "H" and labelled with the wind speed there. The blue arrows represent the direction and speed of the wind. Longer arrows represent faster winds.
