AAIU Synoptic Report No: 2007-019
AAIU File No: 2007/0074
Published: 17/09/2007

**AIR ACCIDENT
INVESTIGATION UNIT**

PRELIMINARY INCIDENT REPORT

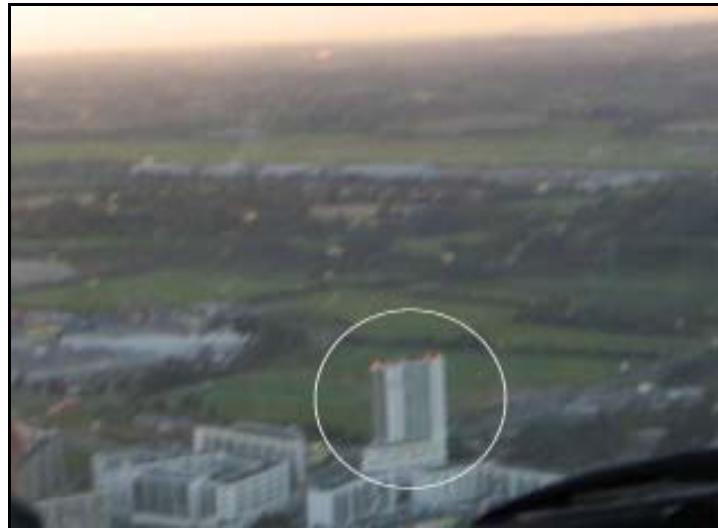
Photo No. 1

Subsequently, the AAIU conducted a series of approaches on RWY 34 to identify the reason for the deviation of G-FLTM from the correct approach course. It was found that lighting from a 16-storey building situated at Santry Cross (**Photo No. 1**) appeared, at night, to resemble the red and white lights of a runway approach light system (**Photo No. 2**). The building is equipped with four fixed red obstacle lights situated on the roof.

Building at Santry Cross under daylight (evening) conditions

2. The IAA review the suitability of obstacle lighting as installed on the 52 metre-high building situated at Santry Cross, Dublin. [\(SR 17 of 2007\)](#)
