FINAL REPORT

AAIU Synoptic Report No: 2007-021

Aircraft Type and Registration:	Luton LA.4A Minor, G-AWMN
No. and Type of Engines:	1 x VW 1776 CC
Aircraft Serial Number:	PFA 827
Year of Manufacture:	1987
Date and Time (UTC):	29 July 2007 @ 15.00 hrs
Location:	Kilrush Airfield, Co Kildare
Type of Flight:	Private
Persons on Board:	Pilot - One
Injuries:	Pilot - None
Nature of Damage:	Substantial to fuselage, propeller undercarriage and tailplane
Commander's License:	UK PPL(A)
Commander's Details:	Male, aged 30 years
Commander's Flying Experience:	112.8 hours (including 1.4 hours on type)
Notification:	Duty Pilot Kilrush Airfield informed AAIU.
Information Source:	AAIU field investigation.

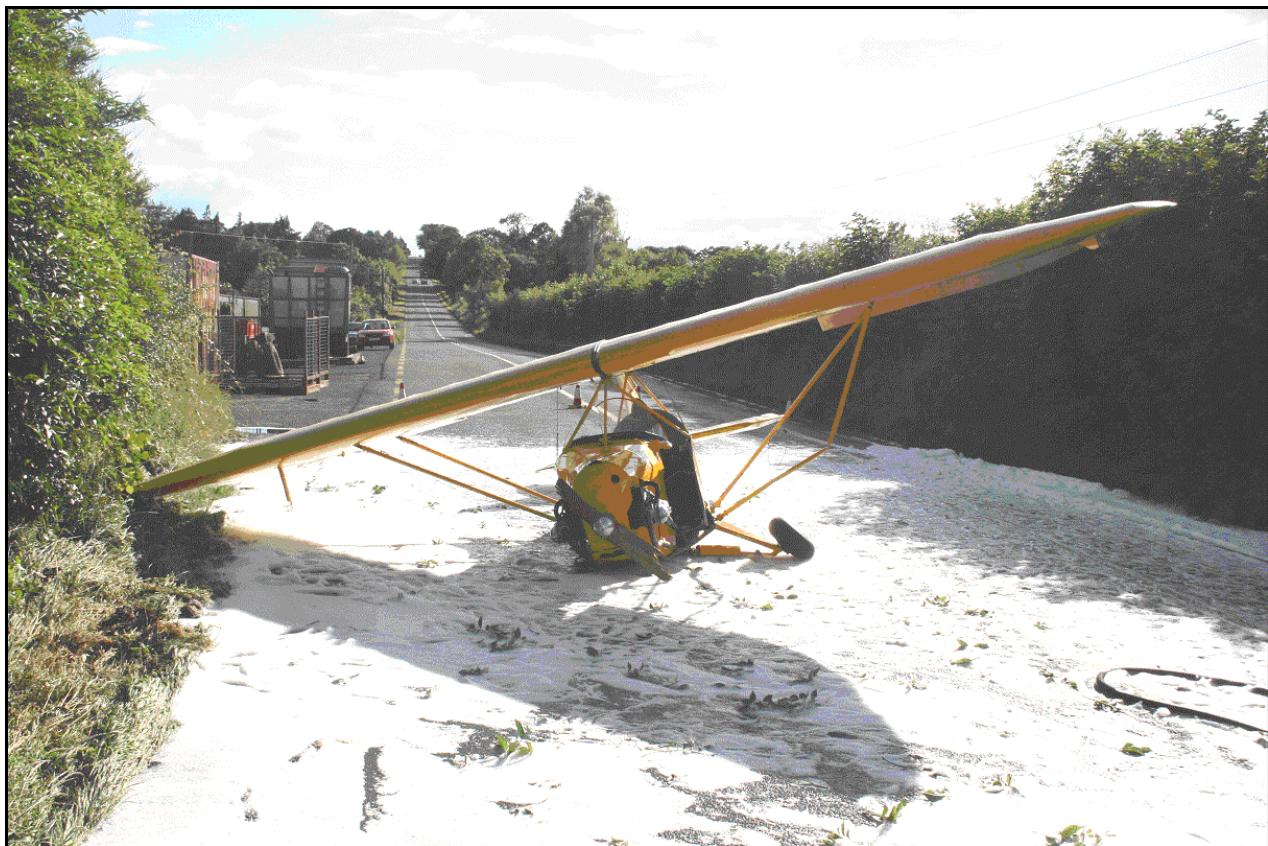
The pilot used RWY 29 at Kilrush, a grass runway of 600 metres in length. In his report to the AAIU he said that it was his second flight of the day and he was making a normal approach to land on RWY 29. As he passed over the threshold at 50 kts he initiated a flare as he took the power off to land and the aircraft bounced back up from the runway. He said that he felt that the bounce was sufficient to initiate a go-around and he applied full throttle and turned the carb heat to cold, but could not gain sufficient airspeed to climb over the power lines. The pilot thought he had cleared these lines but the tail wheel caught them and the aircraft spun down onto the main Athy road (See Photo No.1).

Photo No.1: Final resting position of G-AWMN on Athy road
