# FINAL REPORT

**AAIU Synoptic Report No: 2007-022**

<b>Aircraft Type and Registration:</b>	G-OSJL, Robinson R44 RAVEN (II)
<b>No. and Type of Engines:</b>	1 x Lycoming I0-540-AE1A5
<b>Aircraft Serial Number:</b>	11452
<b>Year of Manufacture:</b>	2006
<b>Date and Time (UTC):</b>	15 July 2007 @ 18.00 hrs
<b>Location:</b>	Near Maynooth, Co Kildare
<b>Type of Flight:</b>	Private
<b>Persons on Board:</b>	Pilot - One
<b>Injuries:</b>	Pilot - None
<b>Nature of Damage:</b>	Tail rotor and vertical fin sheared off
<b>Commander's License:</b>	UK PPL(H)
<b>Commander's Details:</b>	Male, aged 56 years
<b>Commander's Flying Experience:</b>	96 hours (all on type)
<b>Notification</b>	Pilot notified AAIU
<b>Information Source:</b>	Pilot submitted Accident Report Form to AAIU

## **SYNOPSIS**

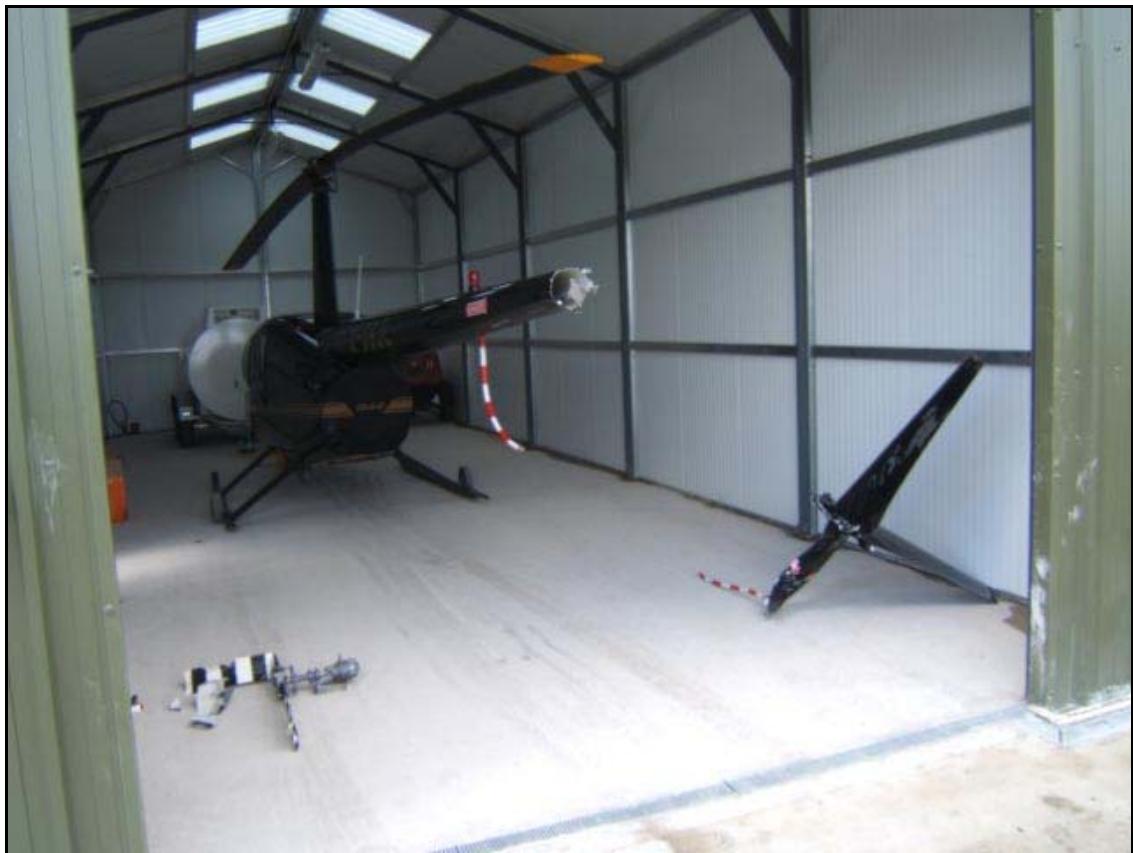
**Photograph supplied by the Pilot**

The pilot stated that following his approach and hover over the helipad, the helicopter moved backwards slightly and struck the stinger (tail skid) into the concrete helipad. The helicopter reacted by spinning through 180 degrees and settled back on the helipad, with the tail rotor and vertical fin sheared off. The helicopter remained upright and the pilot exited without injury. There was no fire.
