FINAL REPORT

AAIU Synoptic Report No: 2007-023

Aircraft Type and Registration:	Luscombe 8A, N2837K	
No. and Type of Engines:	1 x Continental A65	
Aircraft Serial Number:	5564	
Year of Manufacture:	1947	
Date and Time (UTC):	7 May 2006 @ 17.55 hrs	
Location:	Navan Airfield	
Type of Flight:	Private	
Persons on Board:	Crew - 1	Passengers - 1
Injuries:	Crew - Nil	Passengers - Nil
Nature of Damage:	Damaged beyond economic repair	
Commander's Licence:	PPL	
Commander's Details:	Male, aged 42 years	
Commander's Flying Experience:	432 hours of which 69 hours were on type	
Notification:	The owner of Navan Airfield reported this accident to the AAIU	
Information Source:	Accident Report Form submitted by Pilot. AAIU Field Investigation

SYNOPSIS

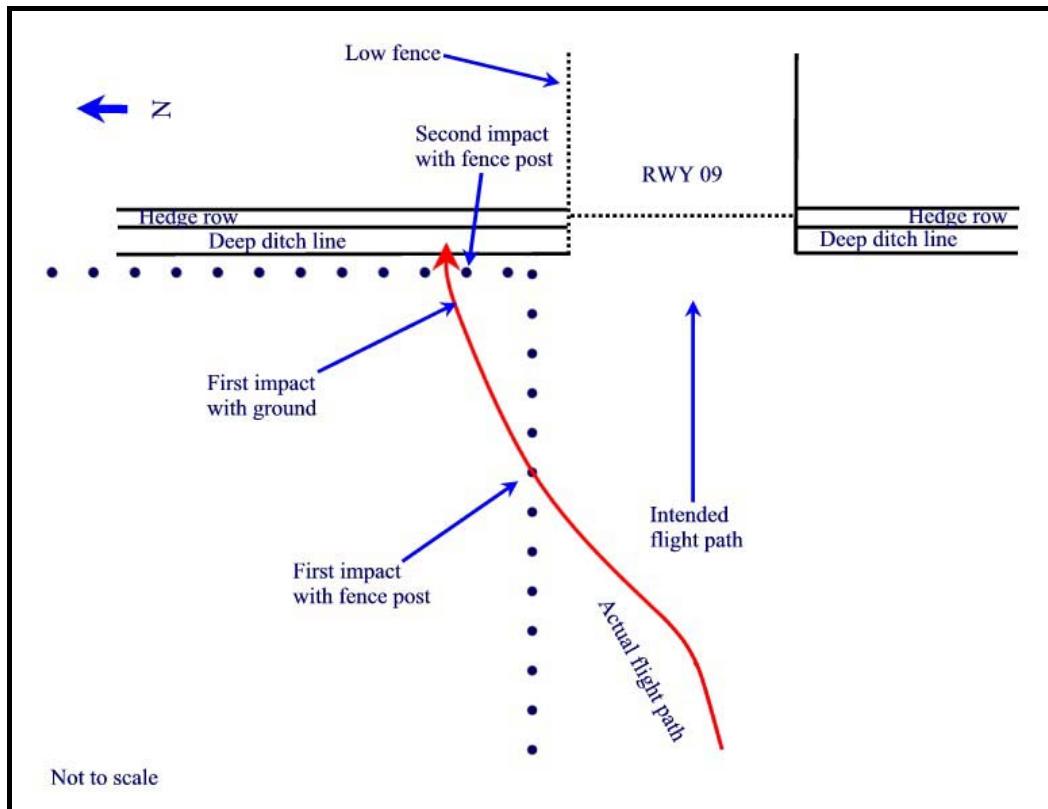
Sketch No.1: Impact site map

On arrival at the accident site the aircraft was found in a near vertical nose down condition, in a deep and vegetated ditch. (See **Sketch 1**)

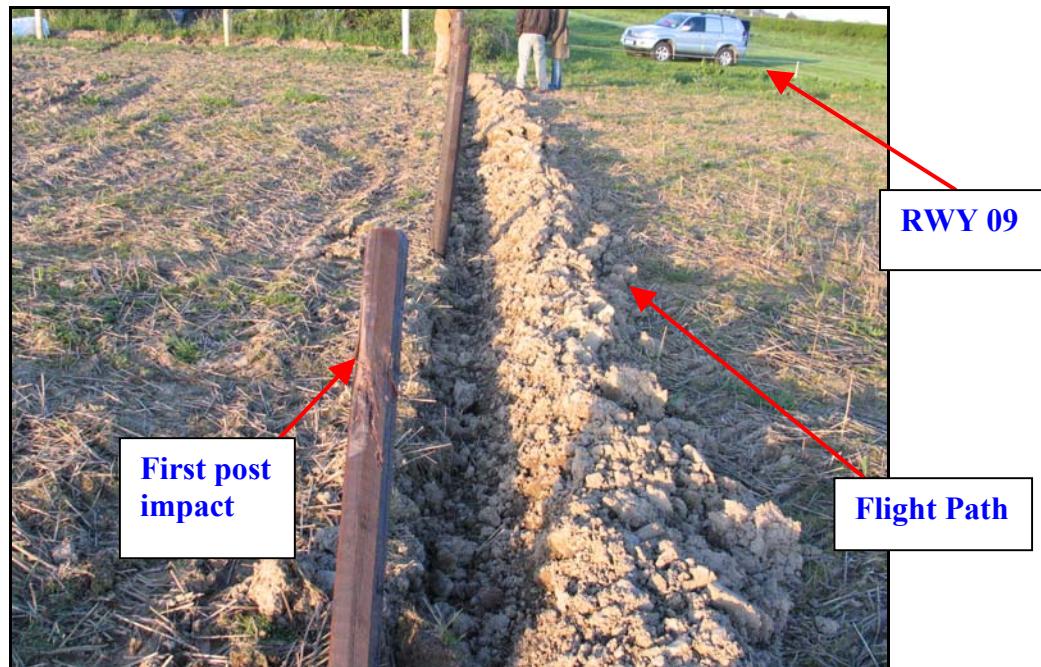
A line of wooden posts separated the approach path from an adjacent field on the left hand side. The posts were located approximately 10 metres in from the lateral boundary. The 6th post, which was creosoted, exhibited significant fresh impact damage from its top to 0.75 metres from the ground (**Photo No. 1**). A first ground impact mark was found approximately 20 metres further on from the first post just back from the deep vegetated ditch. A second post, which was located at right angles to, and along the edge of a ditch line also exhibited impact damage in the form of a vertical slice down through the post. The ditch line posts were not creosoted (**Photo No. 2**).

Photo No. 1: First impacted fence post

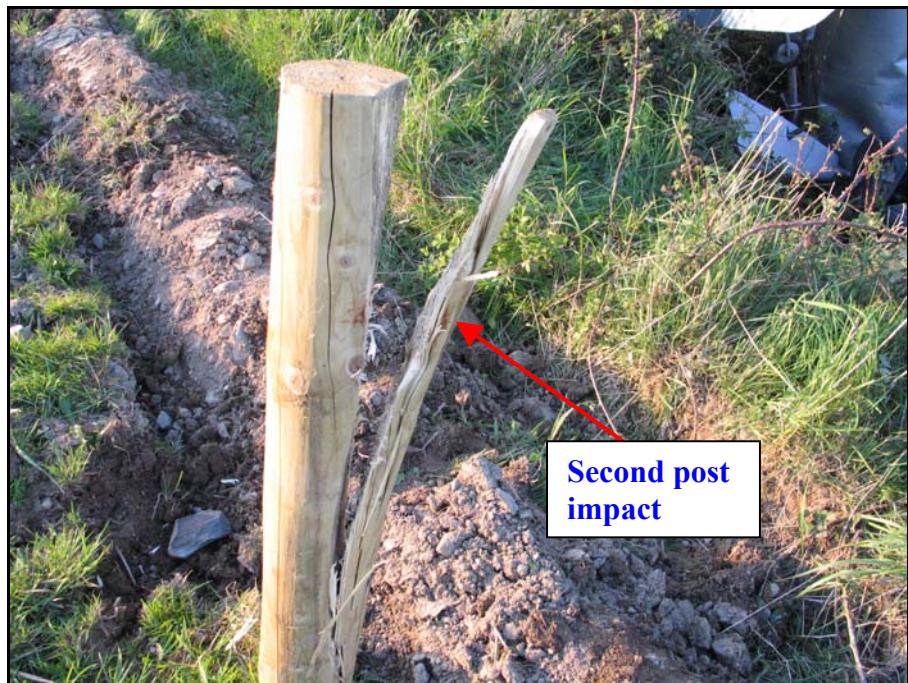
Photo No. 2: Second fence post impacted by propeller

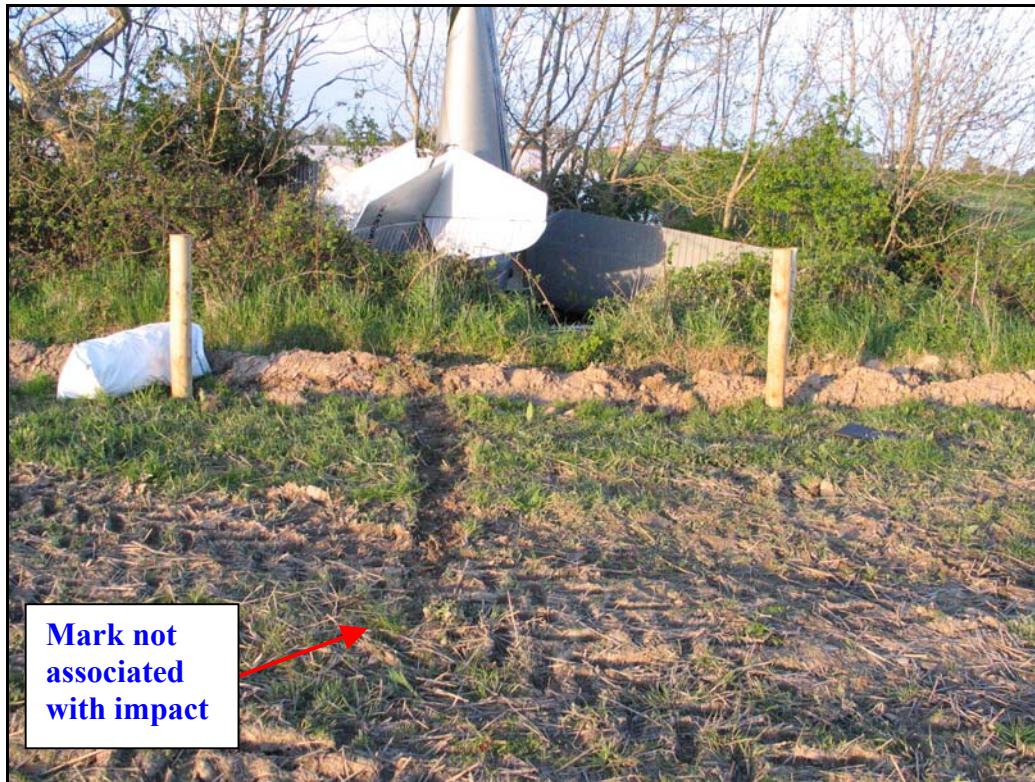
The fuselage failed at the aft bulkhead during the accident sequence. The empennage remained connected to the fuselage solely by the elevator and the rudder control cables. These cables cut into the lower rear fuselage skin forward of the failure point for about 0.6 metres as a result of the empennage hanging from the fuselage (**Photo No. 3**).

Photo No. 3: Resting position of N2837K
