FINAL REPORT

AAIU Synoptic Report No: 2007-024

Aircraft Type and Registration: Urban-Air UFM10 Samba, OK-GUA24

The aircraft, following landing, damaged its nose gear and propeller during an off-runway excursion. There was no injury or fire.

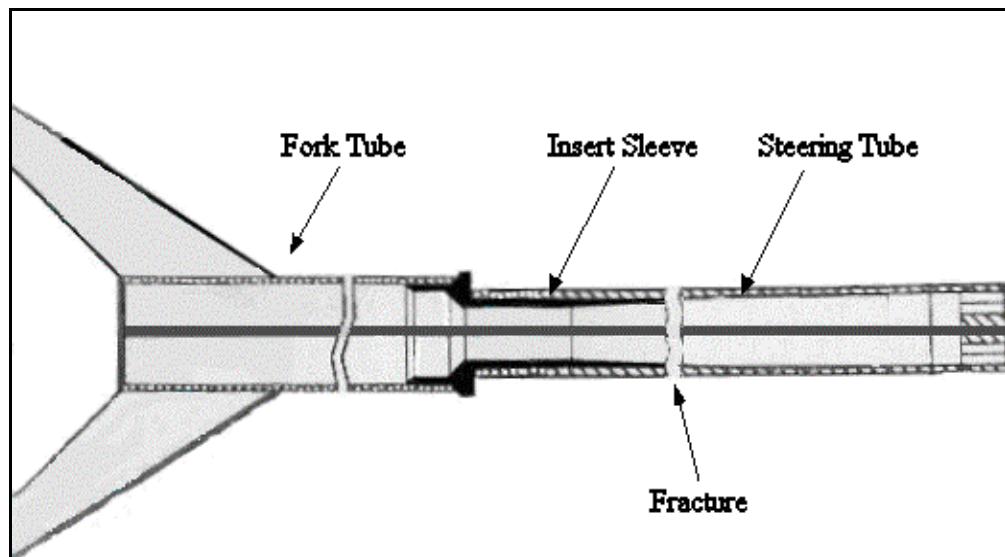
APPENDIX 1

The nose wheel is held in a fork unit, similar to that on a bicycle (see **Appendix 1**). The fork tube is attached to the steering tube through an internal 60 mm long sleeve, which is plug welded to the steering tube at three circumferential locations. The fork unit is formed from steel tubes and includes a rubber shock absorber. The steerable nose wheel is connected to the rudder controls. Main wheels are mounted on a spring axle and are equipped with hydraulic brakes. These are operated by a single brake lever mounted on the pilot's control column, thus differential braking is not available.

Schematic of steering tube

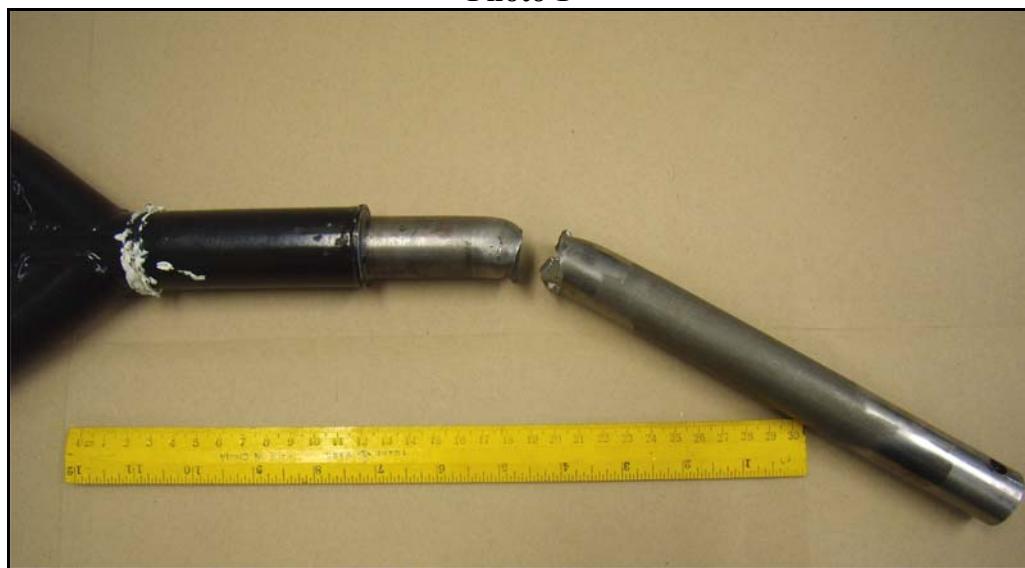
Photo 1

The nose wheel tyre, steering tube and fork assembly was inspected by the AAIU. The tyre shows grass skid marks on its right hand sidewall; the left hand side was clean. The steering tube fracture (see **Photo 1**) occurred at a fail safe point designed into the leg to prevent excessive loads being transferred to the nose structure of the aircraft. There was localised bending in the steering tube adjacent to the fracture in the steering tube, consistent with forward and sideways loading. Examination of the fracture surfaces revealed fracture features typical of a single event overload failure, with no indication of any pre-existing defect.

As the aircraft left the runway the nose wheel, while under considerable strain but still skidding on the grass, would have suddenly encountered the hard pebble area causing the nose leg to fracture. The nose leg construction facilitates fracture at this point in order to reduce damage to the front structure and composite skin, in the event of a possible overload.

3.4 The nose wheel steering tube fractured at its designed weakest point when the nose wheel encountered a hard surface.

Photograph of the damaged steering tube
