## FINAL REPORT

**AAIU Synoptic Report No: 2007-026**

<b>Aircraft Type and Registration:</b>	ATR 42, EI-CVS	
<b>No. and Type of Engines:</b>	2 x PW 120	
<b>Aircraft Serial Number:</b>	033	
<b>Year of Manufacture:</b>	1986	
<b>Date and Time (UTC):</b>	1 November 2006 @ 14.45 hrs	
<b>Location:</b>	Enroute Kerry to Dublin	
<b>Type of Flight:</b>	Public Transport	
<b>Persons on Board:</b>	Crew - 4	Passengers - 33
<b>Injuries:</b>	Crew - Nil	Passengers - Nil
<b>Nature of Damage:</b>	No. 1 Engine internal damage only	
<b>Commander's Licence:</b>	ATPL	
<b>Commander's Details:</b>	Male, aged 48 years	
<b>Commander's Flying Experience:</b>	5,523 hours of which 2,748 were on type	
<b>Notification source:</b>	Shannon Duty Airport Manager	
<b>Information Source:</b>	Aircraft Operator

### **SYNOPSIS**

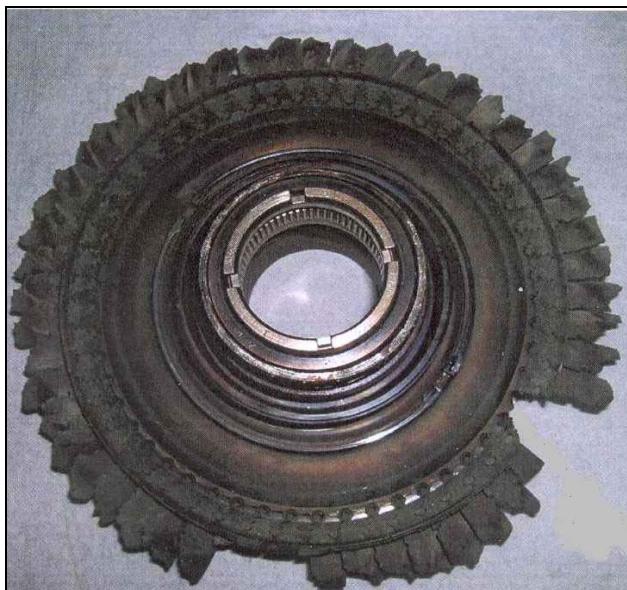
Examination of the LPT disc assembly and the two blades confirmed a complete rupture of one fixing at the bottom serration (rivet slot vicinity) releasing two blades.

- The blade airfoils were battered and fractured from debris impact at various heights above the platform.
- The disc balancing rims as well as the balancing rivets and the disc centre hub were rubbed on a 120-degree arc from orbiting.

Shown above (*LH picture*) is the LP turbine disc missing two complete blades with a section of disc which liberated from the disc body. Three blades fractured above the disc platform, with the remaining blades suffering severe impact damage. The other picture (*RH*), shows severe intershaft rubbing and heat discoloration of the LPT shaft from contact with the rear end of the HP impeller and the bore of the HP Turbine disc.

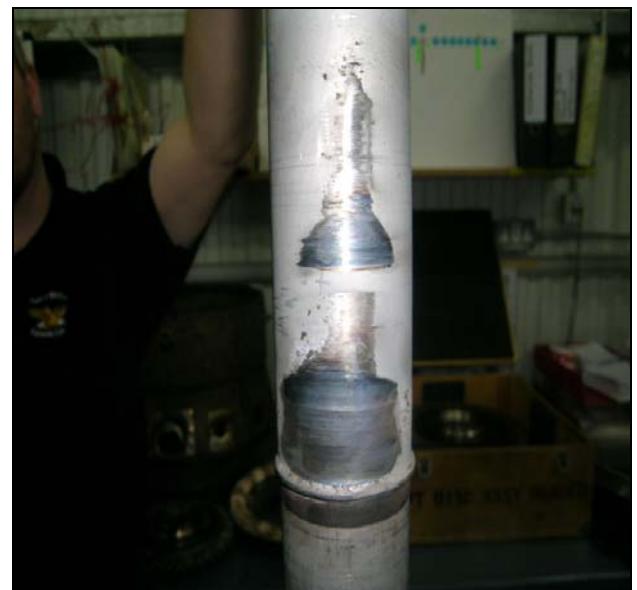
Severe intershaft rubbing was observed to the LPT shaft corresponding to the rear of the HP Impeller and High Pressure Turbine (HPT) disc. Intershaft rubbing was also observed to the outside diameter of the PT shaft at various positions. This rubbing shows that the PT shaft had “whipped” inside the LP shaft. Both the LP and HP Impellers were found to have heavy rubbing to the inducer and exducer areas.

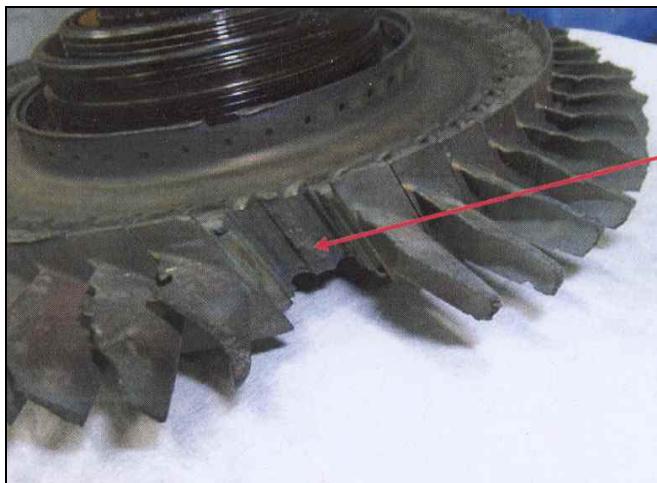
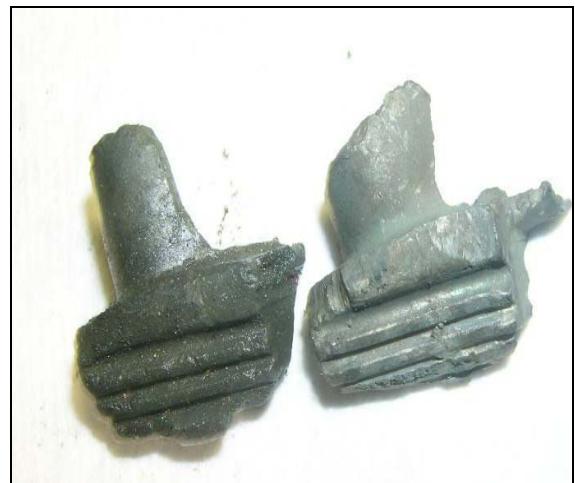
Disassembly of the turbo-machinery revealed that a quantity of two LP blades had liberated from the LPT Disc (**Appendix C**). The remains of the two blades were retrieved from the engine. A section consisting of one fir tree segregation (so called as it resembles a fir tree) of the LPT disc, was found to be sheared at the base of the fir tree area, which released the two blades. The liberated part of the disc was not found.

The arrow indicates where one complete fir tree area liberated from the LP disc. The remains of the blades as shown were retrieved from the area of the 1st stage PT stator. The missing section from the disc body was not found within the engine.

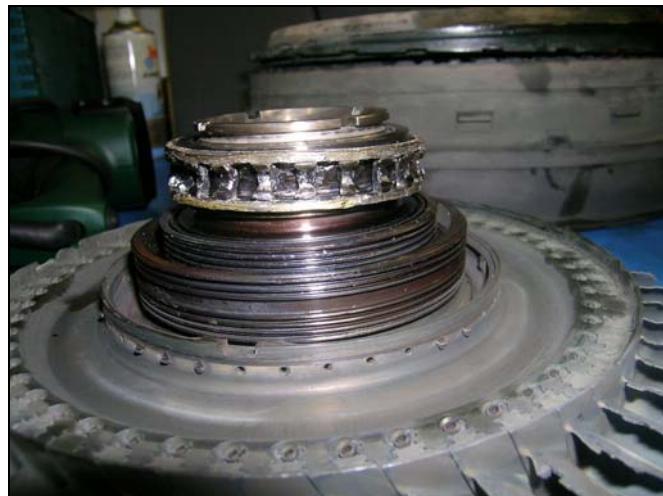
The number 6 & 7 bearing retaining bolts had sheared, the pressure, vent, and scavenge oil tubes were sheared. The rollers of the No. 6 bearing had become fused to the outer race of the bearing. There was severe down stream bombardment damage to the 1<sup>st</sup> stage PT stator and 1<sup>st</sup> stage PT blades.

- Several blade platform edges were rubbed and worn due to an axial contact with the upstream LPT vane ring assembly.
- The No. 6 bearing inner ring and cage (**Appendix D**) were still mounted on the disc. Both bearing components were rubbed, smeared and deformed. The No. 6 bearing air-seals were unevenly rubbed and worn.

Above, the deformed and fused No.6 bearing

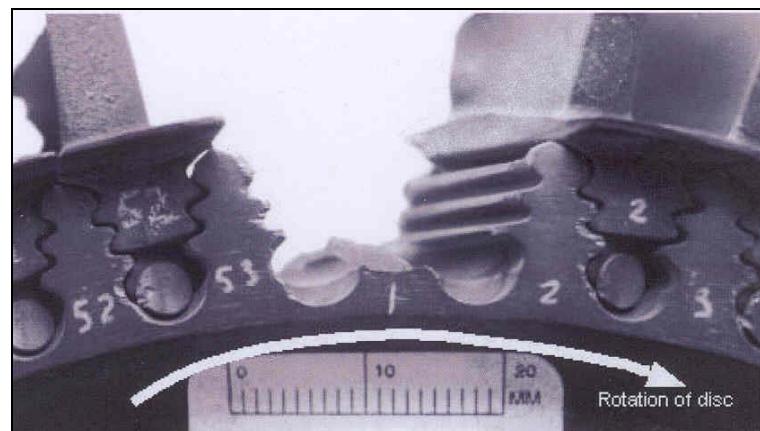
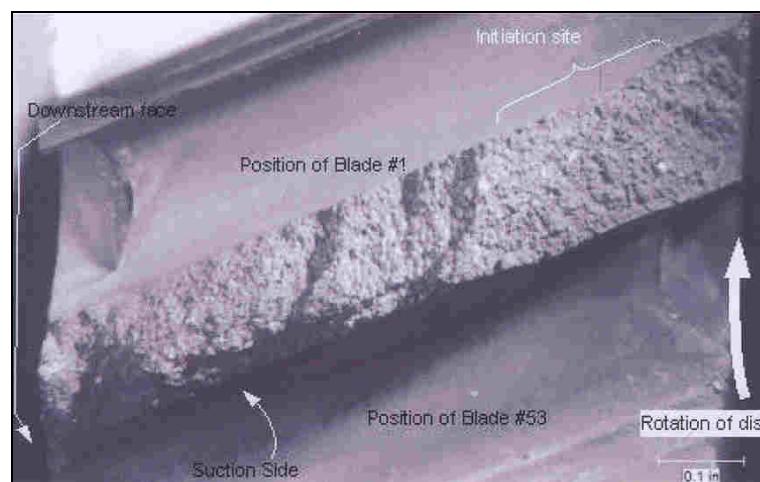
The LPT disc assembly was sent to the manufacturer's laboratory for further analysis. Cracking of the LPT disc fixing occurred at the bottom serration, pressure side, near the upstream face. The crack exhibited river lines at grain facets and showed evidence of an intergranular fracture. The fractured disc fixing area revealed microvoids at the grain boundaries indicative of advanced stage of creep.

- The fracture mechanism of the LPT disc fixing was creep assisted by fatigue.
- There were no metallurgical anomalies noted on the LPT disc material.
- Damage to the submitted adjacent hardware was secondary as a consequence of the rupture of the LPT disc fixing.

A close-up of the fractured surface shows an intergranular topography. The crack initiation site is at the upstream face, pressure side. (Photo Courtesy of the Engine Manufacturer)

The manufacturer should give more urgency to the implementation of Service Bulletin No.21555 by changing the Compliance Category from 7 to 6. [\(SR 18 of 2007\)](#).
