# Take off without permission

Eindhoven Airport, 11 October 2012

Identification number:	2012-105
Classification:	incident
Date, time <sup>2</sup> of occurrence:	11 October 2012, 14.50 hours
Location of occurrence:	Eindhoven Airport / Eindhoven Air Force Base
Registration:	EI-DLD
Aircraft type:	Boeing 737-800
Aircraft category:	Twin engine passenger aircraft
Type of flight:	carrier / commercial
Phase of operation:	taxi / take-off
Damage to aircraft:	none
Flight crew:	2 + 4
Passengers:	146
Injuries:	none
Other damage:	none
Light conditions:	Daylight

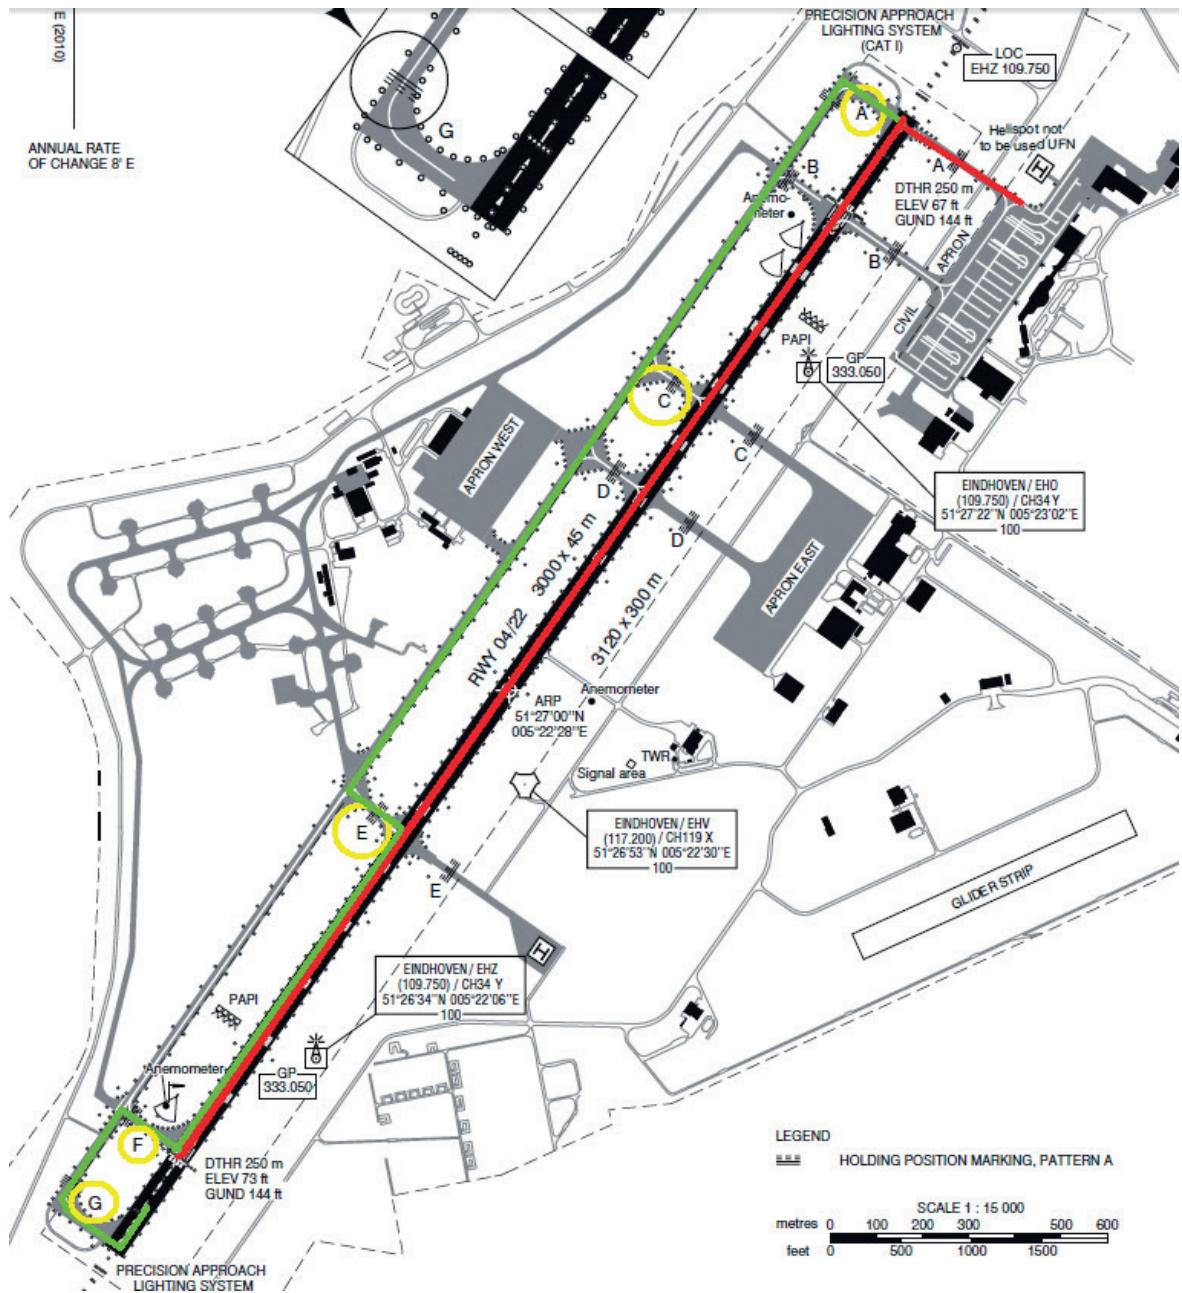
Figure 2: Overview of runway, taxiway and taxi route, standard route in green, followed in red, intersections marked in yellow

Eindhoven Airport is a joint civil and military airport with a single runway. Ground and air traffic control is provided by personnel of the Royal Netherlands Air force. The airport terminal is situated at the east side of the runway, the taxiway is situated at the north-west side of the runway. Because of the layout of the airport, whenever runway 04 is used for takeoff and landing, aircraft have to cross the runway for taxiing to the departure end of the runway via the parallel taxiway.

Because of maintenance work in progress, the taxiway was partly closed for aviation traffic. Maintenance was done in phases whereby a memo was sent to all airfield users before every change of phase.
