Air Accident Investigation Unit Ireland

SYNOPTIC REPORT

ACCIDENT
Cessna 182L, EI-CDP
Clonbullogue, Co. Offaly

8 August 2015

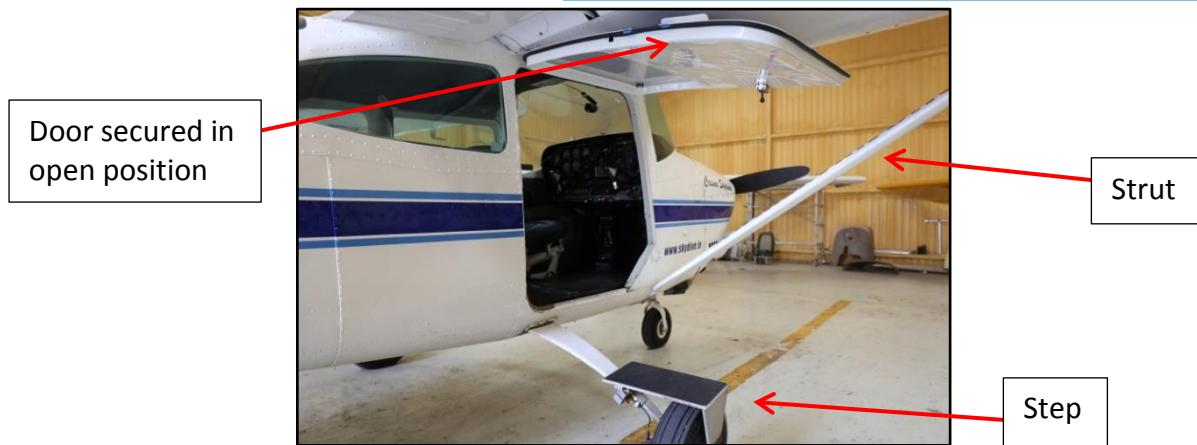
Upon reaching 3,500 ft overhead the drop-zone, the first student was cleared by the JM to exit the aircraft ('Climb Out') onto the right-hand side undercarriage step. The Student then dangled (hung) from the wing strut, settled himself and on receiving the 'Go' command from the JM, released his grip to fall away. See **Photo No. 1** for aircraft configuration for skydiving operations.

Photo No. 1: Aircraft configuration for Skydiving Operations

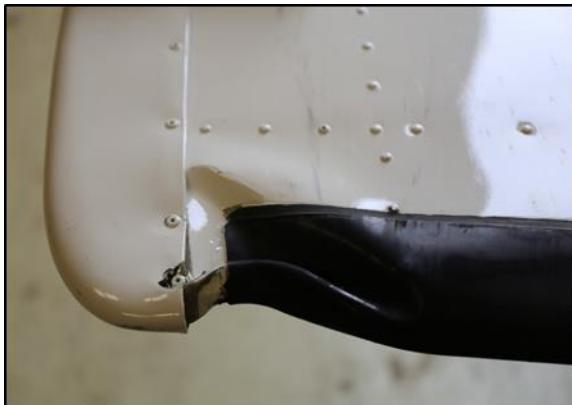
- Impact indentation on the leading edge of the right horizontal stabiliser close to the stabiliser tip (**Photo No. 2**).
- Skin damage in the form of a tear to the outer portion of the trailing edge of the horizontal stabiliser in the vicinity of the elevator trim tab (**Photo No. 3**).

Photo No. 2: Leading edge indentation

Significant damage was caused to the empennage of the aircraft as a result of excessive, asymmetric loads coming to bear on the horizontal stabiliser. It is considered likely that the unfurling (un-inflated) canopy positioned itself over the top section of the right-hand side horizontal stabiliser and the lines ran over the leading edge tip of stabiliser and down towards the descending Student. When the Student became suspended at full length ('*on the lines*') his deceleration would have exerted significant loads in the fore and aft plane of the horizontal stabiliser. This resulted in denting of the leading edge of the horizontal stabiliser and significant damage to the empennage. Once the Student '*cut-away*' his main canopy, the tension/load would have been released from the lines. It is possible that around the same time, some form of initial inflation occurred to the main canopy, thereby creating a force to pull the now-released lines and canvas risers over the starboard horizontal stabiliser.

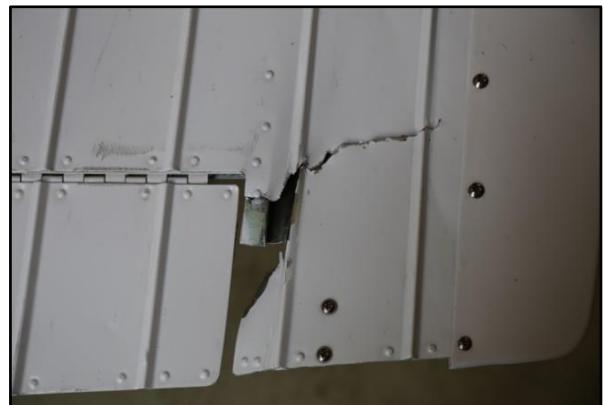
Photo No. 3: Tear to trailing edge skin

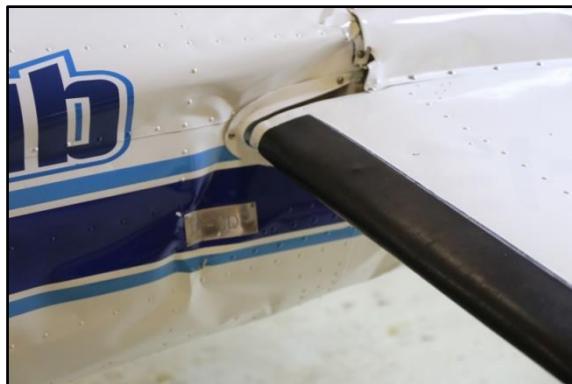
- Significant structural damage to either side of the rear fuselage skin adjacent to the horizontal stabiliser root area (**Photos No. 4 & 5**).

Photos No. 4 & 5: Significant structural damage to either side of the rear fuselage

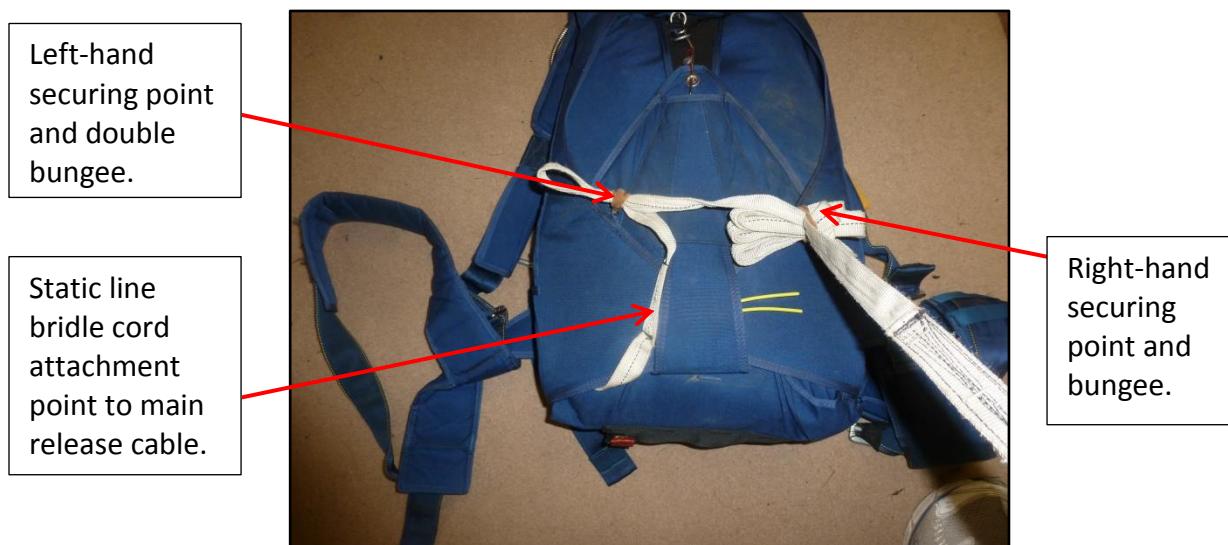
The parachute container has one securing point on each side of the rear of the container (**Photo No. 8**). The left-side securing point utilises two static line bungees (two *rubber bands*) and is used to secure the static line to the container and provide a level of protection upstream of the main release cable. In other words the static line has to be pulled through the double bungees before a pull can occur on the main release cable. This reduces the risk of a premature pack opening by the effect of airflow or snagging. The second securing point (right-side) utilises one bungee and is used to secure excessive static line slack as the skydiver walks to the aircraft. Once in the aircraft this particular bungee is released.

Photo No. 8: Bungee securing points

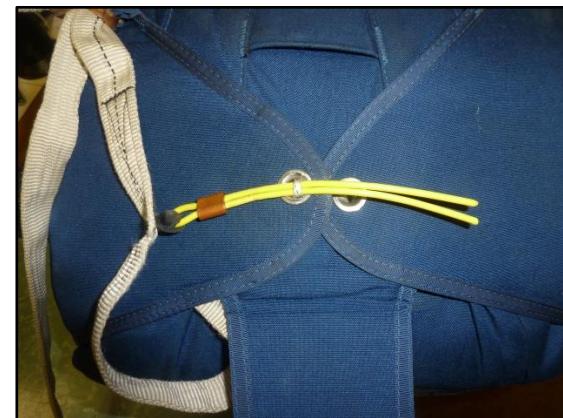
The main release mechanism is generally of two different types. The first employs a metal pin (**Photo No. 9**) and is usually used by experienced skydivers. The second type, as was used in the subject event, is a Teflon-coated yellow cable (**Photo No. 10**) that measures 12 cm in length and is used by students and inexperienced skydivers. The increased length of the Teflon-coated cable over that of the metal pin, offers a greater element of pull-through protection, thereby reducing the risk of premature release.

Photo No. 10: Main cable release

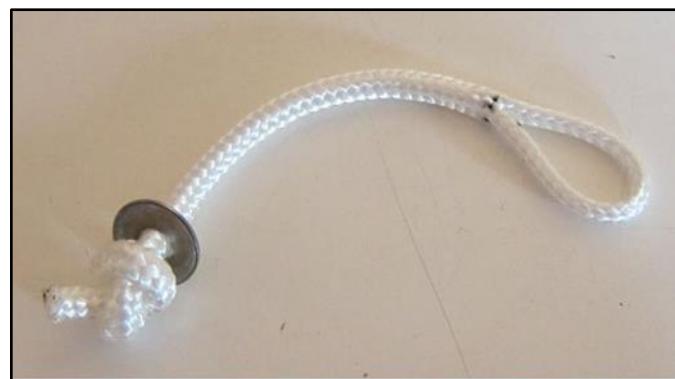
A '*closing loop*' (**Photo No. 11**) is a short length of cord with a loop at one end and a knot and washer at the other end, which is connected to an inner flap on the container. The purpose of the '*closing loop*' is to secure the main pin/cable outside the container flaps in order to keep the main canopy D-bag and lines within the container until deployment.

Photo No. 11: Closing loop

A '*closing loop*' that is too long, or a container system that does not secure the container flaps under tension, could allow a premature release of the main release cable and lead to an out-of-sequence deployment.

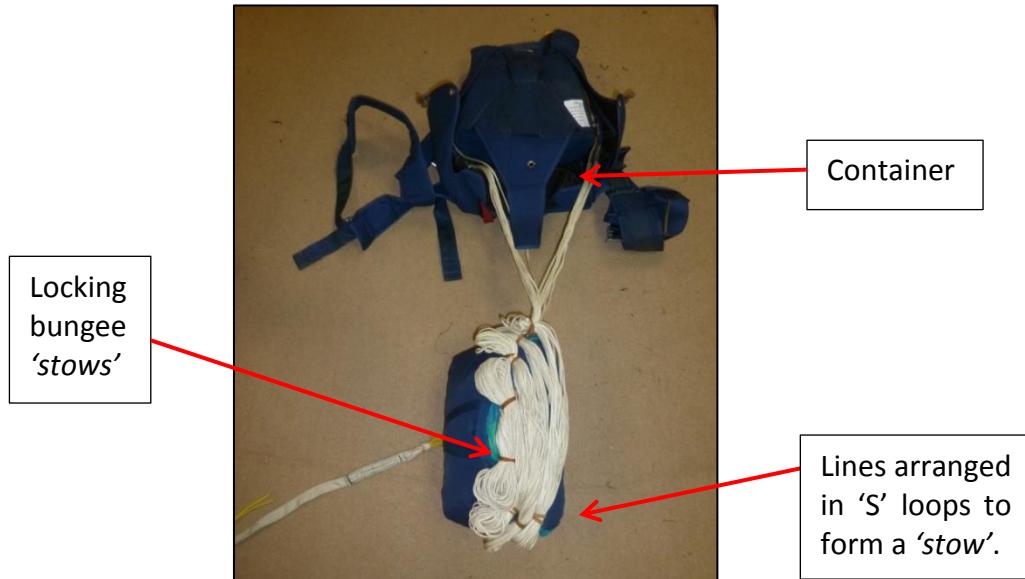
The suspension lines, which connect the main canopy to the harness, are located on top of the D-Bag during packing (**Photo No. 13**) and placed within the container. The lines are arranged in 'S' loops to form a '*stow*' and are secured by bungees on the bag. It is considered good practice to double wrap the locking bungee '*stows*' in order to ensure proper tension (approx 12 pounds). This allows for a sequenced release of the lines during deployment. If the '*stows*' are not tightly wrapped (for example using only one bungee), little pull force would be required to pull the lines from the '*stow*' bungees and therefore there is a risk that the lines could suffer a '*Line-dump*'. A '*Line-dump*' occurs when the lines are dumped out of their '*stow*' bungees as the D-Bag releases from the container. Without '*stow*' bungees to hold the bag closed, the canopy will release into the airflow and will begin to inflate before the skydiver reaches the end of the lines.

Photo No. 13: Suspension lines in 'S' loops and double wrapped locking bungee 'stows' on the D-Bag.
