**AIR ACCIDENT
INVESTIGATION UNIT**

PRELIMINARY ACCIDENT REPORT

Report No:	2007-015
1. AIRCRAFT MANUFACTURER:	Aerospatiale (Eurocopter)
Model:	AS 350B1
State of Registry:	Ireland
Registration:	EI-IHL
Serial Number:	1963
Year of Manufacture:	1987
2. OPERATOR:	Irish Helicopters Ltd
3. TYPE OF OPERATION:	Aerial Work
4. DATE / TIME:	12 July 2007 @ 11.23 hrs UTC
5. POSITION OF OCCURRENCE:	Ballynacally, County Clare
6. PERSONS ON BOARD:	Crew: 2 Passengers: nil
7. INJURIES:	Crew: 2, (1 fatal) Passengers: nil
8. DAMAGE:	The helicopter was destroyed
9. INVESTIGATOR-IN-CHARGE:	Mr Leo Murray

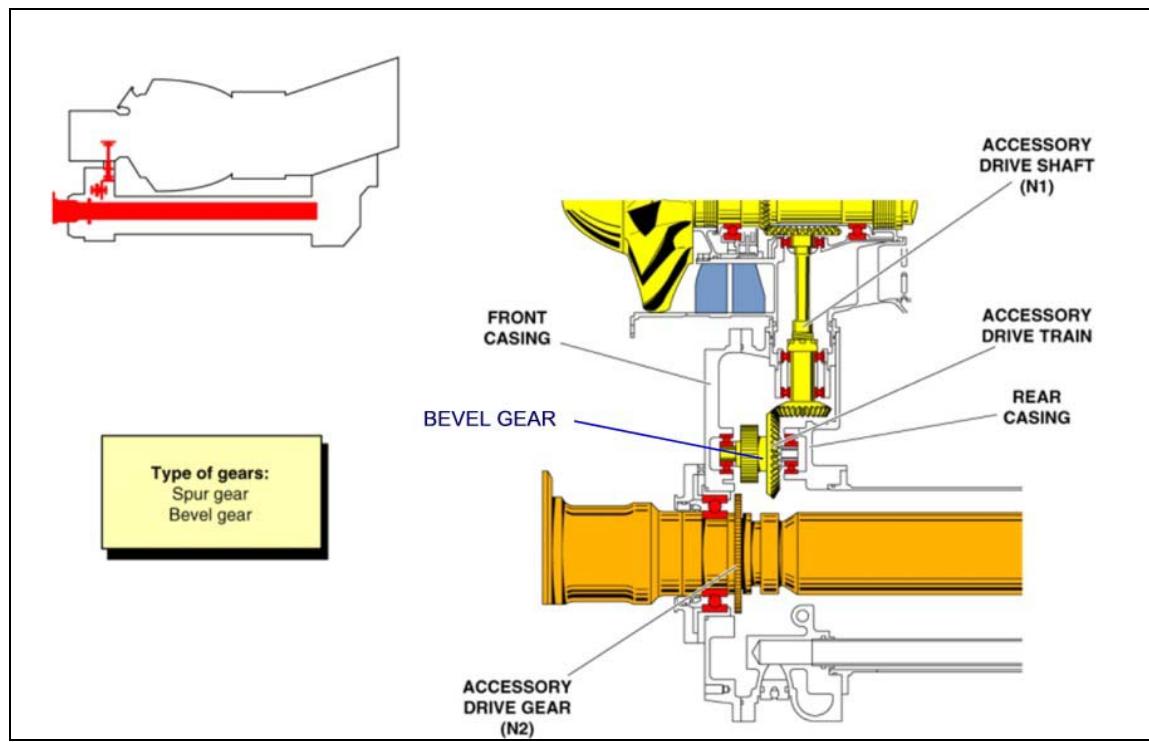
Fig. 1 Schematic of Arriel 1D accessory drive gearing

The helicopter concerned was powered by a single Arriel 1D turbine engine, Serial No. 7035. The wreckage was recovered to the AAIU facility at Gormanston in County Meath for examination. The engine was removed and taken to the Manufacturers' facility at Tarnos, France for detailed examination under the supervision of the AAIU. Opening of the transmission shaft and accessory gearbox revealed that the Bevel Gear of the Accessory Drive Train had disintegrated (see **Appendix A**).

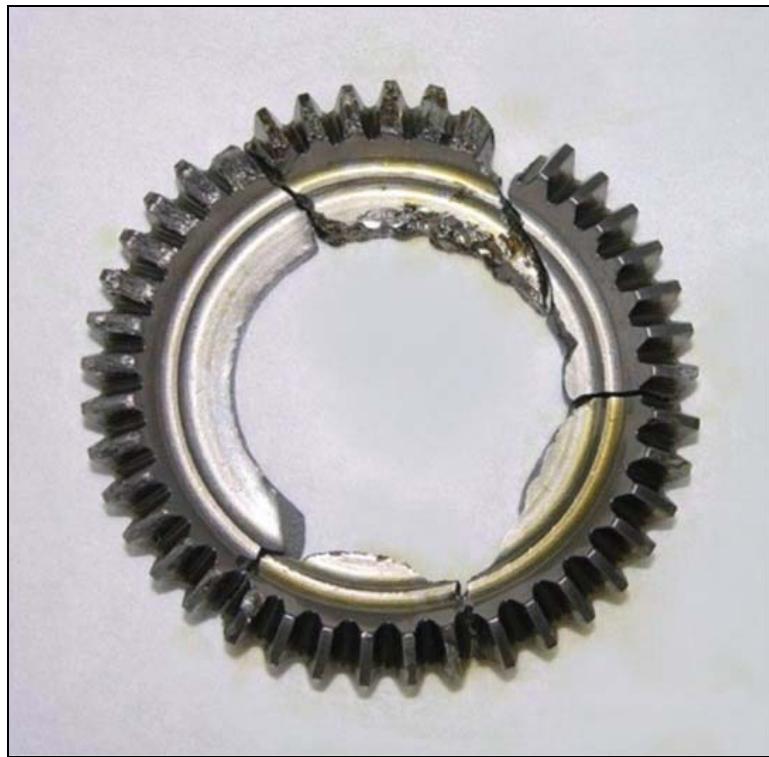
The cause of this failure has yet to be determined. The direct effect of this failure was to stop the fuel supply, causing stoppage of the engine within seconds.

Fig. 2 Bevel gear fragments

The Irish Aviation Authority review the suitability of single-engine helicopters operating on Aerial Work Permits engaged in low-level operations.

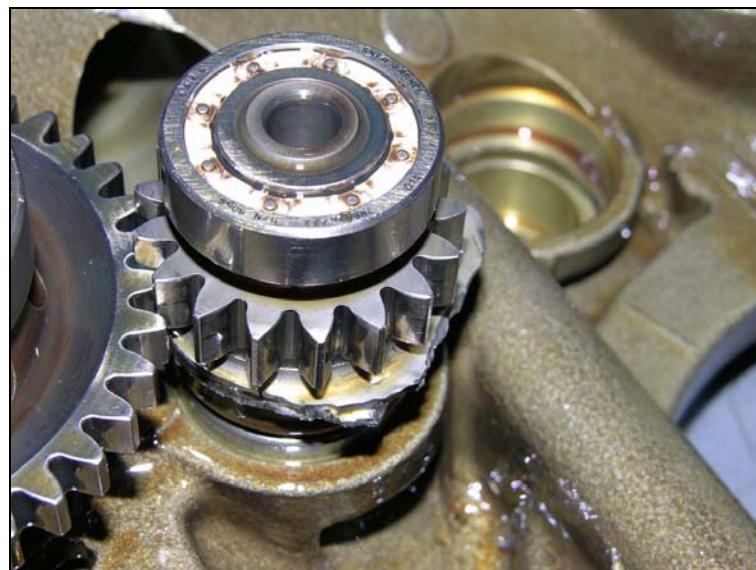
Fig. 3 Remains of bevel gear on accessory drive train
