**ACCIDENT**

| <b>Aircraft Type and Registration:</b> | Boeing 737-800, EI-DLV | |
| <b>Nature of Damage:</b> | Failure of left nose landing gear axle and separation of left nosewheel | |

**Synopsis**

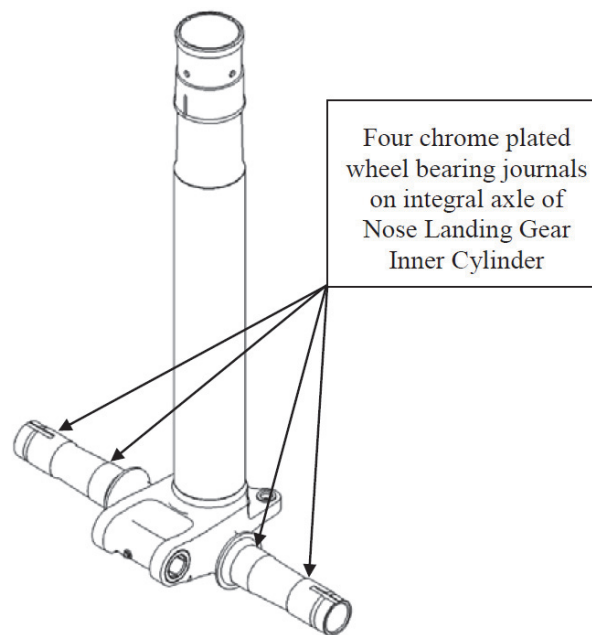
**Figure 3**

The nosewheel axles are integral parts of the NLG inner cylinder (Figure 3). Each axle has an inboard and an outboard journal onto which the two bearings from each nosewheel are fitted. The axles are made of a high strength steel alloy and the journals are chrome plated with a minimum chrome thickness of 0.003 inches. The highest stressed area of the axle is at the 6 o'clock position and the highest stress occurs during landing when the nosewheels touch down and load the axles upwards.

NLG inner cylinder with its four chrome plated wheel bearing journals
