AAIB Special Bulletins / Interim Reports

Aircraft Type and Registration:	EC225 LP Super Puma, G-REDW	
No & Type of Engines:	2 Turbomeca Makila 2A1 turboshaft engines	
Year of Manufacture:	2009 (Serial no: 2734)	
Date & Time (UTC):	10 May 2012 at 1114 hrs	
Location:	20 nm east of Aberdeen	
Type of Flight:	Commercial Air Transport (Passenger)	
Persons on Board:	Crew - 2	Passengers - 12
Injuries:	Crew - None	Passengers - 2 (Minor)
Nature of Damage:	Salt water immersion	
Commander's Licence:	Airline Transport Pilot's Licence	
Commander's Age:	40 years	
Commander's Flying Experience:	3,060 hours (of which 2,740 hours were on type)	
Information Source:	AAIB Field Investigation

Aircraft Type and Registration:	EC225 LP Super Puma, G-CHCN	
No & Type of Engines:	2 Turbomeca Makila 2A1 turboshaft engines	
Year of Manufacture:	2007 (Serial no: 2679)	
Date & Time (UTC):	22 October 2012 at 1425 hrs	
Location:	In the North Sea, approximately 32 nm southwest of Sumburgh, Shetland Islands	
Type of Flight:	Commercial Air Transport (Passenger)	
Persons on Board:	Crew - 2	Passengers - 17
Injuries:	Crew - None	Passengers - None
Nature of Damage:	To be assessed following salt water immersion	
Commande

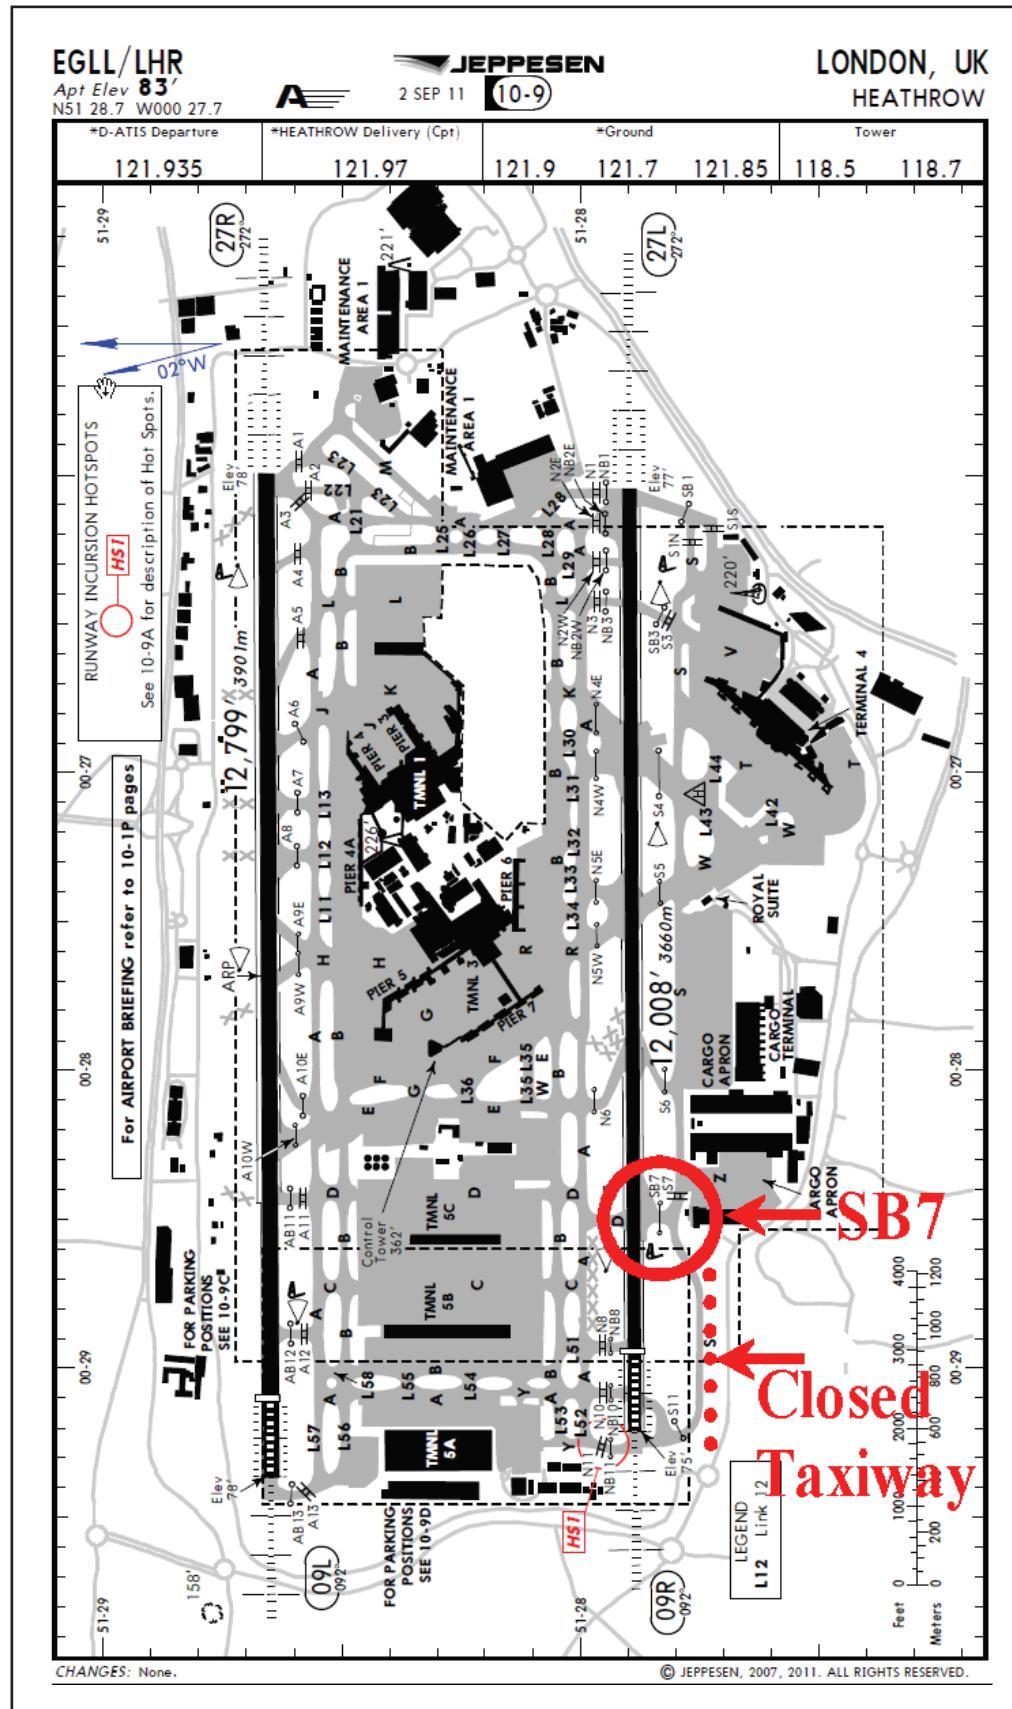
Figure 1
Heathrow Airport chart

At the time of the incident, the departure runway was 09R. The airport operator was expecting to initiate low visibility procedures (LVP) and Taxiway S, between SB7 and S11, was closed as a normal part of the preparation for such operations. Crews departing from Terminal 4 were offered the option of departing from the SB7 intersection or, if the aircraft required a longer runway, then they could be required to cross to the north of Runway 09R for departure. A chart of the airfield showing the SB7 intersection and the section of taxiway closed is shown in Figure 1.

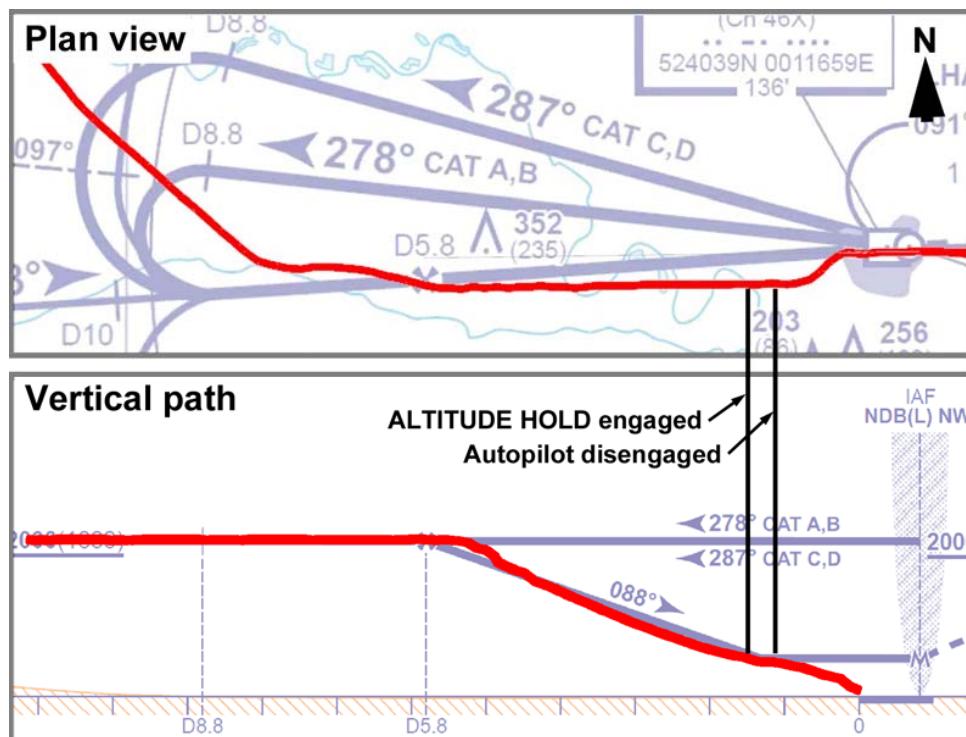
the wind was from 110° at 07 kt. The commander, who was pilot flying (PF), subsequently briefed for radar vectors to the final approach for an NDB/DME approach to Runway 09. The co-pilot, who had gained his captaincy seven months before the incident, was the pilot monitoring (PM). Figure 1 shows the NDB/DME approach plate to Runway 09, with flight path overlay.

Excerpt from NDB/DME approach plate, Runway 09 at Norwich, with flight path overlay

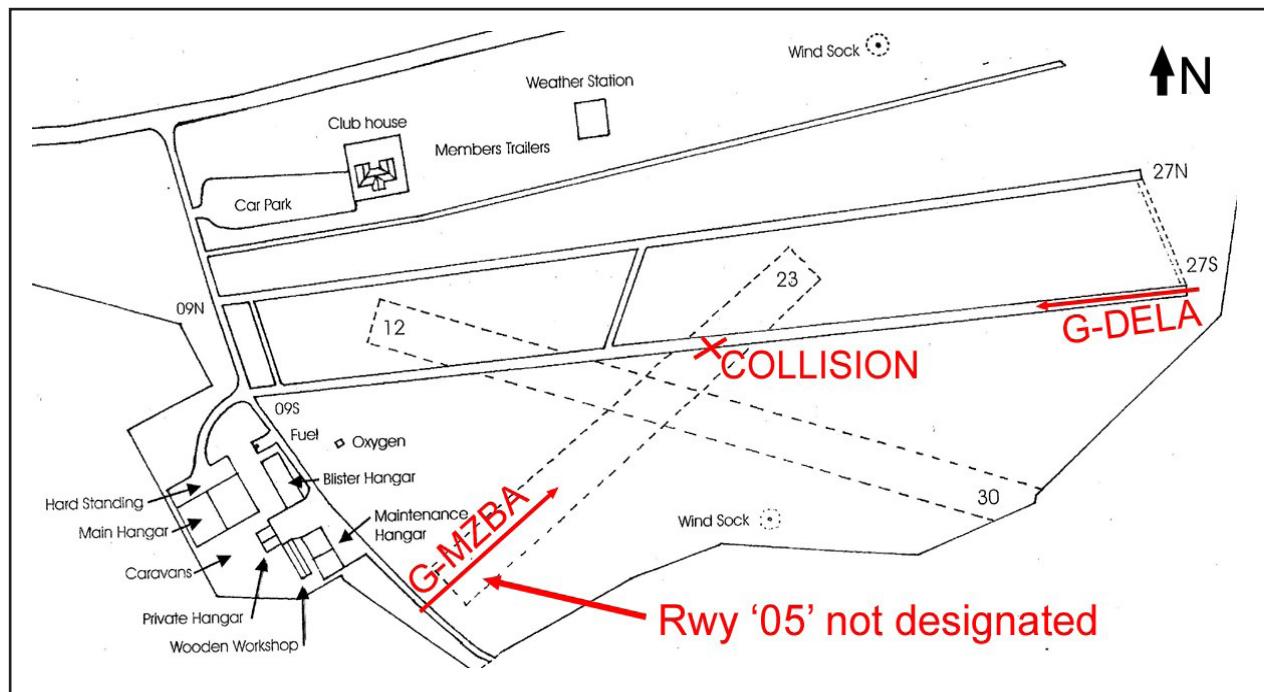
Figure 1

Aboyne airfield is an unlicensed airfield operated by Deeside Gliding Club and used primarily by gliders. It has two parallel paved runways, 09N/27N and 09S/27S (Figure 1), and two intersecting grass runways, 12/30 and 05/23, although Runway 05 is not designated. The pilot of the glider G-DELA was returning to the airfield after a two-hour flight and joined overhead at 1,500 ft aal to determine the wind direction and circuit traffic. He assessed the wind as being a light northerly with occasional variations to the north-east. He elected to use Runway 27S which he stated was "normal for the given conditions" while accepting that there might be a small tailwind. He then saw another glider and

There is no specific reference to landing on Runway 05 and this runway is not designated as a runway on the club's airfield chart (Figure 1). However, the pilot of G-MZBA had worked on the construction of Runway 05/23; he commented that the reason the '05' was not marked on the ground or on the chart was because there had been insufficient funds for paving slabs for the '05' numbers and he considered that Runway '05' was available for use. The Chief Flying Instructor commented that in glider operations any grass area on the airfield is considered available for landing and thus, although Runway 05 was not designated, landing on that section of grass was not prohibited by the club's rules.
