Technical report

IN-049/2019

Incident involving two Boeing 737-8AS aircraft, registrations
EI-ENH and EI-DYR, on 11 September 2019 at Málaga
Airport

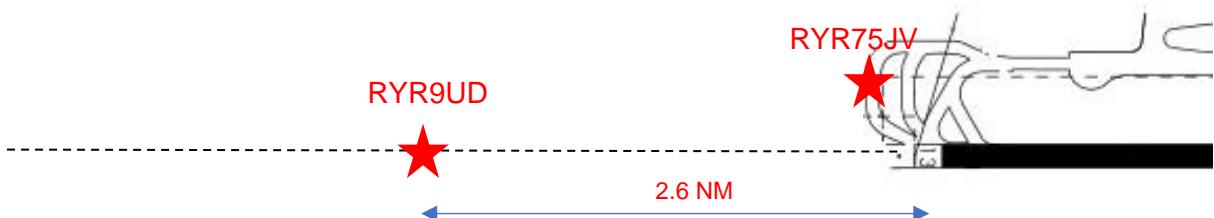
Illustration 5 Position of aircraft at 19:52:58 UTC

At 19:52:58 UTC, the trace shows aircraft RYR9UD established on final at 2.6 NM from the threshold of RWY13. At that moment, the RYR75JV aircraft had just passed the HN3 holding point signal.

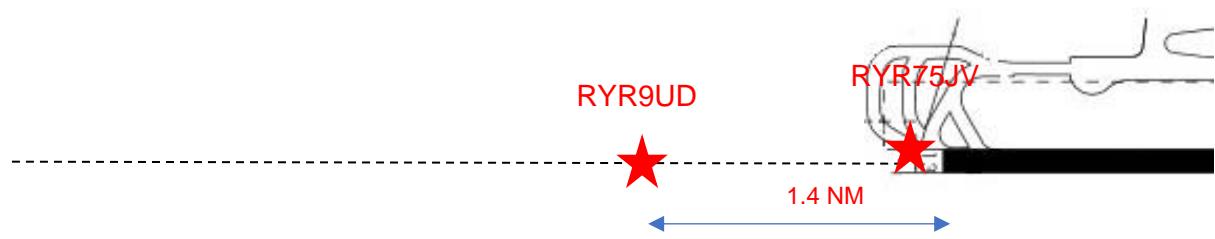
Illustration 6 Position of aircraft at 19:53:29 UTC

At 19:53:29 UTC, the trace shows aircraft RYR9UD established on final at 1.4 NM from the threshold of RWY 13 at an altitude of 500 ft AMSL, and aircraft RYR75JV proceeding to RWY 13, approaching the runway threshold.

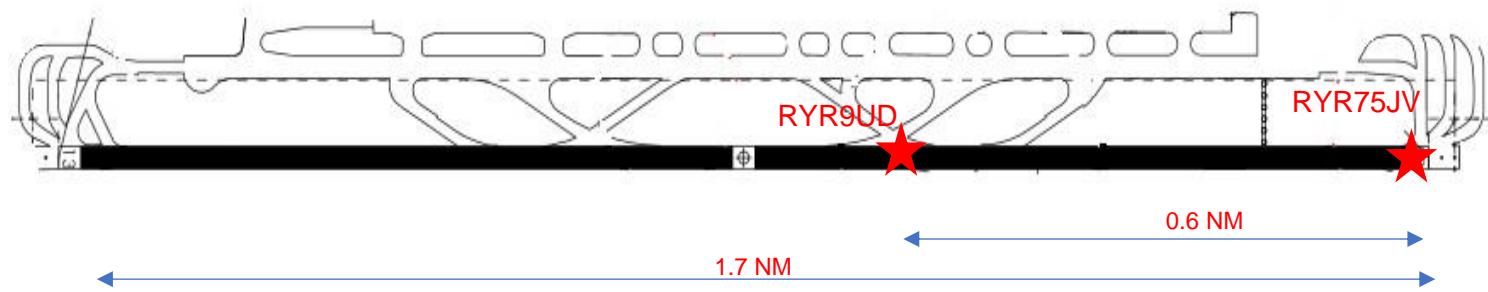
Illustration 12 Position of aircraft at 19:54:35 UTC

At 19:54:35 UTC, the trace shows aircraft RYR9UD decelerating during its landing roll-out on RWY 13, and aircraft RYR75JV on its initial climb, passing the threshold of runway 31 at an altitude of 700 ft AMSL. The distance between the two aircraft was 0.6 NM.

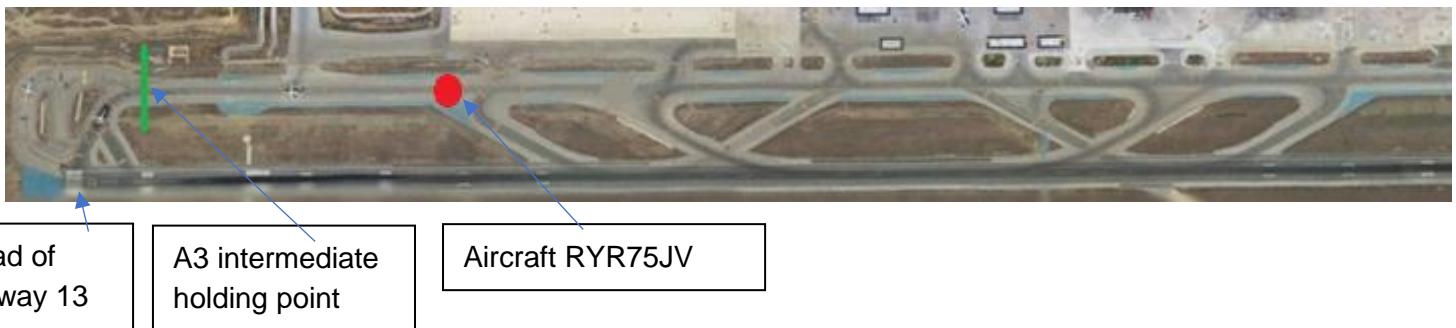
Illustration 14 Position of aircraft RYR75JV at 19:49:49 UTC

At 19:49:49 UTC, the LCL TWR LEMG controller instructed aircraft RYR75JV to hold short of the runway, and the crew acknowledged the instruction. At that moment, the RYR75JV aircraft was 600 m from the A3 intermediate holding point.

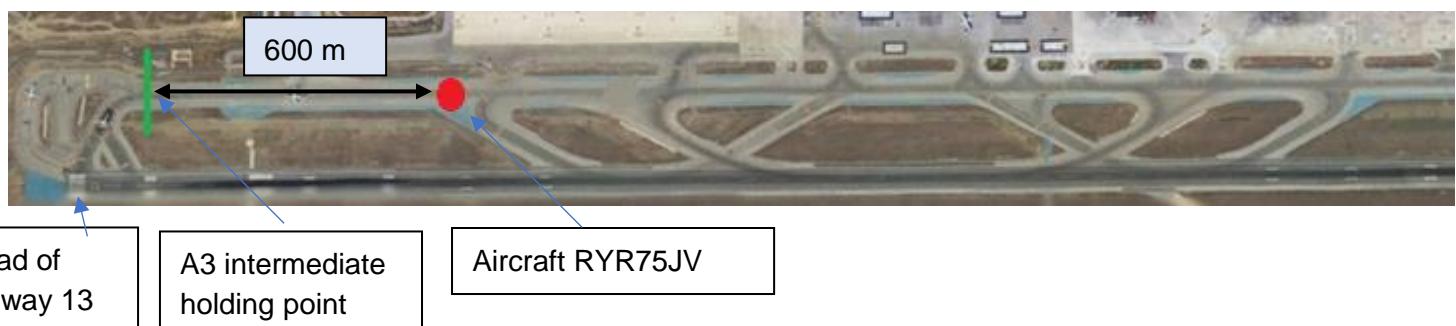
At 19:49:49 UTC, 30 seconds after the aircraft's last communication with the GMC position, the air traffic controller in the LCL position instructed aircraft RYR75JV to hold short of RWY 13. At that moment, the RYR75JV aircraft was 600 m from the A3 intermediate holding point.

Having not received specific instructions as to which holding point they should go to, the crew chose to taxi to holding point HN-3, which is the holding point furthest from the runway head.

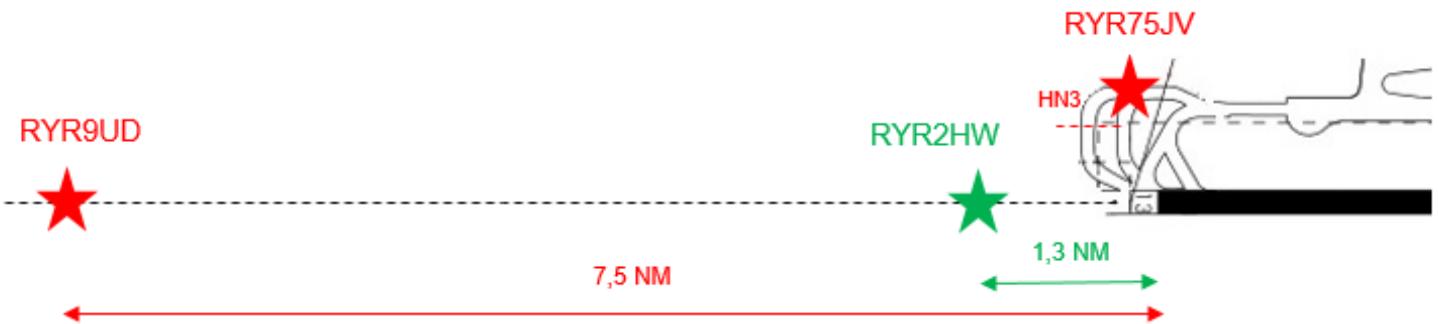
The LCL position controller planned to take advantage of the 6NM gap between two approaches to clear the take-off of the EI-ENH aircraft with callsign RYR75JV. The following image shows the relative positions of the aircraft at 19:51:17 UTC.

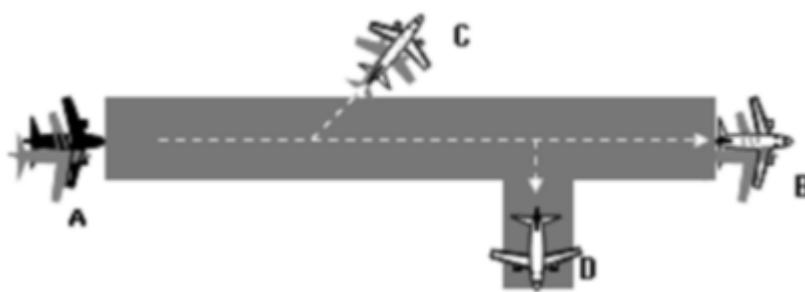
In the incident being analysed, the air traffic controller did not heed any of the three aforementioned instructions or provision 4.5.10.1.1 of the Air Traffic Regulations, which establishes the following:

The landing was authorised when the aircraft was practically above the runway threshold, allowing it to cross said threshold while the outbound aircraft was still on the runway. Moreover, there was no degree of assurance that the regulatory separation could be maintained, as the aircraft on approach was travelling faster than the aircraft on take-off, increasingly reducing the separation between the aircraft. The air traffic controller failed to anticipate the required separation between the aircraft.
