## SL 2020/14

## REPORT ON THE AIR ACCIDENT AT OSLO AIRPORT GARDERMOEN, NORWAY ON 18 DECEMBER 2018 WITH BOEING 787-9 DREAMLINER, ET-AUP OPERATED BY ETHIOPIAN AIRLINES

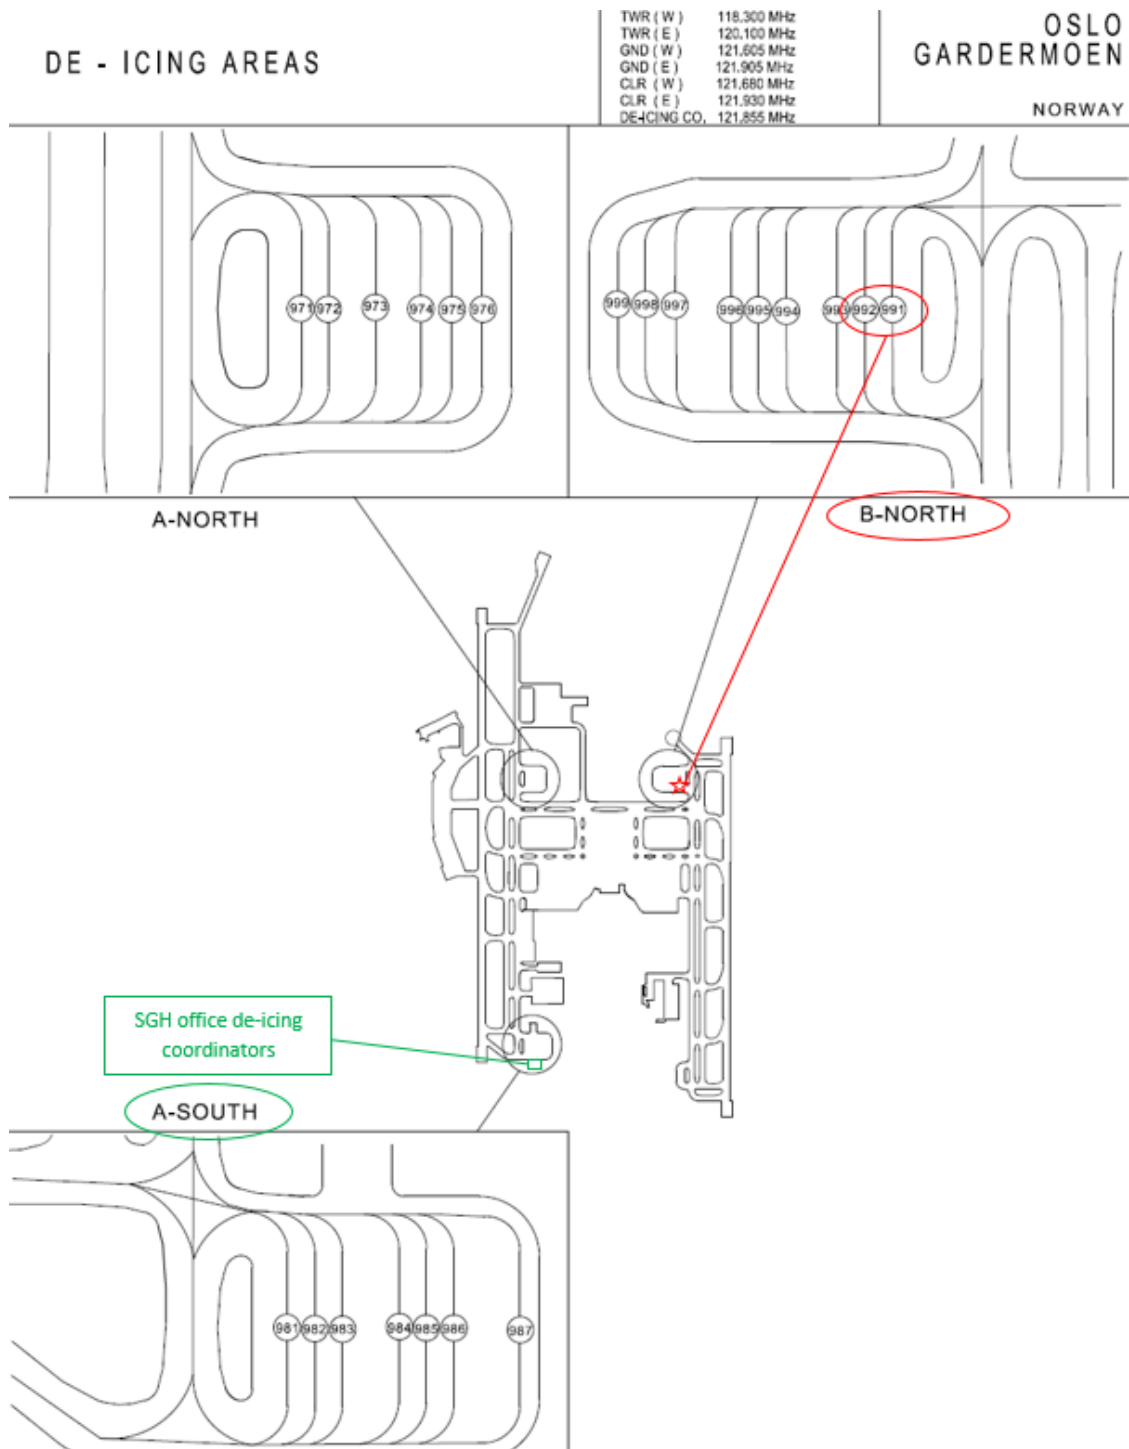
- 1.10.3 There were no electronic systems at the airport to automatically warn of an aircraft taxiing towards the wrong de-icing stand.
- 1.10.4 By way of comparison, at the terminal gates, there is a docking system which monitors and provides information about the nose of the aircraft in relation to its correct position. The system notifies both the crew and the gate personnel in the event of any deviation.

Figure 8: The AIP chart current at the time of the accident shows Oslo Airport Gardermoen with the location of the de-icing areas and the SGH office used by the de-icing coordinators. Source: Avinor. Illustration: AIBN

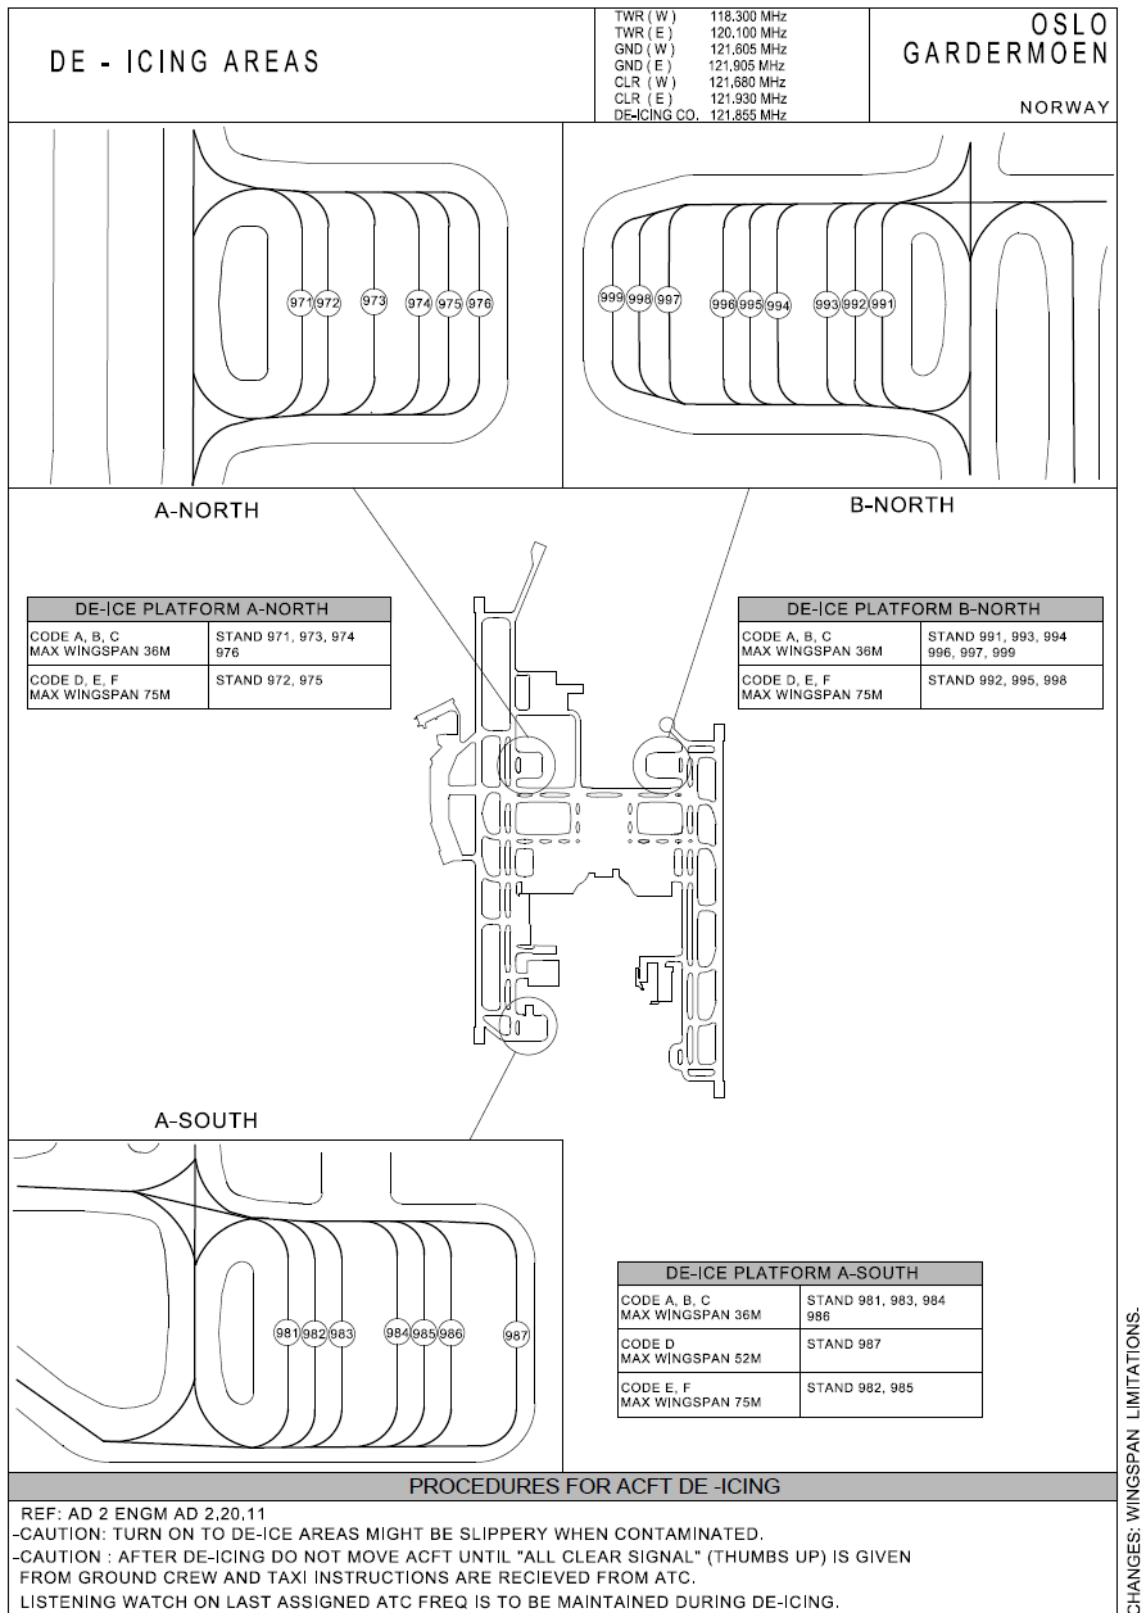
The information above was included in AIP Norway on 10 October 2019 (see Figure 14).

Figure 14: Revised AIP chart from October 2019 announcing the maximum allowed wingspan at the various de-icing stands. Source: Avinor
